# Site ID: **a-65084**

## Management with Targeted Refurbishment Survey

1 Midwinter Close  
Cheltenham  
Gloucestershire  
GL50 4PQ  
United Kingdom

**26th March 2016**

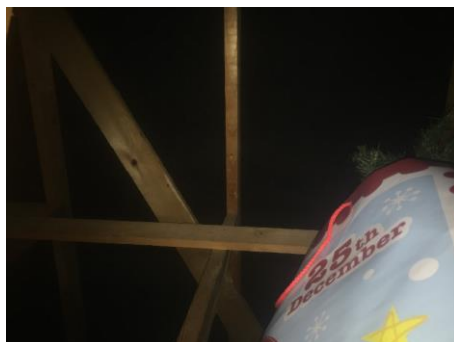
**a-65084-i01-01**

Roof felt

It has been noted in previous experience that this type of material has been known to contain asbestos.

Until such time as proven otherwise, the material should be managed as an asbestos containing product in accordance with CAR 2012 and subject to regular inspection.

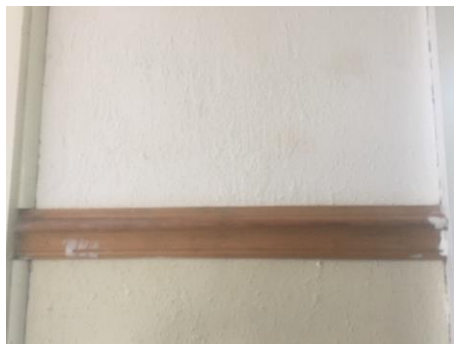
**a-65084-i02-02**

Brushed pattern extending to ceiling on stair well

**No asbestos was detected in the material tested.**

**No further action is required.**

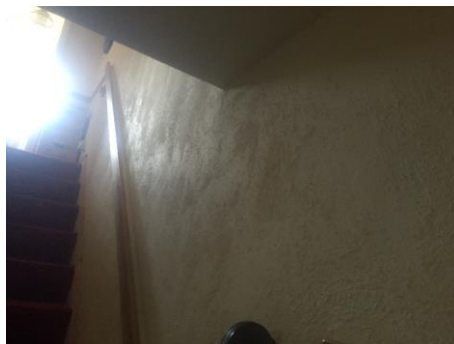
**a-65084-i09-03**

Brushed pattern extending to ceiling on stair well

**No asbestos was detected in the material tested.**

**No further action is required.**

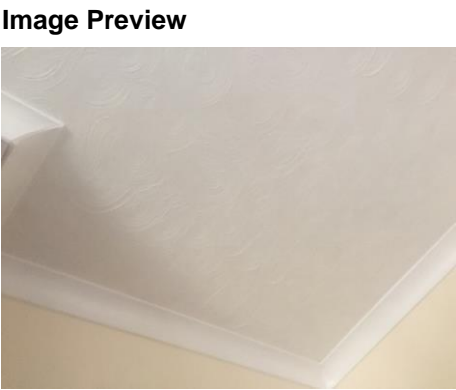
Site ID	Sample ID
<b>a-65084</b>	<b>a-65084-i11-04</b>

**Description**  
Wave pattern

**Comments**  
No asbestos was detected in the material tested.

**Recommendations**  
No further action is required.

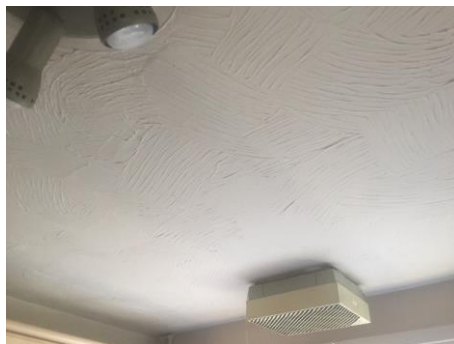
**a-65084-i14-05**

Brushed pattern

**No asbestos was detected in the material tested.**

**No further action is required.**

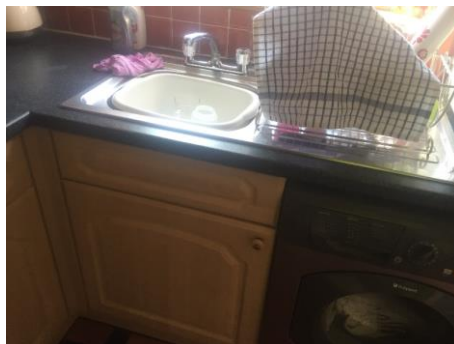
**a-65084-i14-06**

Bitumen sink pad

**No asbestos was detected in the material tested.**

**No further action is required.**

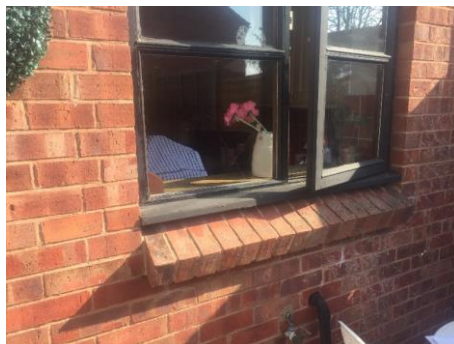
**a-65084-e01-07**

Sealant to all windows and doors

**No asbestos was detected in the material tested.**

**No further action is required.**

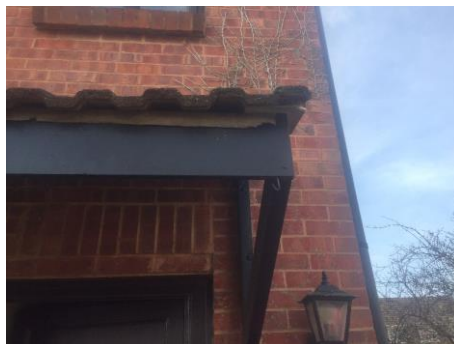
**a-65084-e01-08**

Undercloaking to canopy

The material was seen to be in fair condition at the time of the initial inspection.

The condition of the material should be managed by a competent person/company and its presence made aware to those at risk, as part of a Control of Asbestos Regulations (CAR) 2012 compliant management strategy.

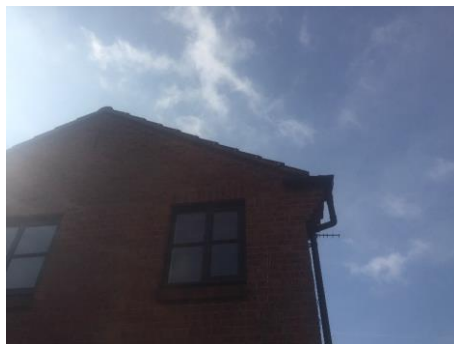
**a-65084-e01-09**

Undercloaking to roof

It has been noted in previous experience that this type of material has been known to contain asbestos.

Until such time as proven otherwise, the material should be managed as an asbestos containing product in accordance with CAR 2012 and subject to regular inspection.

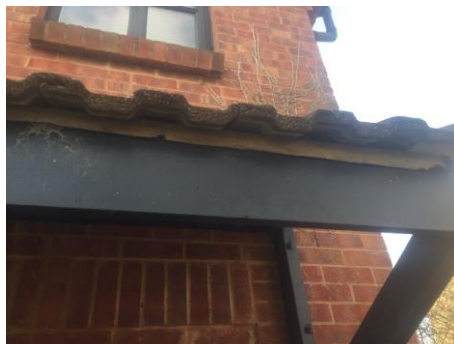
**a-65084-e01-10**

Canopy roof felt

**No asbestos was detected in the material tested.**

**No further action is required.**
