## Management Survey (with MA only)

**9-49 Various  
Haydon Court  
Swindon**

**,  
SN25 1QN**

**Sanctuary Group**

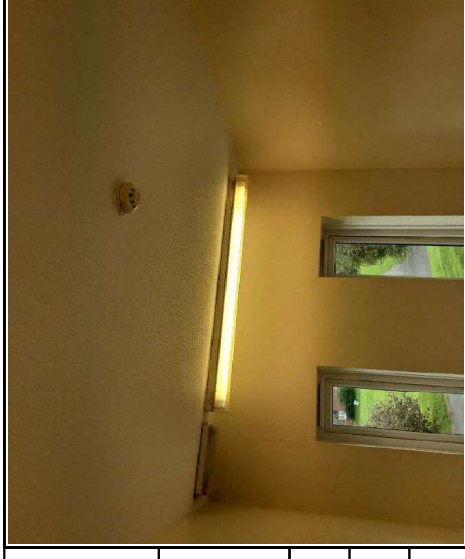
| Damage & Deterioration: | Good Condition | | |

| Risk Assessment Category: | Very Low |

| Recommendation: | Manage and Monitor |

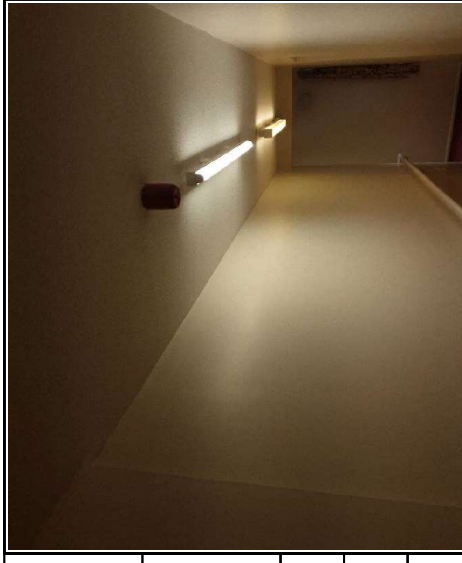
| Inspection Number: | 2 | Intrusive Area – Yes or No: | No |

| Damage & Deterioration: | Good Condition | | |

| Risk Assessment Category: | N/A |

| Recommendation: | Not applicable |

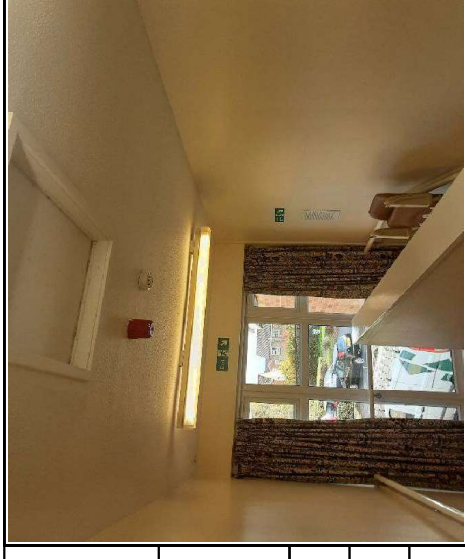
| Inspection Number: | 3 | Intrusive Area – Yes or No: | No |

| Damage & Deterioration: | Good Condition | | |

| Risk Assessment Category: | Very Low |

| Recommendation: | Manage and Monitor |

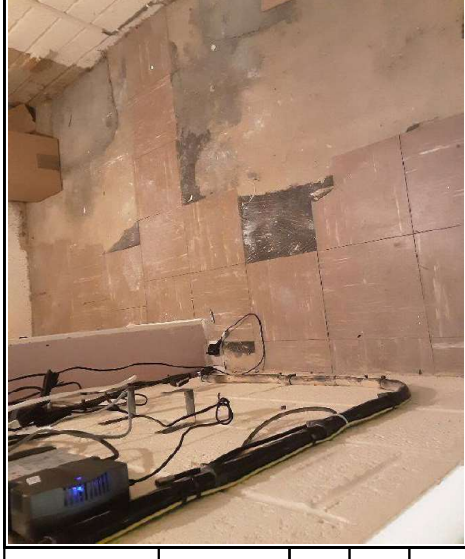
| Inspection Number: | 8 | Intrusive Area – Yes or No: | No |

| Damage & Deterioration: | Medium Damage | | |

| Risk Assessment Category: | N/A |

| Recommendation: | Not applicable |

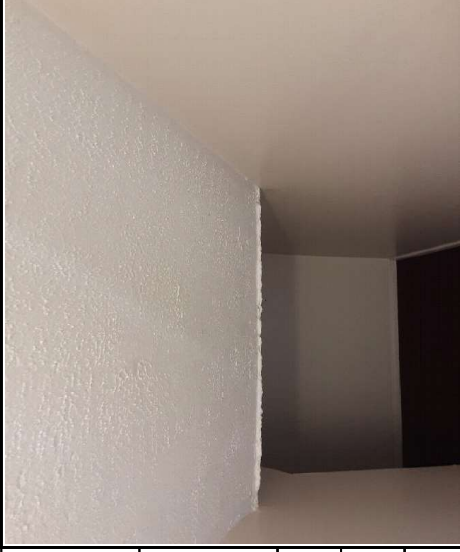
| Damage & Deterioration: | Low Damage | | |
| Asbestos Type: | Chrysotile | | |
| Material Score: | 4 | | |

| Recommendation: | Manage and Monitor | |

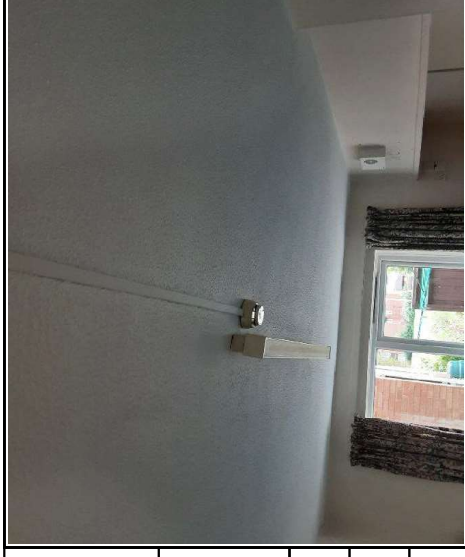
| Damage & Deterioration: | Low Damage | | |

| Risk Assessment Category: | Very Low |

| Recommendation: | Manage and Monitor |

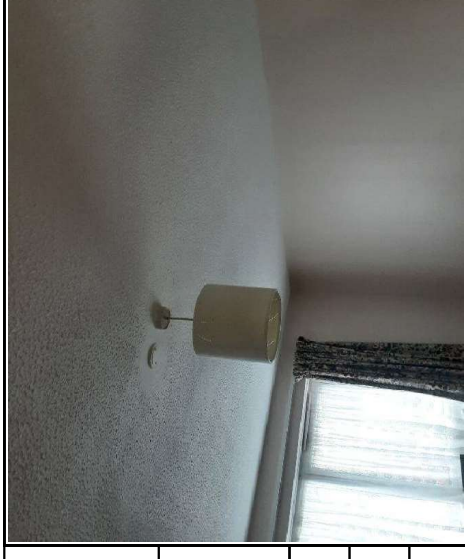
| Inspection Number: | 13 | Intrusive Area – Yes or No: | No |

| Damage & Deterioration: | Good Condition | | |

| Risk Assessment Category: | Very Low | | |

| Recommendation: | Manage and Monitor | | |

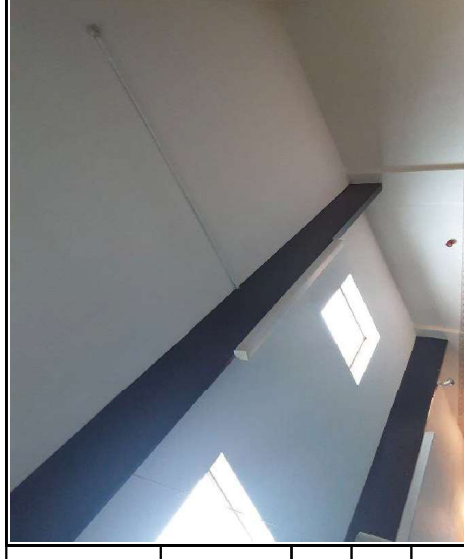
| Inspection Number: | 18 | Intrusive Area – Yes or No: | No |

| Damage & Deterioration: | Good Condition | | |

| Risk Assessment Category: | Very Low | | |

| Recommendation: | Manage and Monitor | | |

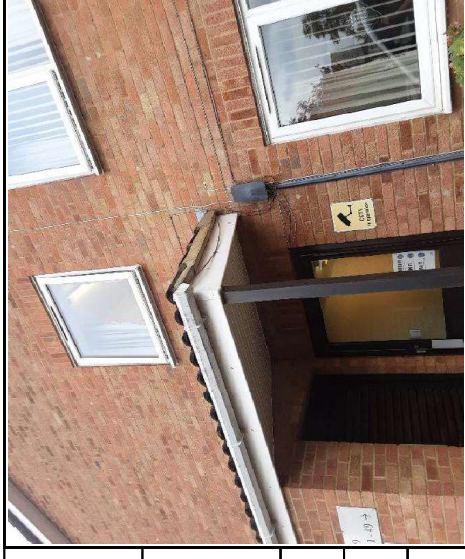
| Inspection Number: | 25 | Intrusive Area – Yes or No: | No |

| Damage & Deterioration: | Good Condition | | |

| Risk Assessment Category: | <b>Very Low</b> |

| Recommendation: | <b>Manage and Monitor</b> |

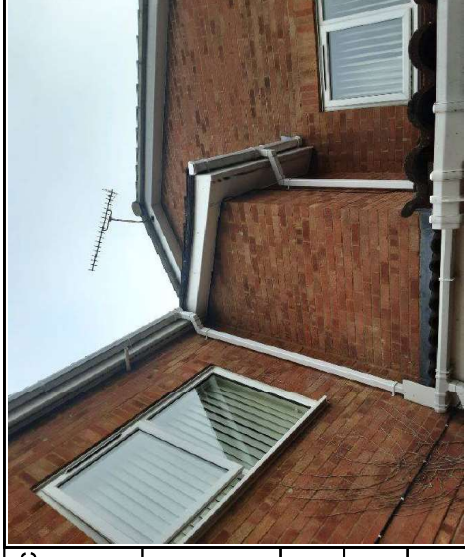
| Inspection Number: | 29 | Intrusive Area – Yes or No: | No |

| Damage & Deterioration: | Good Condition | | |

| Risk Assessment Category: | Very Low | | |

| Recommendation: | Manage and Monitor | | |
