# Management Survey with part Refurbishment

Swindon Borough Council

Survey Reference Number: A-04697

VOID  
5 Lewisham Close  
Moreton  
Swindon  
SN25 3EF

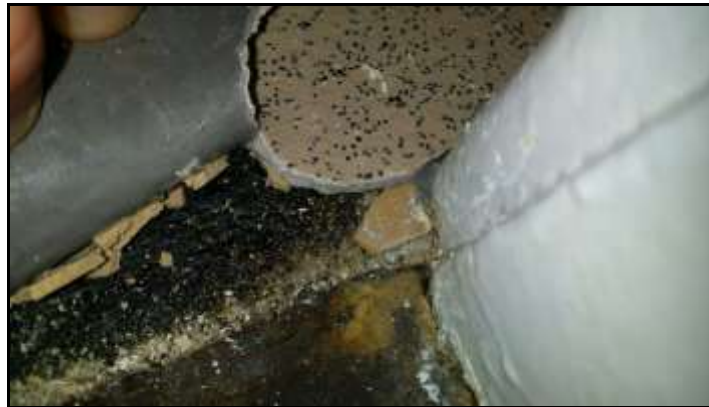
<b>Area Title</b>	Kitchen
<b>Floor / Level</b>	Ground Floor
<b>Product Type</b>	Floor Tile + Adhesive
<b>Sample Reference</b>	Previously Sampled
<b>Item Description</b>	Floor : Floor Tile + Adhesive
<b>Estimated Extent</b>	6 m <sup>2</sup>

<b>Product Type</b>	Asbestos reinforced composites etc.	1
<b>Treatment</b>	Refer to Appendix III	0
<b>Damage Extent</b>	Good Condition	0
<b>Asbestos Type</b>	Chrysotile	1
<b>Material Factor Rating</b>		2

<b>Material Factor Rating</b>	Result from Material Assessment (above)	2
<b>Material Category</b>	Potential for fibre release	Very Low

Remove if affected by works - Should this item be affected by the upcoming planned works then it should be removed in accordance with current legislation, if not then the item can be left in place. Asbestos warning stickers may be applied.

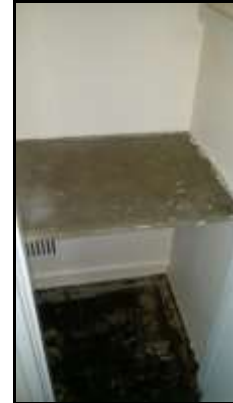
<b>Area Title</b>	Store 1
<b>Floor / Level</b>	Ground Floor
<b>Product Type</b>	Asbestos Cement
<b>Sample Reference</b>	Previously Sampled
<b>Item Description</b>	Shelf: Asbestos Cement
<b>Estimated Extent</b>	1 no

<b>Product Type</b>	Asbestos reinforced composites etc.	1
<b>Treatment</b>	Refer to Appendix III	1
<b>Damage Extent</b>	Good Condition	0
<b>Asbestos Type</b>	Chrysotile	1
<b>Material Factor Rating</b>		3

<b>Material Factor Rating</b>	Result from Material Assessment (above)	3
<b>Material Category</b>	Potential for fibre release	Very Low

Manage - Condition and surface treatment are adequate for the material to be left in place. Asbestos warning stickers may be applied.

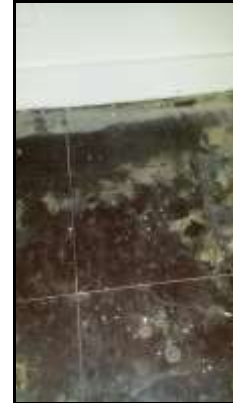
<b>Area Title</b>	Store 1
<b>Floor / Level</b>	Ground Floor
<b>Product Type</b>	Floor Tile + Adhesive
<b>Sample Reference</b>	Previously Sampled
<b>Item Description</b>	Floor: Floor Tile + Adhesive
<b>Estimated Extent</b>	2 m <sup>2</sup>

<b>Product Type</b>	Asbestos reinforced composites etc.	1
<b>Treatment</b>	Refer to Appendix III	0
<b>Damage Extent</b>	Low Damage	1
<b>Asbestos Type</b>	Chrysotile	1
<b>Material Factor Rating</b>		3

<b>Material Factor Rating</b>	Result from Material Assessment (above)	3
<b>Material Category</b>	Potential for fibre release	Very Low

Remove if affected by works - Should this item be affected by the upcoming planned works then it should be removed in accordance with current legislation, if not then the item can be left in place. Asbestos warning stickers may be applied.

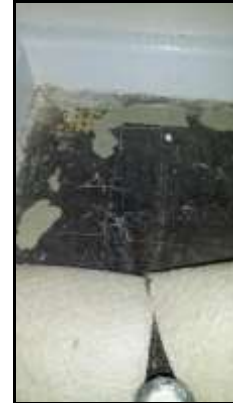
<b>Area Title</b>	Hall
<b>Floor / Level</b>	Ground Floor
<b>Product Type</b>	Floor Tile + Adhesive
<b>Sample Reference</b>	S001
<b>Item Description</b>	Floor : Floor Tile + Adhesive
<b>Estimated Extent</b>	6 m <sup>2</sup>

<b>Product Type</b>	Asbestos reinforced composites etc.	1
<b>Treatment</b>	Refer to Appendix III	0
<b>Damage Extent</b>	Good Condition	0
<b>Asbestos Type</b>	Chrysotile	1
<b>Material Factor Rating</b>		2

<b>Material Factor Rating</b>	Result from Material Assessment (above)	2
<b>Material Category</b>	Potential for fibre release	Very Low

Manage - Condition and surface treatment are adequate for the material to be left in place. Asbestos warning stickers may be applied.

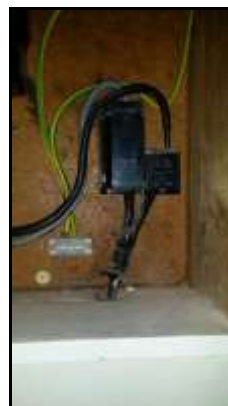
<b>Area Title</b>	Hall
<b>Floor / Level</b>	Ground Floor
<b>Product Type</b>	Well Bound Material
<b>Sample Reference</b>	Presumed
<b>Item Description</b>	Woven textile insulation: Well Bound Material
<b>Estimated Extent</b>	1 lin m

<b>Product Type</b>	Asbestos reinforced composites etc.	1
<b>Treatment</b>	Refer to Appendix III	0
<b>Damage Extent</b>	Good Condition	0
<b>Asbestos Type</b>	Presumed	1
<b>Material Factor Rating</b>		2

<b>Material Factor Rating</b>	Result from Material Assessment (above)	2
<b>Material Category</b>	Potential for fibre release	Very Low

Inspection Required - It was not possible to access and inspect the area or item during the survey. Presume asbestos material is present until full inspection is completed.

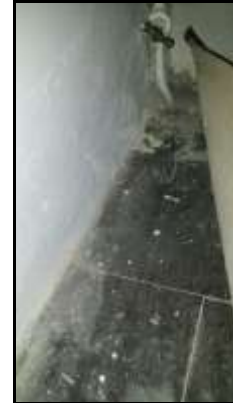
<b>Area Title</b>	Store 2
<b>Floor / Level</b>	Ground Floor
<b>Product Type</b>	Floor Tile + Adhesive
<b>Sample Reference</b>	Refer to 001
<b>Item Description</b>	Floor : Floor Tile + Adhesive
<b>Estimated Extent</b>	2 m <sup>2</sup>

<b>Product Type</b>	Asbestos reinforced composites etc.	1
<b>Treatment</b>	Refer to Appendix III	0
<b>Damage Extent</b>	Good Condition	0
<b>Asbestos Type</b>	Chrysotile	1
<b>Material Factor Rating</b>		2

<b>Material Factor Rating</b>	Result from Material Assessment (above)	2
<b>Material Category</b>	Potential for fibre release	Very Low

Manage - Condition and surface treatment are adequate for the material to be left in place. Asbestos warning stickers may be applied.

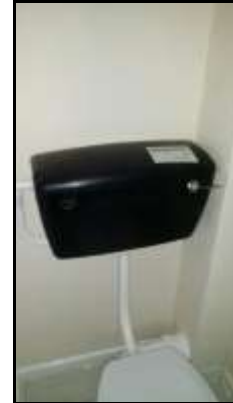
<b>Area Title</b>	Bathroom
<b>Floor / Level</b>	Ground Floor
<b>Product Type</b>	Reinforced Composite
<b>Sample Reference</b>	S003
<b>Item Description</b>	Cistern: Reinforced Composite
<b>Estimated Extent</b>	1 no

<b>Product Type</b>	Asbestos reinforced composites etc.	1
<b>Treatment</b>	Refer to Appendix III	0
<b>Damage Extent</b>	Good Condition	0
<b>Asbestos Type</b>	Amosite	2
<b>Material Factor Rating</b>		3

<b>Material Factor Rating</b>	Result from Material Assessment (above)	3
<b>Material Category</b>	Potential for fibre release	Very Low

Manage - Condition and surface treatment are adequate for the material to be left in place. Asbestos warning stickers may be applied.

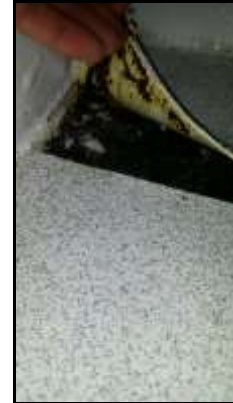
<b>Area Title</b>	Bathroom
<b>Floor / Level</b>	Ground Floor
<b>Product Type</b>	Bitumen Adhesive
<b>Sample Reference</b>	S002
<b>Item Description</b>	Floor : Bitumen Adhesive
<b>Estimated Extent</b>	6 m <sup>2</sup>

<b>Product Type</b>	Asbestos reinforced composites etc.	1
<b>Treatment</b>	Refer to Appendix III	0
<b>Damage Extent</b>	Good Condition	0
<b>Asbestos Type</b>	Chrysotile	1
<b>Material Factor Rating</b>		2

Manage - Condition and surface treatment are adequate for the material to be left in place. Asbestos warning stickers may be applied.

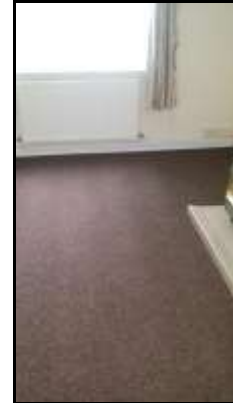
<b>Area Title</b>	Lounge
<b>Floor / Level</b>	Ground Floor
<b>Product Type</b>	Floor Tile + Adhesive
<b>Sample Reference</b>	Refer to 001
<b>Item Description</b>	Floor : Floor Tile + Adhesive
<b>Estimated Extent</b>	16 m <sup>2</sup>

<b>Product Type</b>	Asbestos reinforced composites etc.	1
<b>Treatment</b>	Refer to Appendix III	0
<b>Damage Extent</b>	Good Condition	0
<b>Asbestos Type</b>	Chrysotile	1
<b>Material Factor Rating</b>		2

Manage - Condition and surface treatment are adequate for the material to be left in place. Asbestos warning stickers may be applied.

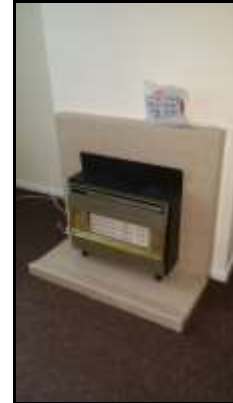
Entry	Floor	Location	Description
006	Ground Floor	Lounge - Behind Fireplace	No access behind fireplace - no gas certificate available

<b>Area Title</b>	Lounge
<b>Floor / Level</b>	Ground Floor
<b>Product Type</b>	No Access Gained
<b>Sample Reference</b>	No Access
<b>Item Description</b>	Behind Fireplace: No Access Gained
<b>Estimated Extent</b>	-

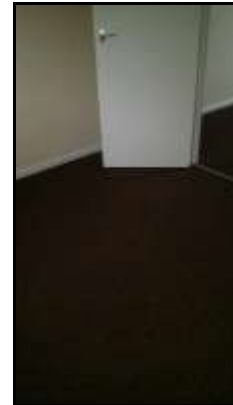
<b>Area Title</b>	Bedroom 1
<b>Floor / Level</b>	Ground Floor
<b>Product Type</b>	Floor Tile + Adhesive
<b>Sample Reference</b>	Refer to 001
<b>Item Description</b>	Floor : Floor Tile + Adhesive
<b>Estimated Extent</b>	12 m <sup>2</sup>

<b>Product Type</b>	Asbestos reinforced composites etc.	1
<b>Treatment</b>	Refer to Appendix III	0
<b>Damage Extent</b>	Good Condition	0
<b>Asbestos Type</b>	Chrysotile	1
<b>Material Factor Rating</b>		2

Manage - Condition and surface treatment are adequate for the material to be left in place. Asbestos warning stickers may be applied.

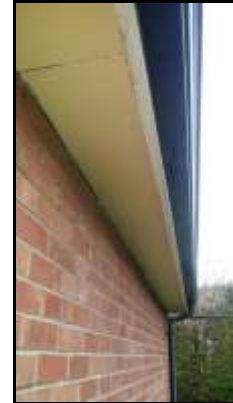
<b>Area Title</b>	External
<b>Floor / Level</b>	Ground Floor
<b>Product Type</b>	Cement
<b>Sample Reference</b>	S004
<b>Item Description</b>	Soffit: Cement
<b>Estimated Extent</b>	24 lin m

<b>Product Type</b>	N/A	0
<b>Treatment</b>	Refer to Appendix III	1
<b>Damage Extent</b>	Good Condition	0
<b>Asbestos Type</b>	Amosite, Chrysotile	2
<b>Material Factor Rating</b>		3

Manage - Condition and surface treatment are adequate for the material to be left in place. Asbestos warning stickers may be applied.
