Asbestos Management Survey Report

58 Verwood Close, Park North, Swindon, SN3 2LE

Undertaken by	
<u>SWINDON ASBESTOS SURVEYING LTD</u>	
Checked by:	Kate Russell
Verified/Signature:	
Date of Survey:	31 August 2011
Date of Report:	7 September 2011
<u>Job No:</u>	<u>SAS5619/10445923</u>
Authorising Surveyor:	Chris O'Sullivan
Verified/Signature:	
<p style="font-size: small;">Swindon Asbestos Surveying Ltd, Aavid Thermalloy House, Cheney Manor Industrial Estate, Swindon, Wilts, SN2 2QN Tel: 01793 401421 Fax: 01793 401424 Email: info@swindon-asbestos.co.uk Website: www.swindon-asbestos.co.uk Company No: 5953002</p>

Asbestos Refurbishment Survey Report

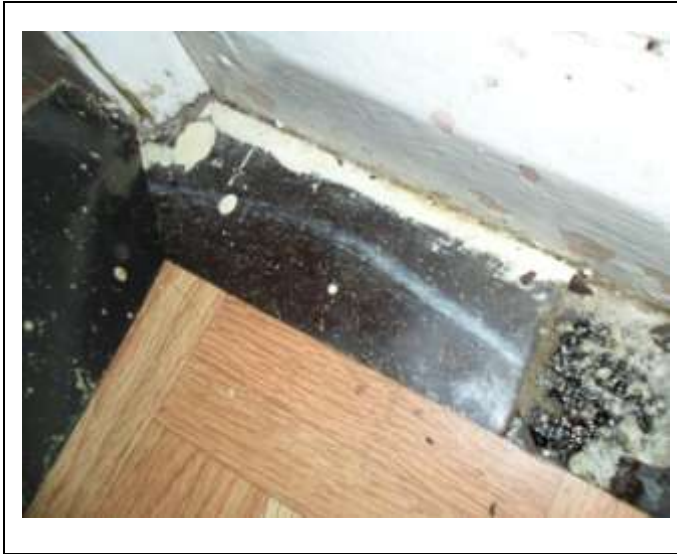
Sample Ref	Laboratory Sample Ref	Fl	Location	Description	Qty	Analysis Result	Total M.A.S	Notifiable Material Y/N
5619/1	124121	G	Entrance Hall	Floor Tiles & Adhesive (under linoleum)	2m ²	Chrysotile	3	N

Product Type	Extent Of Damage	Surface Treatment	Asbestos Type	Total M.A.S	Accessibility/Vulnerability	Combined Total for Advised Timescale
1	1	0	1	3	1	4

ACTION	RECOMMENDATION
Leave & Manage	X
Encapsulate/Reseal	
Remove	
Repair	
Investigate Further

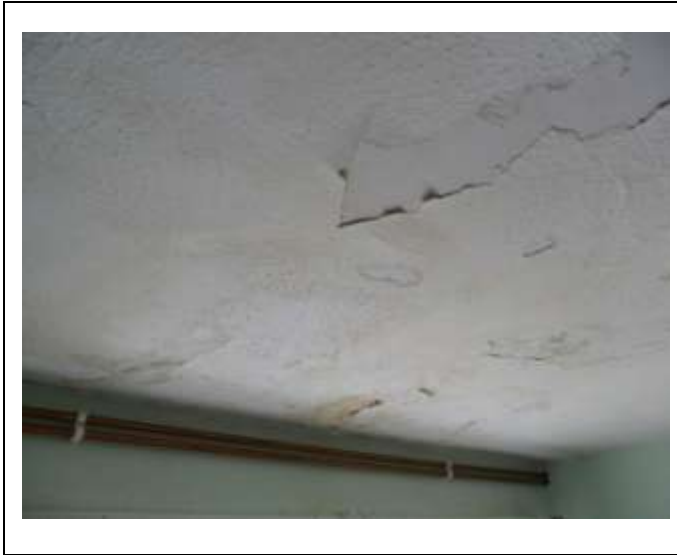
Sample Ref	Laboratory Sample Ref	Fl	Location	Description	Qty	Analysis Result	Total M.A.S	Notifiable Material Y/N
5619/2	124122	G	Kitchen	Ceiling Decorative Coating	6m ²	Chrysotile	4	N

Product Type	Extent Of Damage	Surface Treatment	Asbestos Type	Total M.A.S	Accessibility/Vulnerability	Combined Total for Advised Timescale
1	2	0	1	4	2	6

This material requires repair and should be carried out by trained asbestos operatives following current ACOPS and HSE Guidance Notes. Thereafter it may remain in situ and managed accordingly. No drilling, cutting or any abrasive actions should take place on this material.

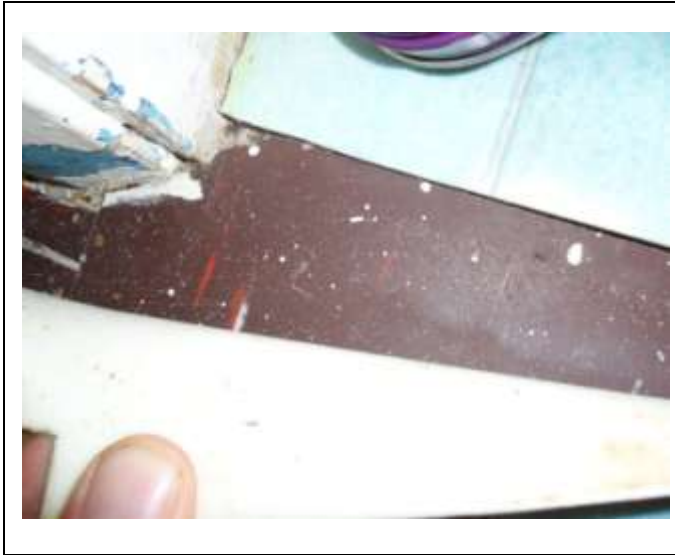
Sample Ref	Laboratory Sample Ref	Fl	Location	Description	Qty	Analysis Result	Total M.A.S	Notifiable Material Y/N
Refer 5619/1	Refer 124121	G	Kitchen	Floor Tiles & Adhesive (under linoleum)	6m ²	Chrysotile	2	N

Product Type	Extent Of Damage	Surface Treatment	Asbestos Type	Total M.A.S	Accessibility/Vulnerability	Combined Total for Advised Timescale
1	0	0	1	2	1	3

This material is considered to be the same as the floor tiles & adhesive in the Entrance Hall. This material is in good condition and may remain in situ and managed accordingly. No drilling, cutting or any abrasive actions should take place on this material.

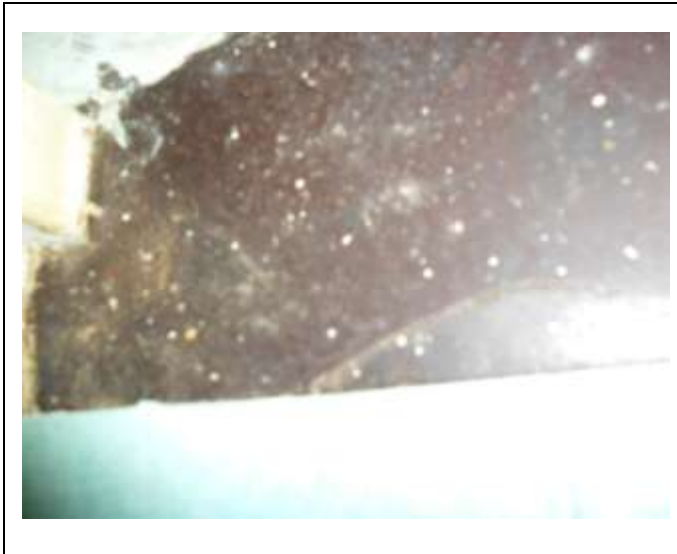
Sample Ref	Laboratory Sample Ref	Fl	Location	Description	Qty	Analysis Result	Total M.A.S	Notifiable Material Y/N
Refer 5619/1	Refer 124121	G	Boiler Cupboard	Floor Tiles & Adhesive (under linoleum)	2m ²	Chrysotile	2	N

Product Type	Extent Of Damage	Surface Treatment	Asbestos Type	Total M.A.S	Accessibility/Vulnerability	Combined Total for Advised Timescale
1	0	0	1	2	1	3

This material is considered to be the same as the floor tiles & adhesive in the Entrance Hall. This material is in good condition and may remain in situ and managed accordingly. No drilling, cutting or any abrasive actions should take place on this material.

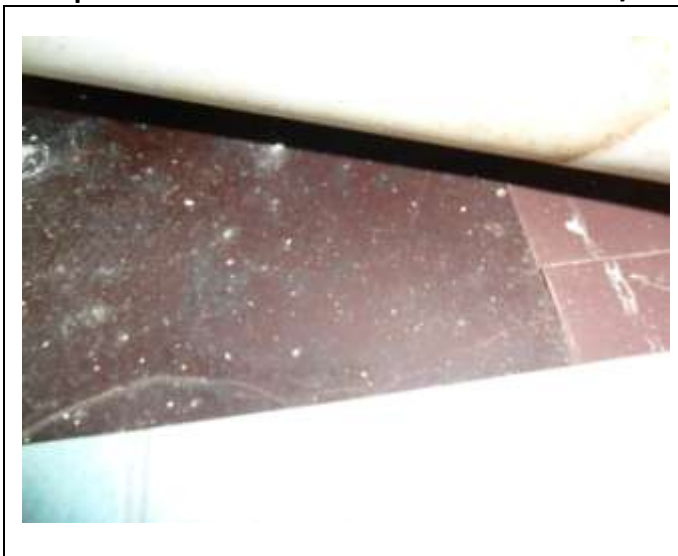
Sample Ref	Laboratory Sample Ref	Fl	Location	Description	Qty	Analysis Result	Total M.A.S	Notifiable Material Y/N
Refer 5619/1	Refer 124121	G	Meter Cupboard	Floor Tiles & Adhesive (under linoleum)	1m ²	Chrysotile	2	N

Product Type	Extent Of Damage	Surface Treatment	Asbestos Type	Total M.A.S	Accessibility/Vulnerability	Combined Total for Advised Timescale
1	0	0	1	2	1	3

This material is considered to be the same as the floor tiles & adhesive in the Entrance Hall. This material is in good condition and may remain in situ and managed accordingly. No drilling, cutting or any abrasive actions should take place on this material.

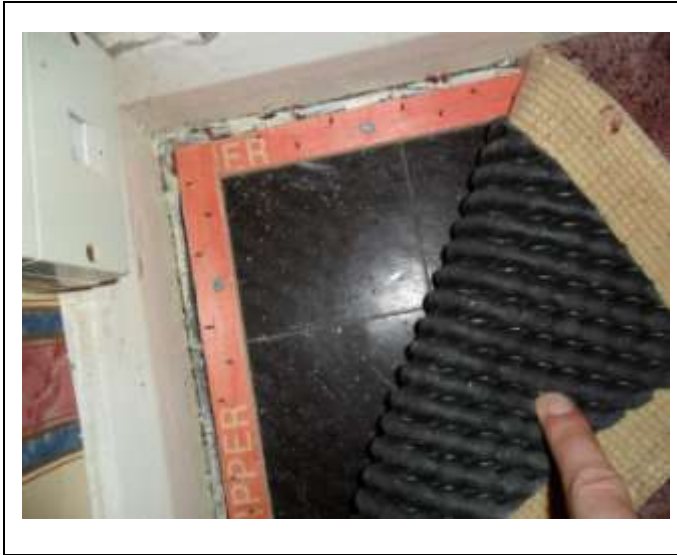
Sample Ref	Laboratory Sample Ref	Fl	Location	Description	Qty	Analysis Result	Total M.A.S	Notifiable Material Y/N
Refer 5619/1	Refer 124121	G	Lounge	Floor Tiles & Adhesive (under carpet)	1m ²	Chrysotile	2	N

Product Type	Extent Of Damage	Surface Treatment	Asbestos Type	Total M.A.S	Accessibility/Vulnerability	Combined Total for Advised Timescale
1	0	0	1	2	1	3

This material is considered to be the same as the floor tiles & adhesive in the Entrance Hall. This material is in good condition and may remain in situ and managed accordingly. No drilling, cutting or any abrasive actions should take place on this material.

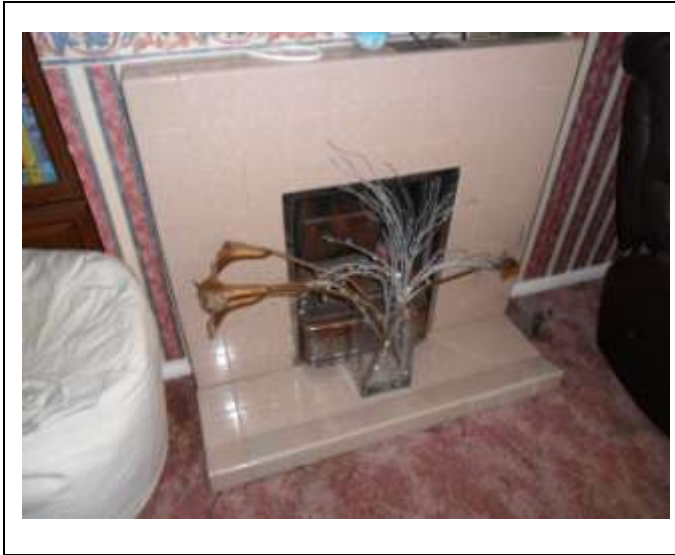
Sample Ref	Laboratory Sample Ref	Fl	Location	Description	Qty	Analysis Result	Total M.A.S	Notifiable Material Y/N
Presumed	Presumed	G	Lounge	Presumed Rope Seal to Fire Surround	<1m ²	Presumed Chrysotile	4	N

Product Type	Extent Of Damage	Surface Treatment	Asbestos Type	Total M.A.S	Accessibility/Vulnerability	Combined Total for Advised Timescale
2	0	1	1	4	1	5

ACTION	RECOMMENDATION
Leave & Manage	X
Encapsulate/Reseal	
Remove	
Repair	
Investigate Further	X

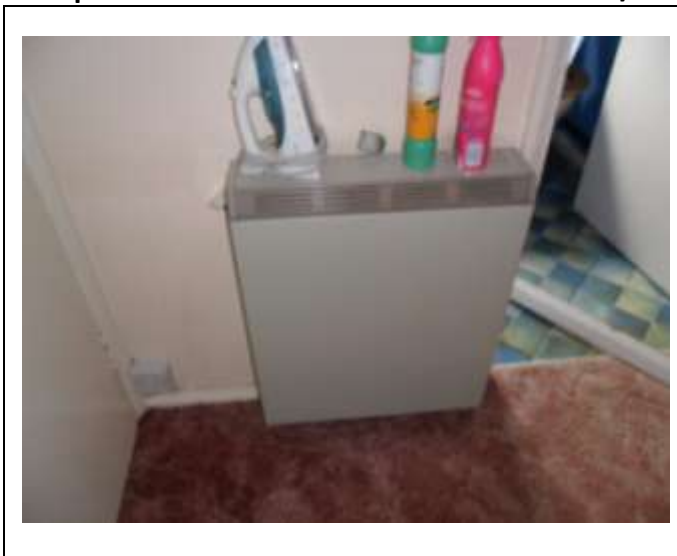
Sample Ref	Laboratory Sample Ref	Fl	Location	Description	Qty	Analysis Result	Total M.A.S	Notifiable Material Y/N
Presumed	Presumed	G	Passage	Presumed Asbestos Insulation Board Linings to Berry Magicoal Storage Heater	<1m ²	Presumed Crocidolite	7	Y

Product Type	Extent Of Damage	Surface Treatment	Asbestos Type	Total M.A.S	Accessibility/Vulnerability	Combined Total for Advised Timescale
2	0	2	3	7	1	8

Recommended Action:	
ACTION	RECOMMENDATION
Leave & Manage	X
Encapsulate/Reseal	
Remove	
Repair	
Investigate Further	X

Advised Timescale for Action/Inspection:	
TIMESCALE	RECOMMENDATION
Immediate	
Within 1 month	
Within 3 months	
Within 6 months	X
Within 12 months

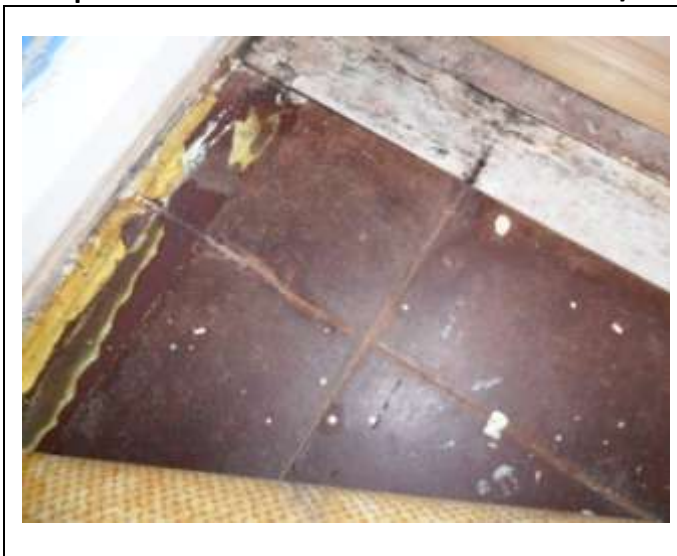
Sample Ref	Laboratory Sample Ref	Fl	Location	Description	Qty	Analysis Result	Total M.A.S	Notifiable Material Y/N
Refer 5619/1	Refer 124121	G	Bathroom	Floor Tiles & Adhesive (under linoleum)	4m ²	Chrysotile	2	N

Product Type	Extent Of Damage	Surface Treatment	Asbestos Type	Total M.A.S	Accessibility/Vulnerability	Combined Total for Advised Timescale
1	0	0	1	2	1	3

This material is considered to be the same as the floor tiles & adhesive in the Entrance Hall. This material is in good condition and may remain in situ and managed accordingly. No drilling, cutting or any abrasive actions should take place on this material.

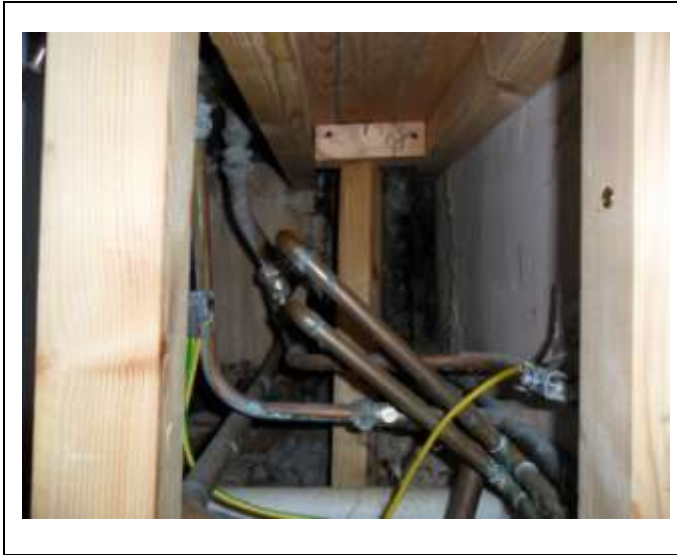
Sample Ref	Laboratory Sample Ref	Fl	Location	Description	Qty	Analysis Result	Total M.A.S	Notifiable Material Y/N
Strongly Presumed	Strongly Presumed	G	Bathroom (under bath)	Strongly Presumed Asbestos Cement Soil & Vent Pipe	3m	Presumed Crocidolite	5	N

Product Type	Extent Of Damage	Surface Treatment	Asbestos Type	Total M.A.S	Accessibility/Vulnerability	Combined Total for Advised Timescale
1	0	1	3	5	1	6

ACTION	RECOMMENDATION
Leave & Manage	X
Encapsulate/Reseal	
Remove	
Repair	
Investigate Further	X

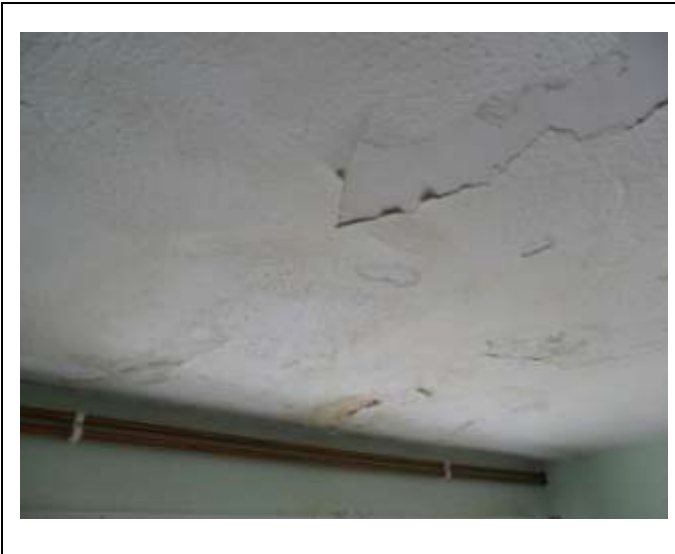
Sample Ref	Laboratory Sample Ref	Fl	Location	Description	Qty	Analysis Result	Material Type	Notifiable Material Y/N
5619/2	124122	G	Kitchen	Ceiling Decorative Coating	6m ²	Chrysotile	Textured Coating	N

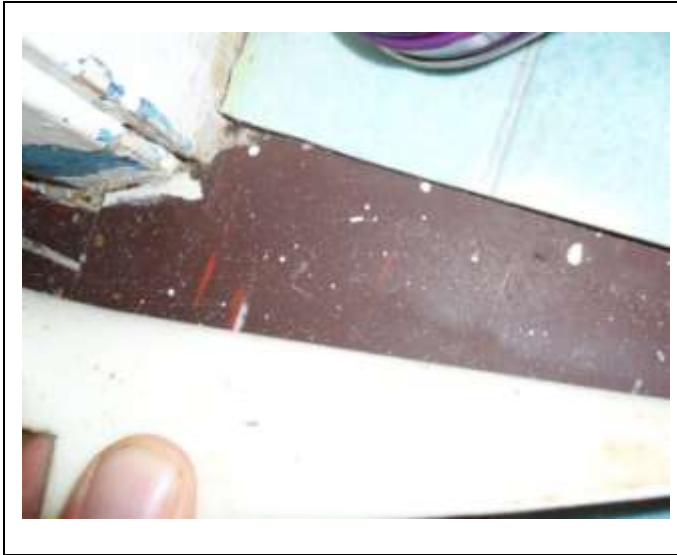
Sample Ref	Laboratory Sample Ref	Fl	Location	Description	Qty	Analysis Result	Material Type	Notifiable Material Y/N
Refer 5619/1	Refer 124121	G	Kitchen	Floor Tiles & Adhesive (under linoleum)	6m ²	Chrysotile	Vinyl & Bitumen	N

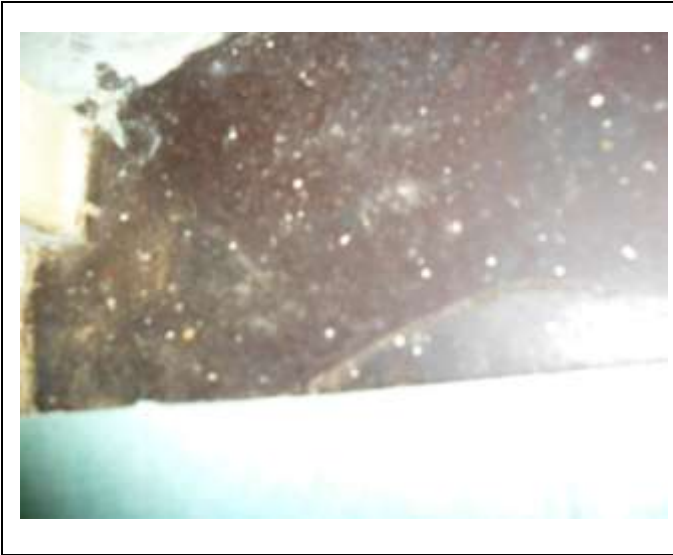
Sample Ref	Laboratory Sample Ref	Fl	Location	Description	Qty	Analysis Result	Material Type	Notifiable Material Y/N
Refer 5619/1	Refer 124121	G	Boiler Cupboard	Floor Tiles & Adhesive (under linoleum)	2m ²	Chrysotile	Vinyl & Bitumen	N

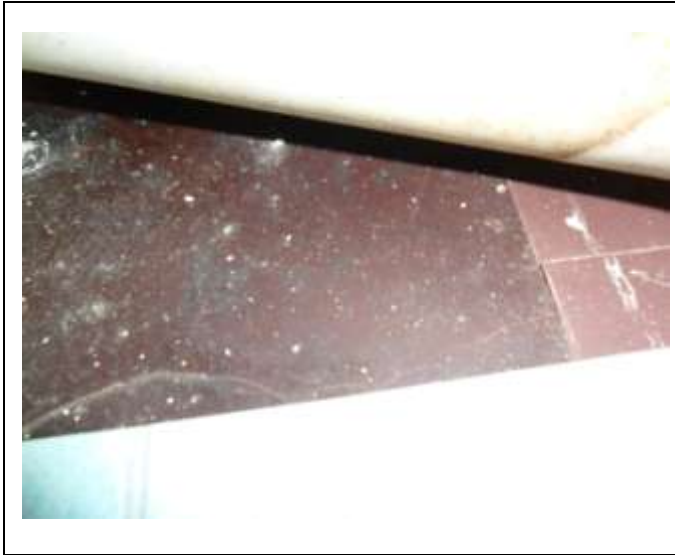
Sample Ref	Laboratory Sample Ref	Fl	Location	Description	Qty	Analysis Result	Material Type	Notifiable Material Y/N
Refer 5619/1	Refer 124121	G	Meter Cupboard	Floor Tiles & Adhesive (under linoleum)	1m ²	Chrysotile	Vinyl & Bitumen	N

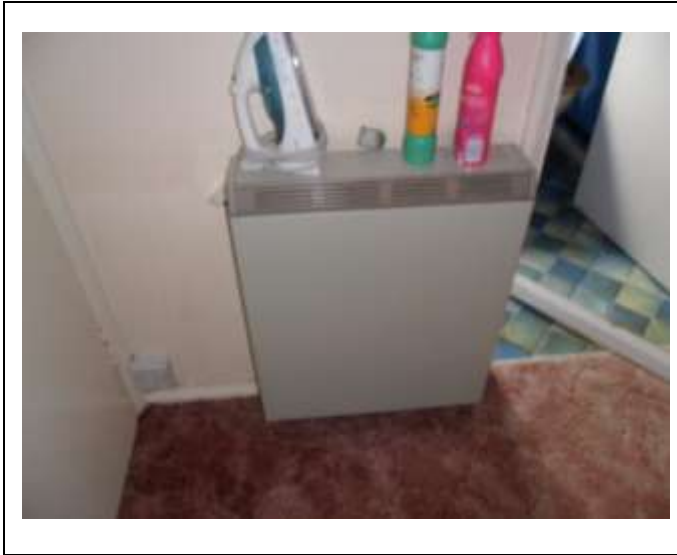
Sample Ref	Laboratory Sample Ref	Fl	Location	Description	Qty	Analysis Result	Material Type	Notifiable Material Y/N
Presumed	Presumed	G	Passage	Presumed Asbestos Insulation Board Linings to Berry Magicoal Storage Heater	<1m ²	Presumed Crocidolite	Presumed Asbestos Insulation Board	Y

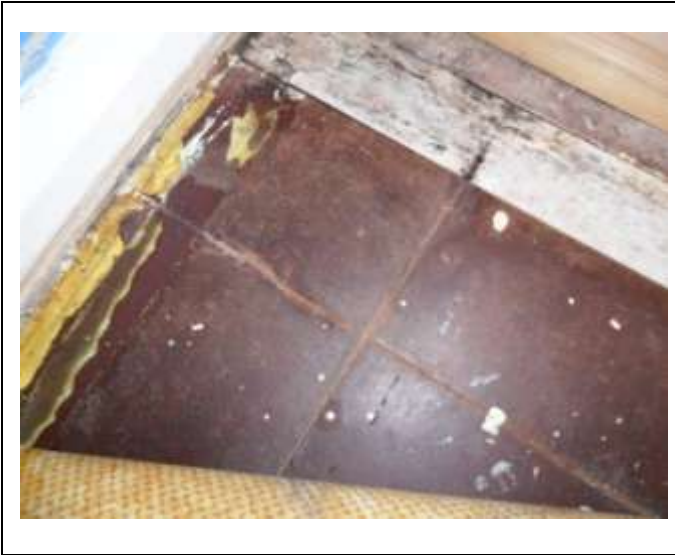
Sample Ref	Laboratory Sample Ref	Fl	Location	Description	Qty	Analysis Result	Material Type	Notifiable Material Y/N
Refer 5619/1	Refer 124121	G	Bathroom	Floor Tiles & Adhesive (under linoleum)	4m ²	Chrysotile	Vinyl & Bitumen	N

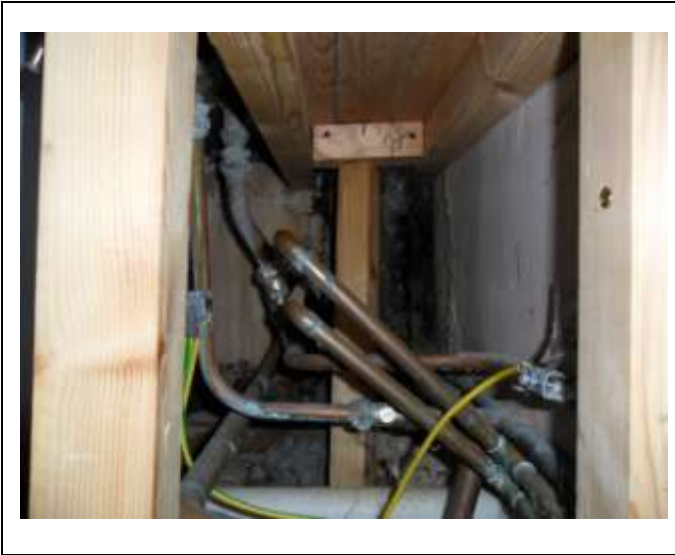
Sample Ref	Laboratory Sample Ref	Fl	Location	Description	Qty	Analysis Result	Material Type	Notifiable Material Y/N
Strongly Presumed	Strongly Presumed	G	Bathroom	Presumed Asbestos Cement Soil Vent Pipe (under bath)	3m	Presumed Crocidolite	Presumed Asbestos Cement	N
