Asbestos Refurbishment Survey

0019006800
68 ACACIA GROVE
PINEHURST
SWINDON
WILTS
SN2 1RZ

Swindon Borough Council

Project Number:	Survey Date:	Issue Date:
N-60190	27 September 2024	21 October 2024

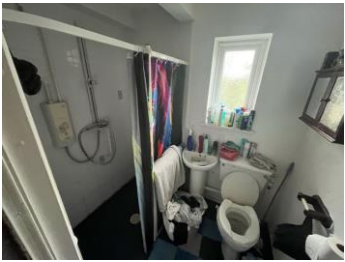
Building: 68 ACACIA GROVE			
Location:	Construction Overview	Photos	
Ground Floor	<p>Floors: The floors consisted of modern timber laminate, modern vinyl sheeting.</p> <p>Walls: The walls consisted of plaster skimmed masonry walls with areas of decorative textured woodchip paper lining and areas of modern ceramic tiles.</p> <p>Ceilings: The ceilings consisted of plaster skimmed plasterboard ceilings with areas of decorative woodchip paper lining.</p> <p>Other: Other items include timber and uPVC constructed doors and door frames, modern wall mounted combi boiler system with associated uninsulated metal pipework with a metal flue pipe, wall mounted modern metal heaters with associated uninsulated metal pipework, wall mounted modern electrics, plastic conduits, live electrical wires, timber constructed staircase, modern sink pad to underside of metal sink, plastic and ceramic sanitary ware, timber constructed bath panel revealing (timber floorboards, uninsulated metal and plastic pipework, underside of ceramic bath, plastic soil pipe, plaster skimmed masonry walls), uPVC constructed window sills.</p> <p>External: Externally consisted of brick built walls with a bitumen damp proof course to the shed with no visible damp proof course to the house, natural slate roof tiles, plastic cowl, uPVC constructed rainwater goods, timber constructed soffits and fascias, uPVC constructed windows and window frames, uPVC and timber constructed doors and door frames, modern putty sealant to windows, no visible putty to timber doors of shed.</p>

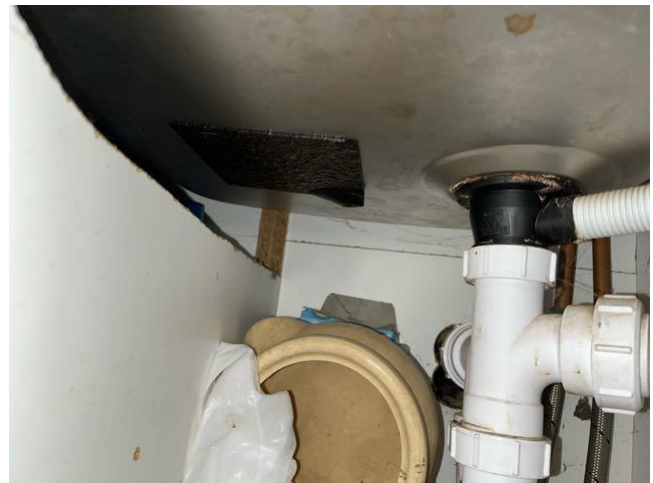
Building	68 ACACIA GROVE
Floor	F00
Room	004 - Kitchen
Description	Mastic pad to underside of metal sink
Sample Reference	S001
Quantity	2 Units

Analysis Result	
No Asbestos Detected	0
Product Type	
Mastic	1

Condition	
Low Damage	1
Surface Treatment	
Composite (Self Sealed)	0

No asbestos was detected within the sample collected and as such no further action is required.

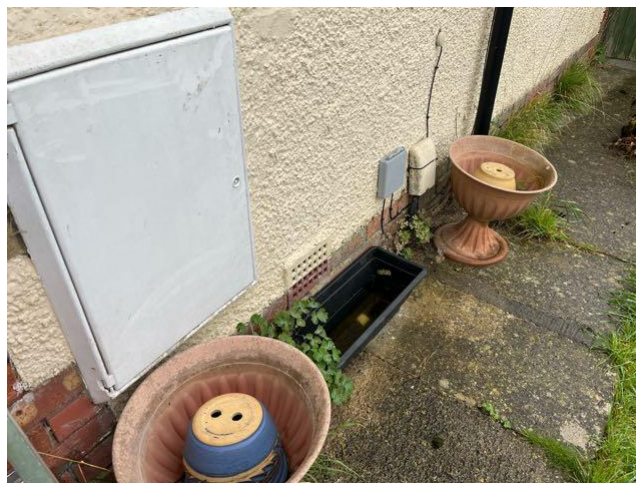
Building	68 ACACIA GROVE
Floor	External
Room	99 - External
Description	Bitumen damp proof course to brickwork
Sample Reference	S002
Quantity	40 Lin M

Analysis Result	
No Asbestos Detected	0
Product Type	
Bitumen	1

Condition	
Low Damage	1
Surface Treatment	
Composite (Self Sealed)	0

No asbestos was detected within the sample collected and as such no further action is required.
