R&D SURVEY TO UNDERSTAIRS CUPBOARD CEILING (INC) VOID

28 Millham Road
Bishops Cleeve
Cheltenham
Gloucestershire
GL52 4BL
UPRN: 0815001028

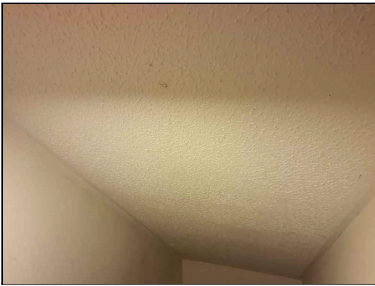
Survey Date:	Lead Surveyor	Survey Type	Floor	Analysis		
	6 May 2025	Daniel Road	Refurbishment/Demolition Survey	Ground Floor			
	Building	Room	Item	Quantity			
	Main Building.	UNDER STAIR CUPBOARD G01	Textured coating CEILING	4m²	Accessibility		
	Sample No (S,SP,P,As)	Product Type	Surface Treatment	Condition			
	FK000370 (S)	N/A	N/A	N/A	N/A		
Normal Occupancy	Score	Likelihood of disturbance	Score	Exposure Potential	Score	Maintenance Activity	Score
Main type of activity	N/A	Location	N/A	Number of occupants	N/A	Type of Maintenance	N/A
		Accessibility	N/A	Frequency of use	N/A	Frequency of maintenance	N/A
		Amount	N/A	Average Time	N/A		
Average Score	N/A	Average Score	N/A	Average Score	N/A	Average Score	N/A
Average of Priority	N/A						
Material Assessment Score	N/A						
Recommendation	No further action required						
Surveyor comments	Textured coating to single layered plasterboard ceiling with void beyond. DR 06/05/25

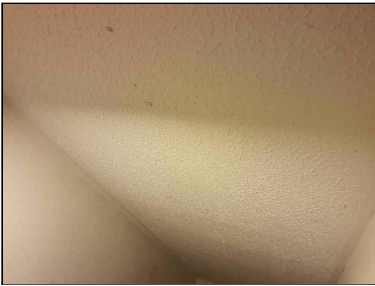
Survey Date:	Lead Surveyor	Survey Type	Floor	Analysis		
	6 May 2025	Daniel Road	Refurbishment/Demolition Survey	Ground Floor	N/A		
	Building	Room	Item	Quantity			
	Main Building.	UNDER STAIR CUPBOARD G01	Visually no suspect materials identified VOID	N/A			
	Sample No (S,SP,P,As)	Product Type	Surface Treatment	Condition	Accessibility		
	Visual (P)	N/A	N/A	N/A	N/A

Normal Occupancy	Score	Likelihood of disturbance	Score	Exposure Potential	Score	Maintenance Activity	Score
Main type of activity	N/A	Location	N/A	Number of occupants	N/A	Type of Maintenance	N/A
		Accessibility	N/A	Frequency of use	N/A	Frequency of maintenance	N/A
		Amount	N/A	Average Time	N/A		
Average Score	N/A	Average Score	N/A	Average Score	N/A	Average Score	N/A
Average of Priority	N/A						
Material Assessment Score	N/A						
Recommendation	No further action required						
Surveyor comments	Non-suspect ceiling void through to timber stairs. DR 06/05/25
