Site ID: **a-104807** Management Survey

Sanctuary Housing Group
Client ID: **S130**

The Hermitage
1 Bremilham Road
Malmesbury
Swindon
SN16 0PQ
United Kingdom

23rd February 2017

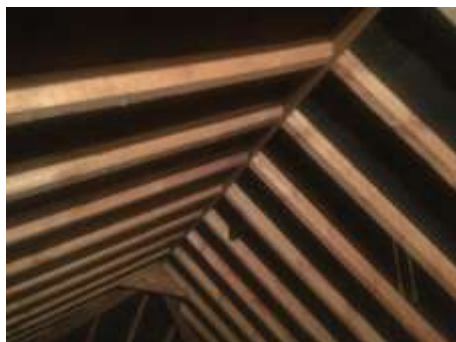
a-104807-i01-01

Sample taken? **No**
Product Type **Bitumen**
Surface Treatment. **Sealed Composite Material**
Condition **Low Damage**
Surface **Ceiling**
Material Risk Assessment **5**
Quantity: **100 SQ M**
Next Inspection Date: **As per client policy/plan.**

Roof felt

It has been noted in previous experience that this type of material has been known to contain asbestos.

Until such time as proven otherwise, the material should be managed as an asbestos containing product in accordance with CAR 2012 and subject to regular inspection.

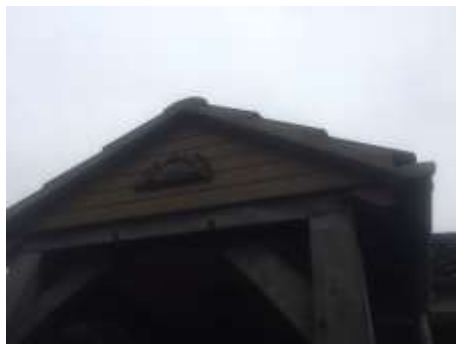
a-104807-e01-02

Sample taken? **Yes**
Product Type **Insulating Board**
Surface Treatment **NA**
Condition **NA**
Surface **Under-Cloaking**
Material Risk Assessment **NA**
Quantity: **2 Lin M**
Next Inspection Date: **NA**

Undercloaking to canopy

No asbestos was detected in the material tested.

No further action is required.

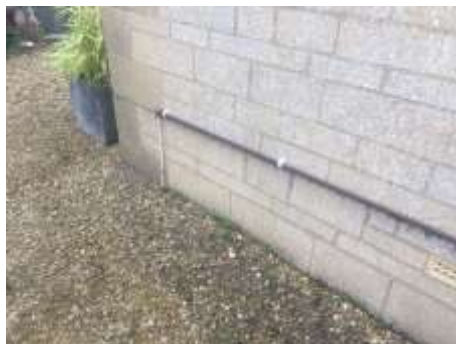
a-104807-e01-03

Sample taken? **Yes**
Product Type **Bitumen**
Surface Treatment **NA**
Condition **NA**
Surface **DPC**
Material Risk Assessment **NA**
Quantity: **30 Lin M**
Next Inspection Date: **NA**

Dpc

No asbestos was detected in the material tested.

No further action is required.

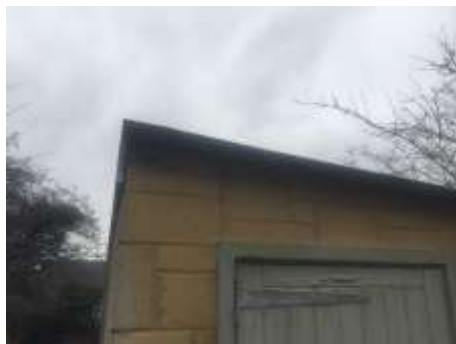
a-104807-e01-04

Chrysotile (white)

Condition **Low Damage**

Material Risk Assessment **4**

Cement shed roof

The material was seen to be in fair condition at the time of the initial inspection.

The condition of the material should be managed by a competent person/company and its presence made aware to those at risk, as part of a Control of Asbestos Regulations (CAR) 2012 compliant management strategy.
