# Site ID: **a-159703**

## Targeted Refurbishment Survey Only

84 Pigeons Farm Road  
Thatcham  
RG19 8XD  
United Kingdom

**4th July 2018**

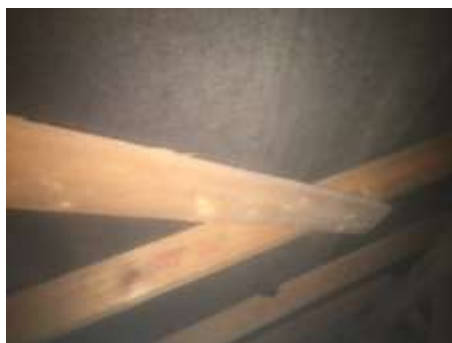
**a-159703-i01-01**

Sample taken? ..... **Yes**Product Type ..... **Bitumen**Surface Treatment ..... **NA**Condition ..... **NA**Surface ..... **Ceiling**Material Risk Assessment ..... **NA**Quantity: ..... **40 SQ M**Next Inspection Date: ..... **NA**

Bitumen roof lining

**No asbestos was detected in the material tested.**

**No further action is required.**

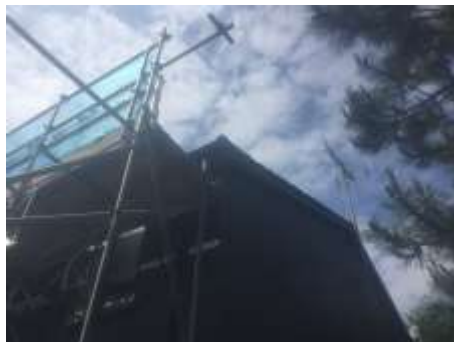
**a-159703-e01-02**

**Chrysotile (white)**

Condition ..... **Low Damage**

Material Risk Assessment ..... **4**

Cement undercloaking

The material was seen to be in fair condition at the time of the initial inspection.

The condition of the material should be managed by a competent person/company and its presence made aware to those at risk, as part of a Control of Asbestos Regulations (CAR) 2012 compliant management strategy.

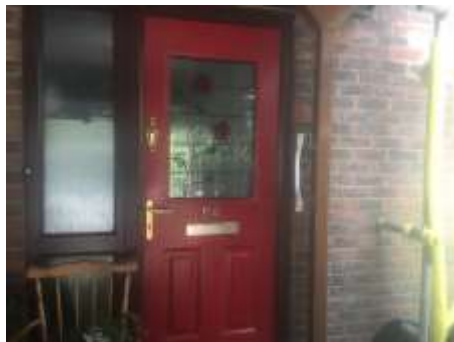
**a-159703-e01-03**

**Chrysotile (white)**

Condition ..... **Low Damage**

Material Risk Assessment ..... **3**

Sealant to doors and window frames

The material was seen to be in fair condition at the time of the initial inspection.

The condition of the material should be managed by a competent person/company and its presence made aware to those at risk, as part of a Control of Asbestos Regulations (CAR) 2012 compliant management strategy.
