Site ID: **a-179486**

Targeted Refurbishment Survey Only

1-4, 53 County Road
Swindon
Wiltshire
SN1 2EG
United Kingdom

9th November 2018

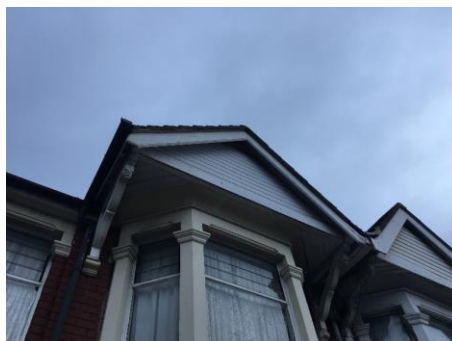
a-179486-e01-01

Chrysotile (white)

Condition **Low Damage**

Material Risk Assessment **4**

Cement under cloaking

The material was seen to be in good condition at the time of the initial inspection.

The condition of the material should be managed by a competent person/company and its presence made aware to those at risk, as part of a Control of Asbestos Regulations (CAR) 2012 compliant management strategy.
