Site ID: **a-73381** Management Survey

Sanctuary Housing Group
Client ID: **S130**

40 Canterbury Close
Yate
Bristol
BS37 5TL
United Kingdom

6th June 2016

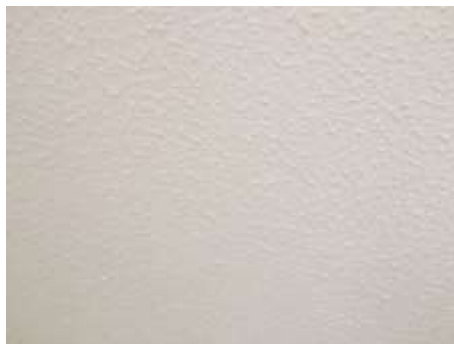
a-73381-i02-02

Heavy stipple

The material was seen to be in fair condition at the time of the initial inspection.

The condition of the material should be managed by a competent person/company and its presence made aware to those at risk, as part of a Control of Asbestos Regulations (CAR) 2012 compliant management strategy.

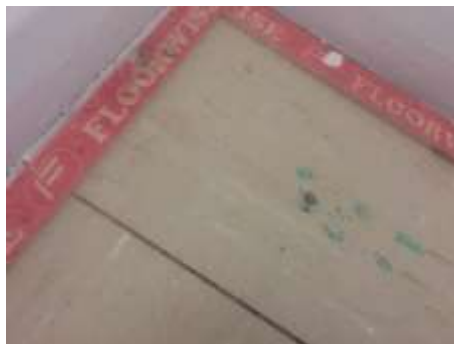
a-73381-i02-03

The material was seen to be in fair condition at the time of the initial inspection.

The condition of the material should be managed by a competent person/company and its presence made aware to those at risk, as part of a Control of Asbestos Regulations (CAR) 2012 compliant management strategy.

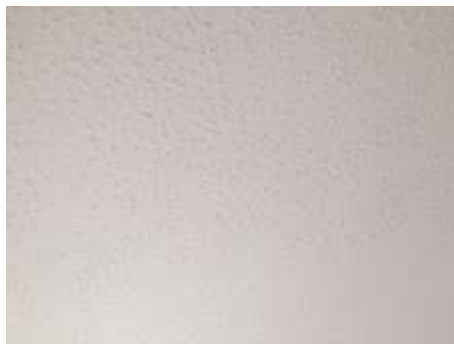
Heavy stipple

The material was seen to be in fair condition at the time of the initial inspection.

The condition of the material should be managed by a competent person/company and its presence made aware to those at risk, as part of a Control of Asbestos Regulations (CAR) 2012 compliant management strategy.

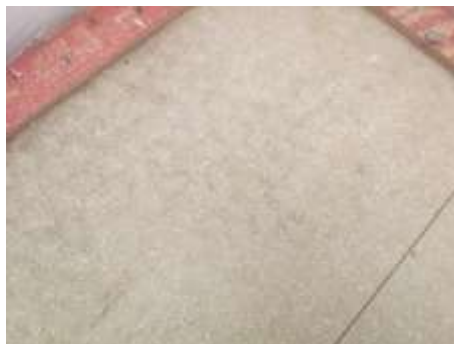
Light green fleck

The material was seen to be in fair condition at the time of the initial inspection.

The condition of the material should be managed by a competent person/company and its presence made aware to those at risk, as part of a Control of Asbestos Regulations (CAR) 2012 compliant management strategy.

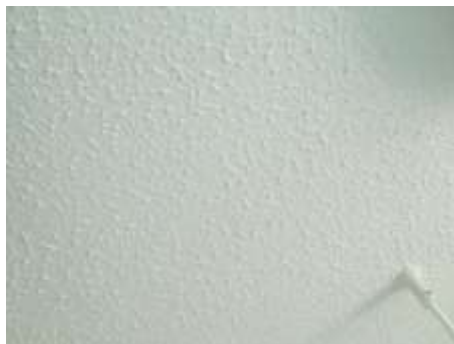
The material was seen to be in fair condition at the time of the initial inspection.

The condition of the material should be managed by a competent person/company and its presence made aware to those at risk, as part of a Control of Asbestos Regulations (CAR) 2012 compliant management strategy.

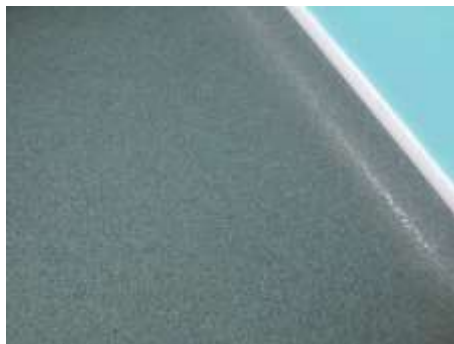
It has been noted in previous experience that this type of material has been known to contain asbestos.

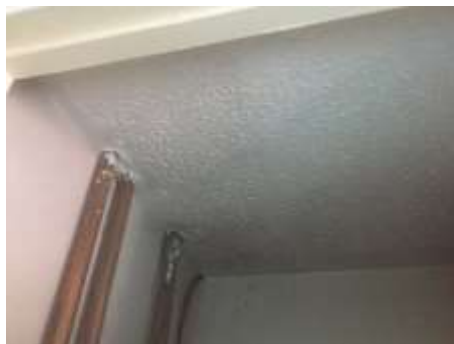
Heavy stipple. Pipework extending through.

The material was seen to be in fair condition at the time of the initial inspection.

The condition of the material should be managed by a competent person/company and its presence made aware to those at risk, as part of a Control of Asbestos Regulations (CAR) 2012 compliant management strategy.

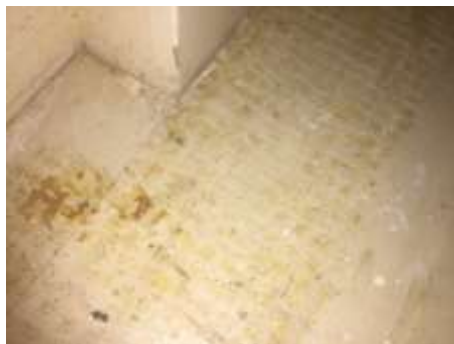
Light green fleck. Bituminous adhesive to floor.

The material was seen to be in fair condition at the time of the initial inspection.

The condition of the material should be managed by a competent person/company and its presence made aware to those at risk, as part of a Control of Asbestos Regulations (CAR) 2012 compliant management strategy.

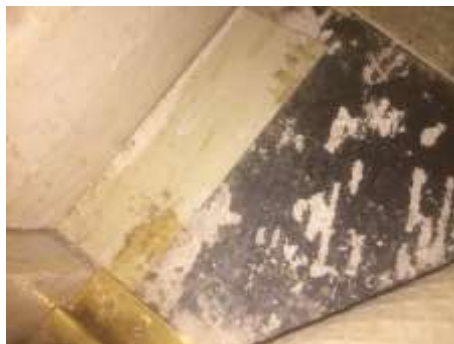
Bituminous adhesive to floor. This material is likely to extend throughout property.

The material was seen to be in fair condition at the time of the initial inspection.

It is recommended that the material has remedial action undertaken by a HSE licensed asbestos contractor. As an ACM (asbestos Containing Material), it's condition should be monitored by a competent person/company and it's presence made aware to those at risk, as part of a Control of Asbestos Regulations (CAR) 2012 compliant management strategy.

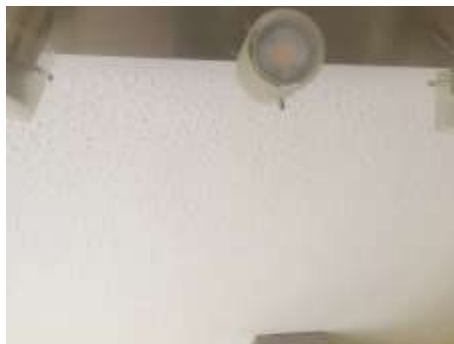
Heavy stipple

The material was seen to be in fair condition at the time of the initial inspection.

The condition of the material should be managed by a competent person/company and its presence made aware to those at risk, as part of a Control of Asbestos Regulations (CAR) 2012 compliant management strategy.

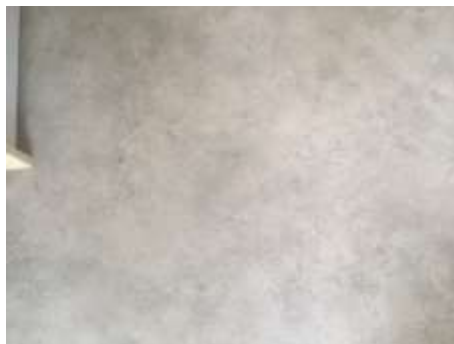
It has been noted in previous experience that this type of material has been known to contain asbestos.

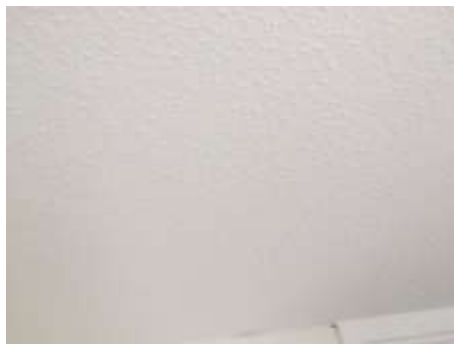
Heavy stipple

The material was seen to be in fair condition at the time of the initial inspection.

The condition of the material should be managed by a competent person/company and its presence made aware to those at risk, as part of a Control of Asbestos Regulations (CAR) 2012 compliant management strategy.

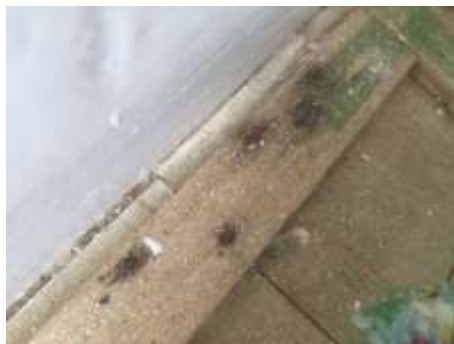
The material was seen to be in fair condition at the time of the initial inspection.

The condition of the material should be managed by a competent person/company and its presence made aware to those at risk, as part of a Control of Asbestos Regulations (CAR) 2012 compliant management strategy.

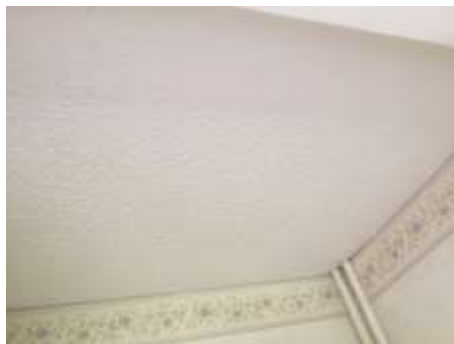
Heavy stipple. Pipework extending through.

The material was seen to be in fair condition at the time of the initial inspection.

The condition of the material should be managed by a competent person/company and its presence made aware to those at risk, as part of a Control of Asbestos Regulations (CAR) 2012 compliant management strategy.

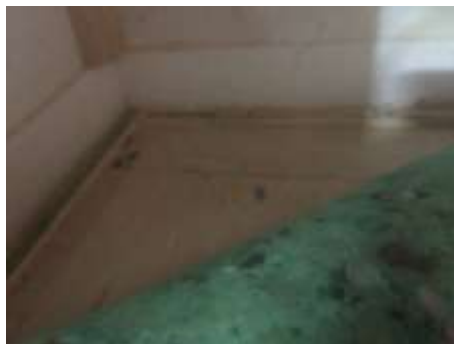
The material was seen to be in fair condition at the time of the initial inspection.

The condition of the material should be managed by a competent person/company and its presence made aware to those at risk, as part of a Control of Asbestos Regulations (CAR) 2012 compliant management strategy.

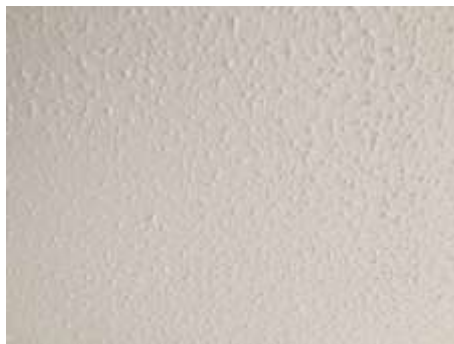
Heavy stipple

The material was seen to be in fair condition at the time of the initial inspection.

The condition of the material should be managed by a competent person/company and its presence made aware to those at risk, as part of a Control of Asbestos Regulations (CAR) 2012 compliant management strategy.

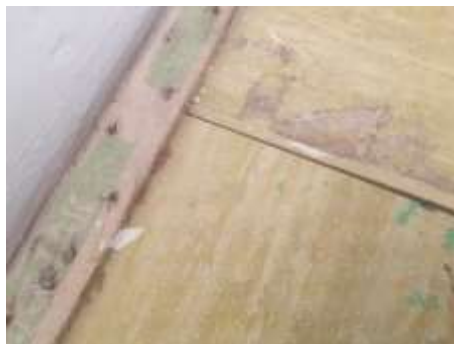
Light green fleck

The material was seen to be in fair condition at the time of the initial inspection.

The condition of the material should be managed by a competent person/company and its presence made aware to those at risk, as part of a Control of Asbestos Regulations (CAR) 2012 compliant management strategy.

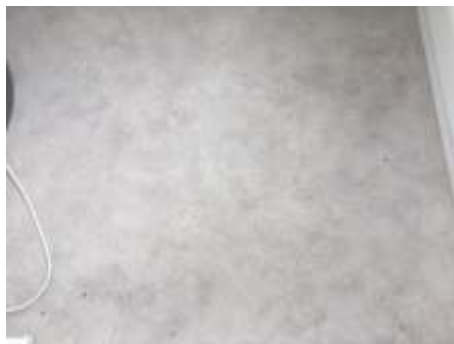
The material was seen to be in fair condition at the time of the initial inspection.

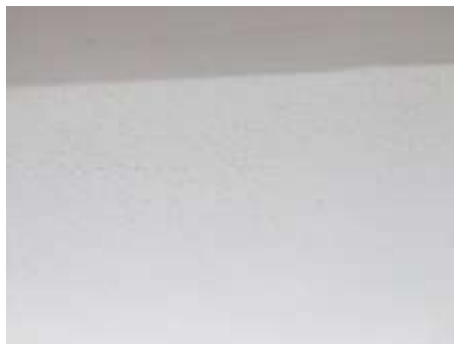
The material was seen to be in fair condition at the time of the initial inspection.

The condition of the material should be managed by a competent person/company and its presence made aware to those at risk, as part of a Control of Asbestos Regulations (CAR) 2012 compliant management strategy.

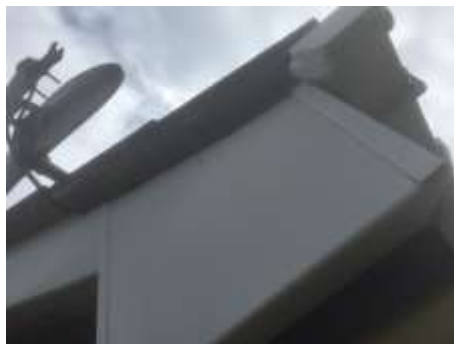
Extends to drying room roof

The material was seen to be in fair condition at the time of the initial inspection.

The condition of the material should be managed by a competent person/company and its presence made aware to those at risk, as part of a Control of Asbestos Regulations (CAR) 2012 compliant management strategy.
