IMS - Advanced Component Replacement request form V1

Carrie ormerod / 2, Ecos Court, Frome,
Somerset, BA11 1HZ

2, Ecos Court, Frome, Somerset,
BA11 1HZ

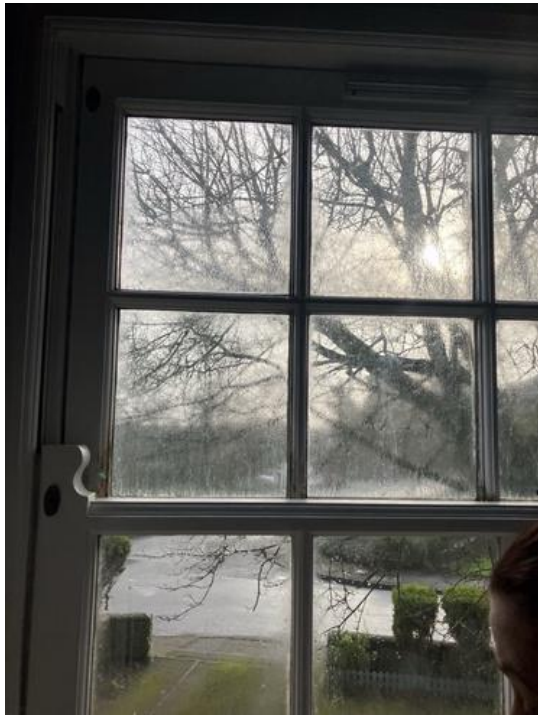
Photo 1

windows.
the windows are rotten causing mould and damp to the property, the windows are drafty, the tenant is struggling to heat the property due to this, also water pools on all cills running onto the floor causing damage to items of property.
