An Asbestos Management Survey (MA & PA) at
30 Wilmot Close
The Prinnels
Swindon
Wiltshire
SN5 6NN

| Our Reference: | J328294 | |
| Scope of Works: | Management survey to all accessible areas of the property. | |

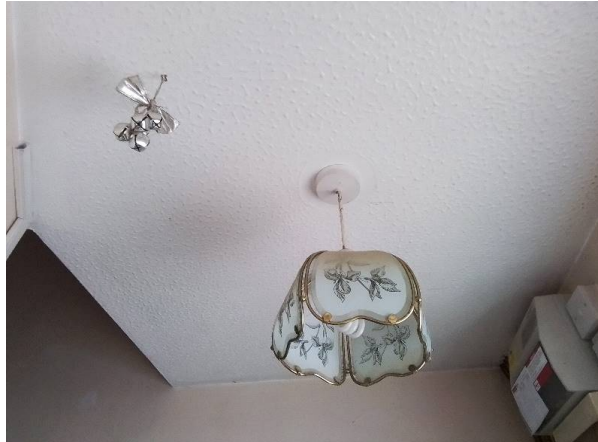
| Room Name: | (001) Entrance | | | | |

| Component: | Textured coating to plasterboard ceiling | | | | |

| Material Assessment | | |
|---|---|---|
| No Asbestos Detected | | |

| Conclusions and Actions | |
|--|---|
| Recommendation: | No further action required |

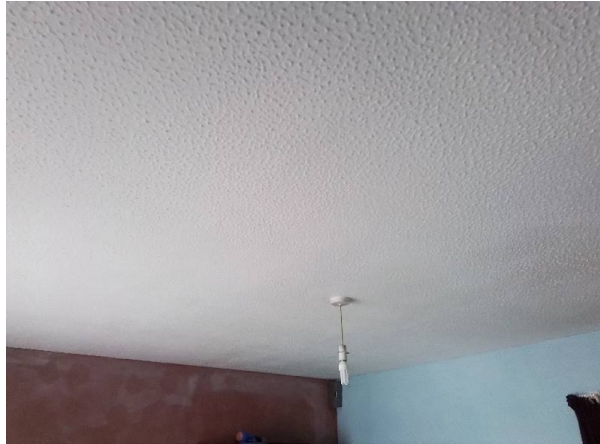
| Room Name: | (002) Lounge | | | | |

| Component: | Textured coating to plasterboard ceiling | | | | |

| Conclusions and Actions | |
|---|---|
| Recommendation: | No further action required |

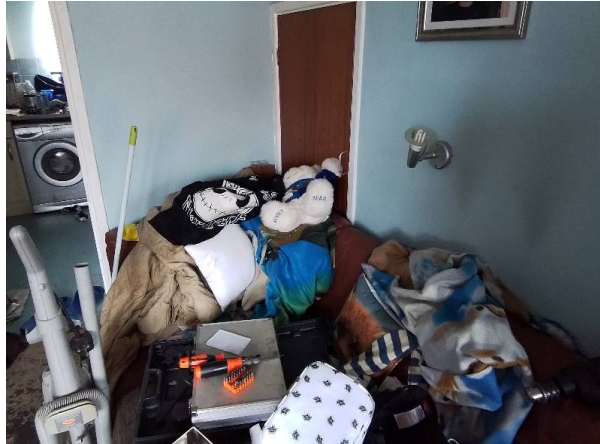
| Component: | No Access | | | | |

| Conclusions and Actions | |
|--|---|
| Recommendation: | Further Inspection Required. |

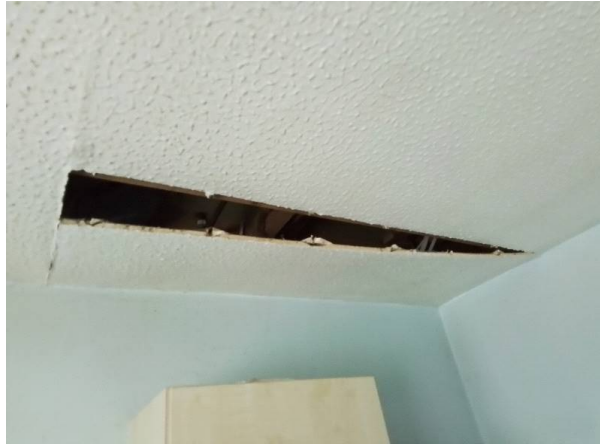
| Component: | Textured coating to plasterboard ceiling | | | | |

| Conclusions and Actions | |
|---|---|
| Textured coating to plasterboard ceiling. Hardboard ceiling above plasterboard ceiling. Metal pipes and modern wiring running in void area above plasterboard ceiling. Plasterboard walls. Modern linoleum to concrete floor. Plasterboard boxing adjacent to extractor fan - no access within boxing (excessive damage). Modern sink pad. uPVC window and ceramic tile sill. uPVC door to garden. Modern extractor fan in wall. Modern radiator. | |

| Conclusions and Actions | |
|---|---|
| Recommendation: | No further action required |

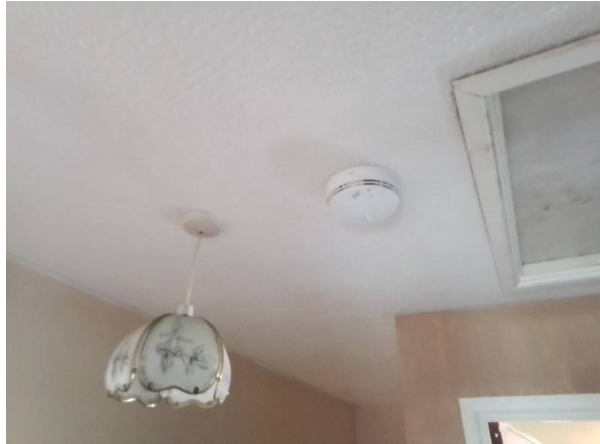
| Component: | Textured coating to plasterboard ceiling | | | | |

| Conclusions and Actions | |
|---|---|
| Recommendation: | No further action required |

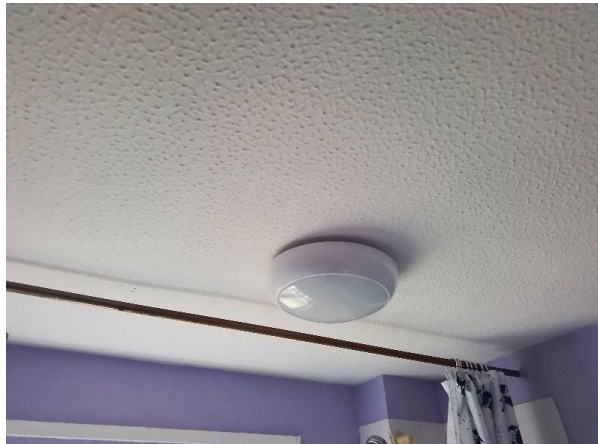
| Component: | Textured coating to plasterboard ceiling | | | | |

| Conclusions and Actions | |
|---|---|
| Textured coating to plasterboard ceiling. Plasterboard walls. Modern linoleum to hardboard floor. Plasterboard boxing to bath - no access within boxing (excessive damage). Plastic bath panel - no access behind bath panel (excessive damage). Ceramic cistern. uPVC window and ceramic tile sill. Modern radiator. | |

| Conclusions and Actions | |
|---|---|
| Recommendation: | No further action required |

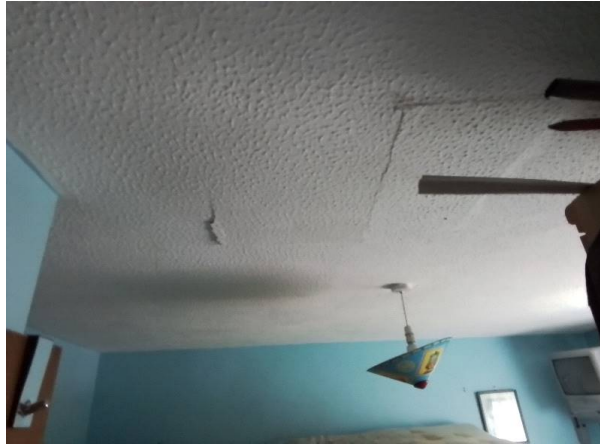
| Component: | Textured coating to plasterboard ceiling | | | | |

| Conclusions and Actions | |
|--|---|
| Recommendation: | No further action required |

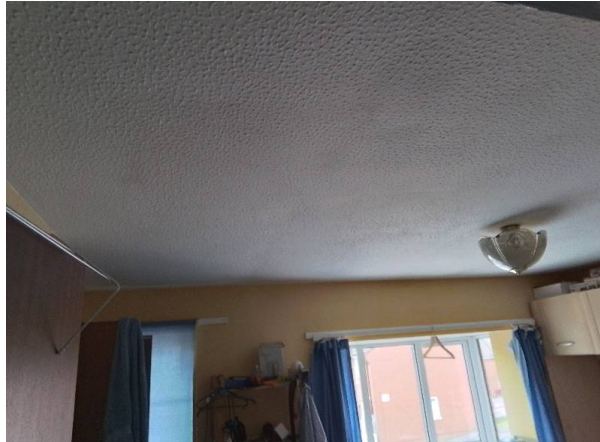
| Component: | Textured coating to plasterboard ceiling | | | | |

| Conclusions and Actions | |
|--|---|
| Recommendation: | No further action required |

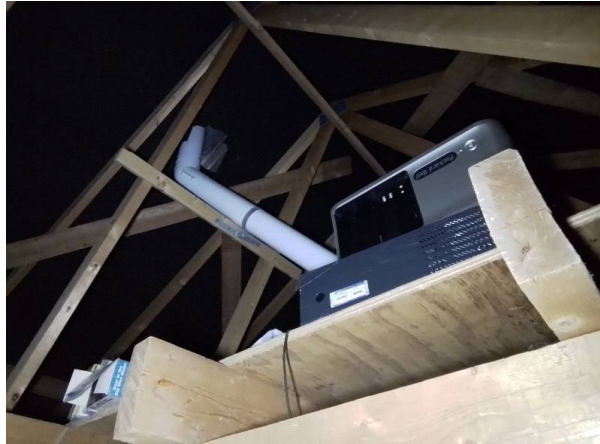
| Component: | No asbestos containing materials found | | | | |

| Conclusions and Actions | |
|---|---|
| Recommendation: | No further action required |

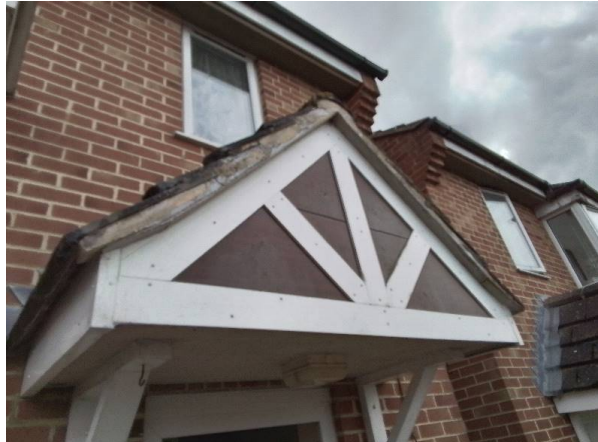
| Component: | Cement board undercloak to roof and entrance canopy | | | | |
| Extent: | 12lm | | | | |

| Material Assessment | | |
|---|---|---|
| Cement (1) | Low Damage (1) | 1 |

| Conclusions and Actions | |
|---|---|
| Recommendation: | Manage and Inspect |

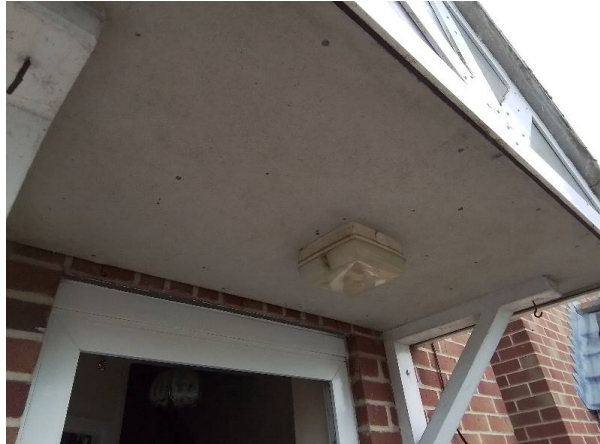
| Component: | Insulation board ceiling panel to entrance canopy | | | | |

| Conclusions and Actions | |
|---|---|
| Recommendation: | No further action required |
