Our Ref: 12018
Date: 29th January 2025

Fire Damage at 13 Hyde Close, Sway.

Thank you for appointing R Elliott Associates Ltd to inspect the roof timbers at 13 Hyde Close, Sway, following a fire in August 2024. A site visit was carried out on Wednesday 22nd January 2025, during which part of the house was inspected internally.

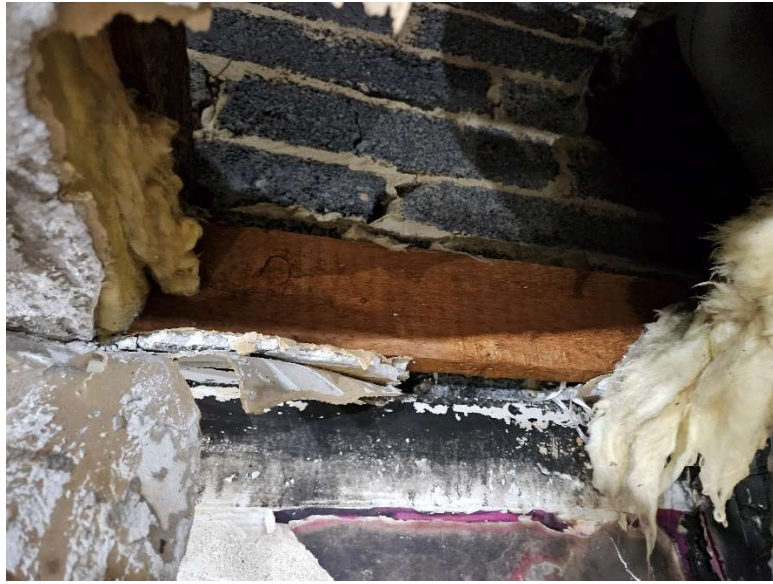
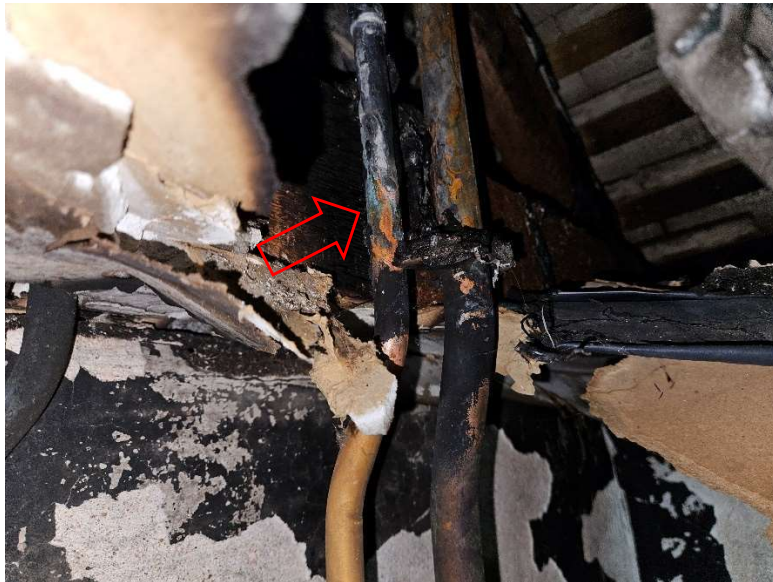
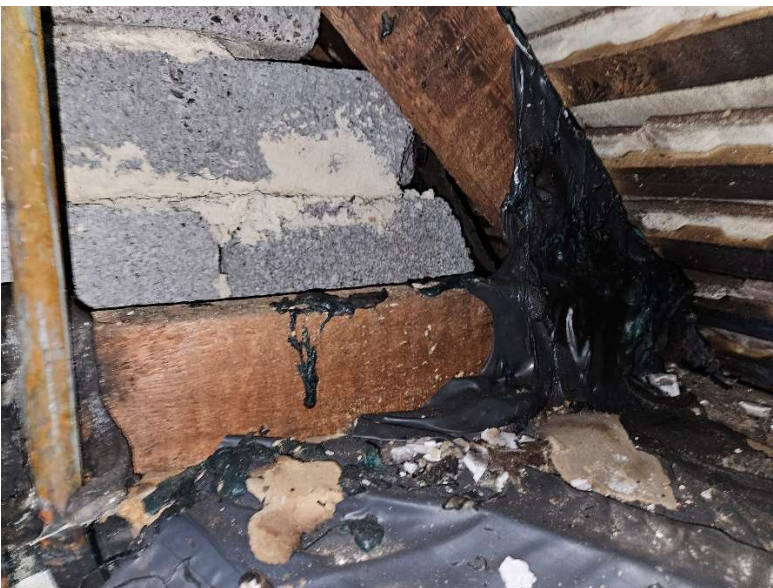
Joist 1 / Rafter 1

Rafter	R1 38x100	R2 38x100	R3 34x99	R4 37x99	R5 38x100	R6 38x100
Joist	J1 35x98	J2 34x99	J3 33x100	J4 34x94	J5 33x100	J6 38x100

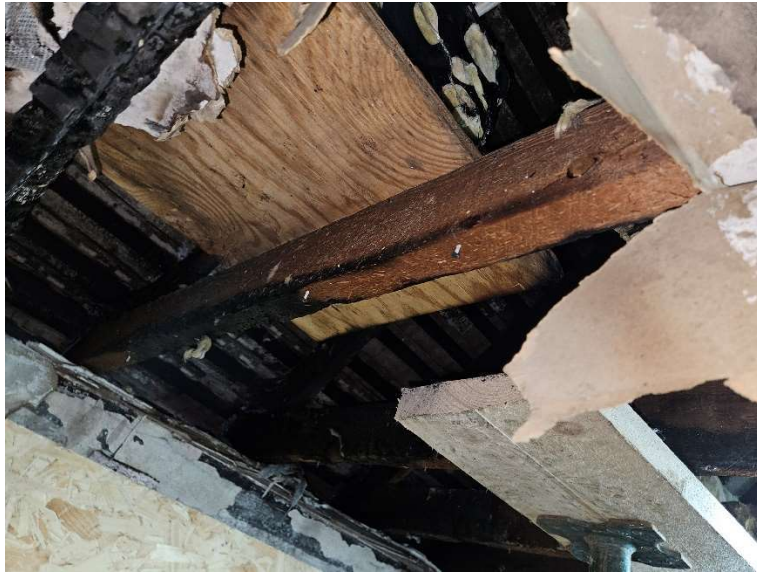
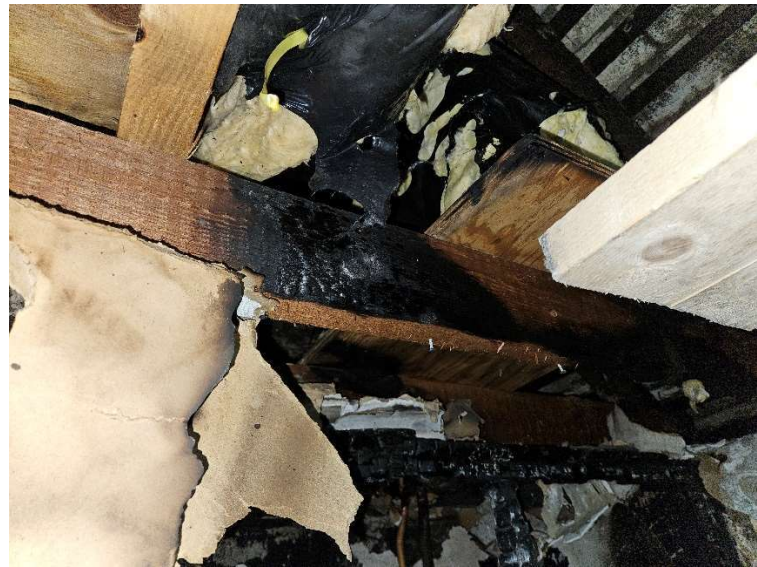
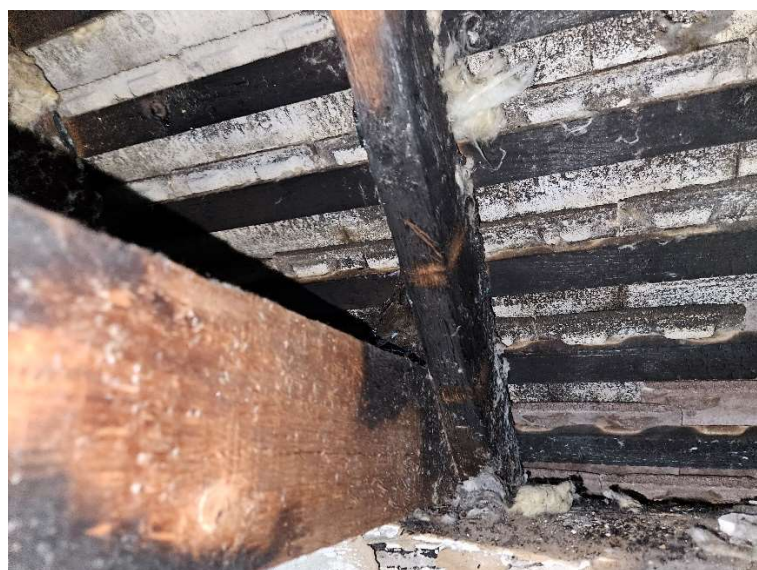
Joist 3 / Rafter 3

The timbers would only fail in deflection, meaning that if retained, they would not snap but would be more likely to cause cracks in the ceiling where the timbers might sag further. For example, J3 would deflect by 20% more than the permissible limit and J4 would deflect by 40%. The way to prevent this would be to reinforce the existing timbers with additional timbers alongside. Such reinforcement would take the form of 38x100mm C24 timbers fixed with M10 bolts at 600mm staggered centres with an overlap with unaffected timber of 0.5 metres. An alternative is to replace the timbers in line with current regulations.

The sections that are recommended to have additional reinforcement are shown as red as follows:

It is recommended that if the existing timbers are retained, the charring and melted roof felt should be removed from the timbers where possible by suitably trained, qualified and equipped personnel. As well as creating a stronger structural connection, this will minimise any potential effects of soot leaching through any adjacent materials and loose particles in the air that can affect persons with asthma.
