Asbestos Survey Report & Register

Survey Type:	Management Survey (with MA only)
Site:	11 Dickenson Road, Weston-super-Mare, Somerset, BS23 1YW
Lead Surveyor:	Paul Cook
Contract:	J014198
Survey Date:	27 Feb 2025
Report Date:	24 Mar 2025
Re-inspection Due:	27th February 2026
Client:	Julian House, 55 New King Street

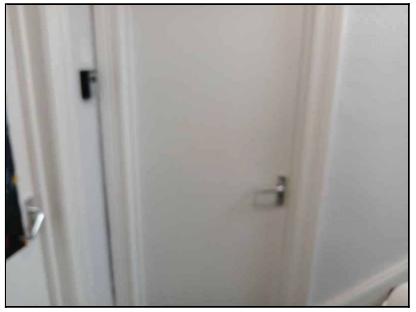
Room/Area	No access and restriction details:	Photo
012 Bedroom 3 103	No access into the room, the resident was not present, and no key was available at the time of the survey.

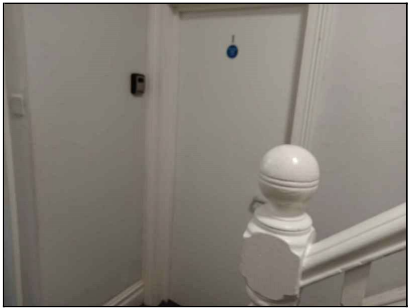
004 Bedroom 1 G04	No access into the room, the resident was not present, and no key was available at the time of the survey.

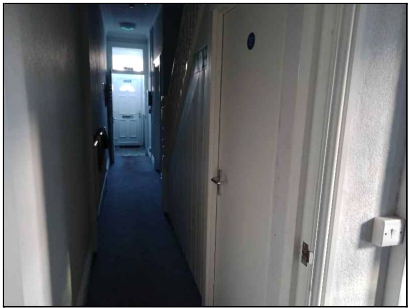
005 Understairs Cupboard G05	No access into the room, and no key was available at the time of the survey.

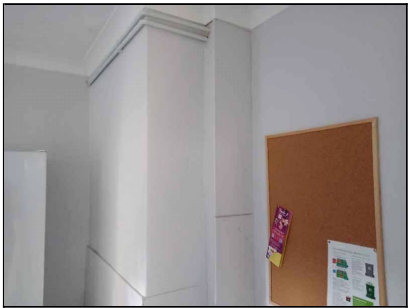
No access into boxing throughout G07	No access into boxing throughout without causing excessive damage.

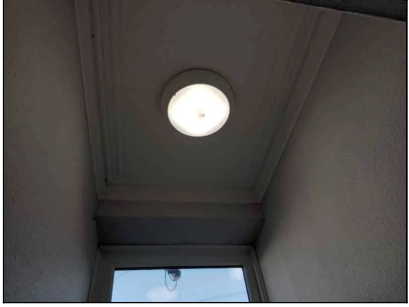
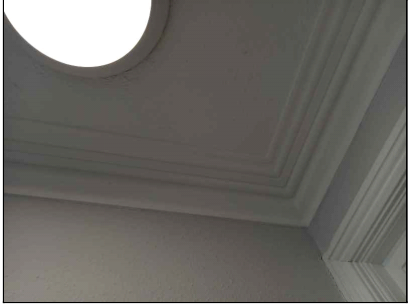
Floor:	Ground Floor		
Room Area:	001 Entrance		
Description	Textured coating to lathe & plaster ceiling		
Quantity	2m ²

Accessibility	Occasionally likely to be disturbed		
Product Type:	Textured Coating (1)		
Damage Extent	Low Damage (1)		
Surface Treatment	Sealed (0)	Re-inspection Due	N/A
Asbestos Type:	No Asbestos Detected	Sample Ref:	FT000881 (S)
Material Assessment:		Risk Score - N/A No Asbestos Detected	
Comment: Composite sample of the textured coating to lathe & plaster ceiling			
Recommendations: No further action required

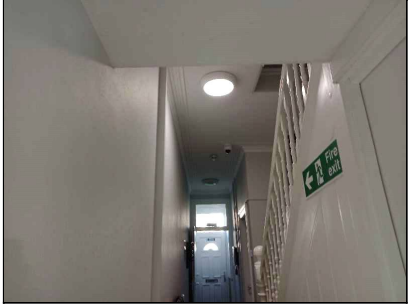
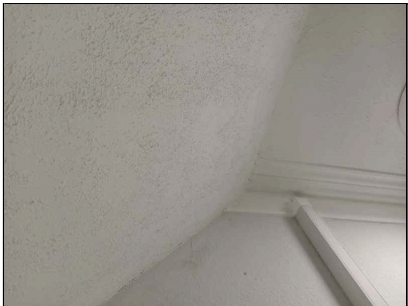
Floor:	Ground Floor		
Room Area:	002 Hall		
Description	Textured coating to lathe & plaster ceiling		
Quantity	7m ²

Accessibility	Occasionally likely to be disturbed		
Product Type:	Textured Coating (1)		
Damage Extent	Low Damage (1)		
Surface Treatment	Sealed (0)	Re-inspection Due	N/A
Asbestos Type:	No Asbestos Detected	Sample Ref:	As FT000881 (SP)
Material Assessment:	Risk Score - N/A No Asbestos Detected		
Comment: Composite sample of the textured coating to lathe & plaster or plasterboard ceiling			
Recommendations: No further action required

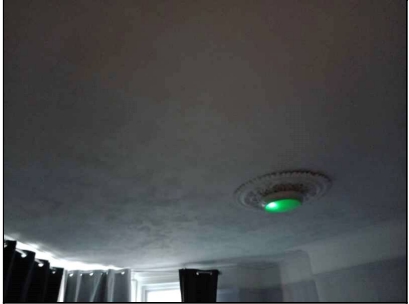
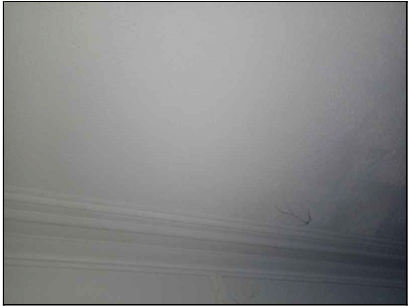
Floor:	Ground Floor		
Room Area:	003 Common Room		
Description	Textured coating to lathe & plaster ceiling		
Quantity	12m ²

Accessibility	Occasionally likely to be disturbed		
Product Type:	Textured Coating (1)		
Damage Extent	Low Damage (1)		
Surface Treatment	Sealed (0)	Re-inspection Due	N/A
Asbestos Type:	No Asbestos Detected	Sample Ref:	FT000882 (S)
Material Assessment:		Risk Score - N/A No Asbestos Detected	
Comment: Composite sample of the textured coating to lathe & plaster ceiling			
Recommendations: No further action required

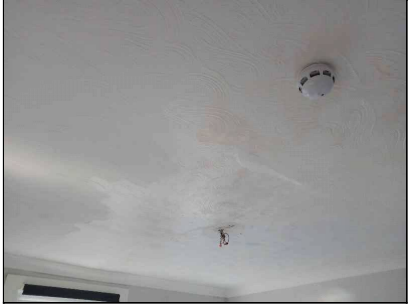
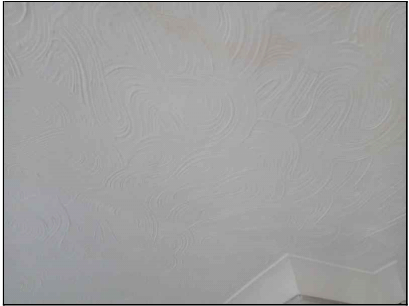
Floor:	Ground Floor		
Room Area:	006 Kitchen / Dining Room		
Description	Textured coating to plasterboard ceiling		
Quantity	10m ²

Accessibility	Occasionally likely to be disturbed		
Product Type:	Textured Coating (1)		
Damage Extent	Low Damage (1)		
Surface Treatment	Sealed (0)	Re-inspection Due	N/A
Asbestos Type:	No Asbestos Detected	Sample Ref:	FT000883 (S)
Material Assessment:		Risk Score - N/A No Asbestos Detected	
Comment: Composite sample of the textured coating to plasterboard ceiling			
Recommendations: No further action required

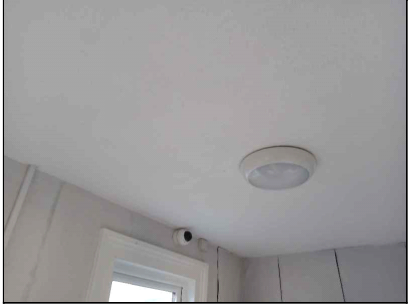
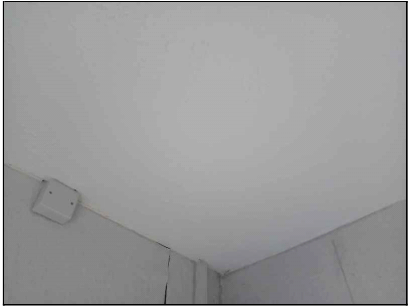
Floor:	Ground Floor		
Room Area:	007 Utility Room		
Description	Textured coating to lathe & plaster ceiling		
Quantity	7m ²

Accessibility	Occasionally likely to be disturbed		
Product Type:	Textured Coating (1)		
Damage Extent	Low Damage (1)		
Surface Treatment	Sealed (0)	Re-inspection Due	N/A
Asbestos Type:	No Asbestos Detected	Sample Ref:	As FT000881 (SP)
Material Assessment:	Risk Score - N/A No Asbestos Detected		
Comment: Composite sample of the textured coating to lathe & plaster ceiling			
Recommendations: No further action required

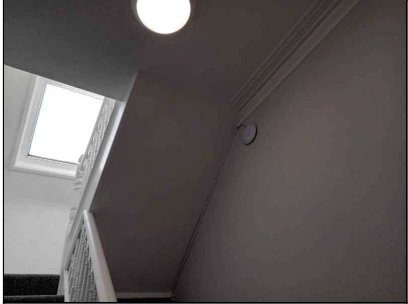
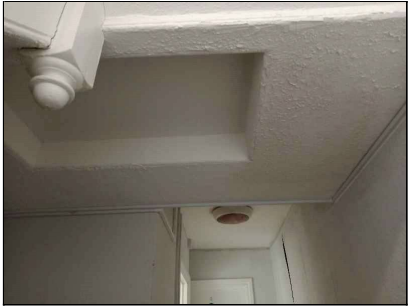
Floor:	1st Floor		
Room Area:	010 Circulation / Stairs		
Description	Textured coating to lathe & plaster ceiling		
Quantity	7m ²

Accessibility	Occasionally likely to be disturbed		
Product Type:	Textured Coating (1)		
Damage Extent	Low Damage (1)		
Surface Treatment	Sealed (0)	Re-inspection Due	N/A
Asbestos Type:	No Asbestos Detected	Sample Ref:	FT000884 (S)
Material Assessment:		Risk Score - N/A No Asbestos Detected	
Comment: Composite sample of the textured coating to lathe & plaster or plasterboard ceiling			
Recommendations: No further action required

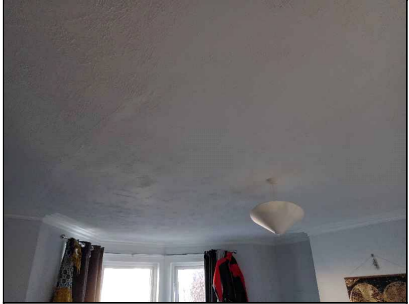
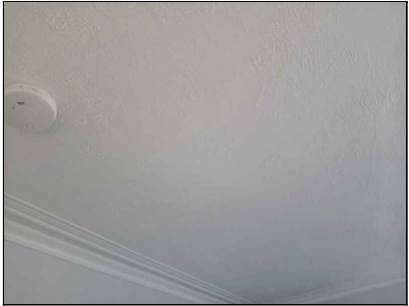
Floor:	1st Floor		
Room Area:	011 Bedroom 2		
Description	Textured coating to lathe & plaster or plasterboard ceiling		
Quantity	15m ²

Accessibility	Occasionally likely to be disturbed		
Product Type:	Textured Coating (1)		
Damage Extent	Low Damage (1)		
Surface Treatment	Sealed (0)	Re-inspection Due	N/A
Asbestos Type:	No Asbestos Detected	Sample Ref:	As FT000884 (SP)
Material Assessment:		Risk Score - N/A No Asbestos Detected	
Comment: Composite sample of the textured coating to lathe & plaster or plasterboard ceiling			
Recommendations: No further action required

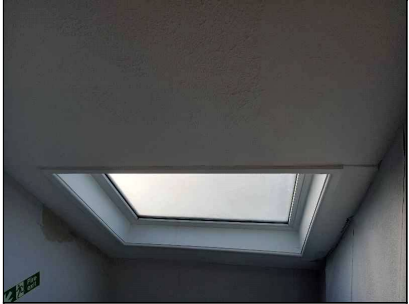
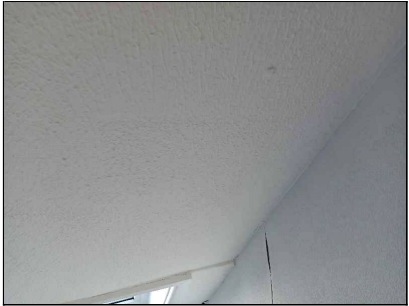
Floor:	2nd Floor		
Room Area:	015 Circulation / Stairs		
Description	Textured coating to lathe & plaster ceiling		
Quantity	7m ²

Accessibility	Occasionally likely to be disturbed		
Product Type:	Textured Coating (1)		
Damage Extent	Low Damage (1)		
Surface Treatment	Sealed (0)	Re-inspection Due	N/A
Asbestos Type:	No Asbestos Detected	Sample Ref:	FT000885 (S)
Material Assessment:		Risk Score - N/A No Asbestos Detected	
Comment: Composite sample of the textured coating to lathe & plaster or plasterboard ceiling			
Recommendations: No further action required

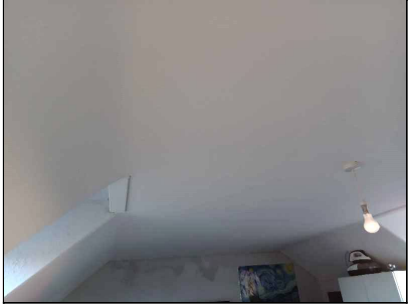
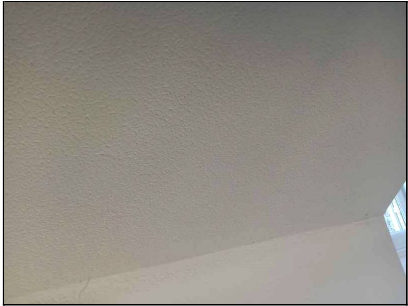
Floor:	2nd Floor		
Room Area:	016 Bedroom 5		
Description	Textured coating to lathe & plaster ceiling		
Quantity	12m ²

Accessibility	Occasionally likely to be disturbed		
Product Type:	Textured Coating (1)		
Damage Extent	Low Damage (1)		
Surface Treatment	Sealed (0)	Re-inspection Due	N/A
Asbestos Type:	No Asbestos Detected	Sample Ref:	BS000198 (S)
Material Assessment:		Risk Score - N/A No Asbestos Detected	
Comment: Composite sample of the textured coating to lathe & plaster or plasterboard ceiling			
Recommendations: No further action required
