## ASBESTOS RE-INSPECTION REPORT

Client	Swindon Borough Council
Site	B001 Herbert Harvey Court (1-42), Covingham, Swindon, SN3 5HX
Date started	18 Aug 2023
Date completed	18 Aug 2023
Date report issued	24 Aug 2023
Survey reference	J903445 V2
Lead surveyor	Luke Baglow
Assistant surveyor	N/A
UPRN	0630000150

B001 Herbert Harvey Court (1-42)  
Covingham  
Swindon  
SN3 5HX

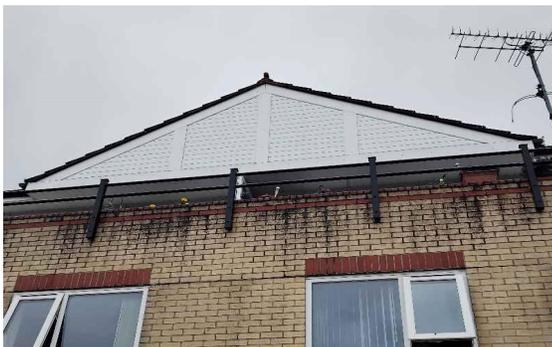
Item Reference	J903445 #34	
	Sample reference number	34 {BA001362}	
	Client name	Swindon Borough Council	
	Site address	B001 Herbert Harvey Court (1-42), Covingham, Swindon, SN3 5HX	
	Date surveyed	18/08/23	
	Date analysed		
	Building	B001 Herbert Harvey Crescent (1 - 42)	
	Floor level	External	
	Room	External	
	Position	Front Gable	
	Item description	Cement Undercloaking	
	Condition / damage	(0) Good Condition	
	Surface treatment	(1) Enclosed sprays and lagging, Sealed AIB, asbestos cement, textured coating, gasket	
	Product type	Asbestos Cement	
Asbestos Type	Chrysotile		
Extent	8lm		
Recommended Action	Monitor and manage	Accessibility	Low
Comments:		Material assessment score	3
		Risk code	Risk code E
Material Status Change: No Change		Reinspection Comments:

Comments						Next reinspection	Extent	Recommended action	Action Timescale	Date action completed
						08/2024	8lm	Monitor and manage		
<b>Material Status Change: No Change</b>						Reinspection Comments:

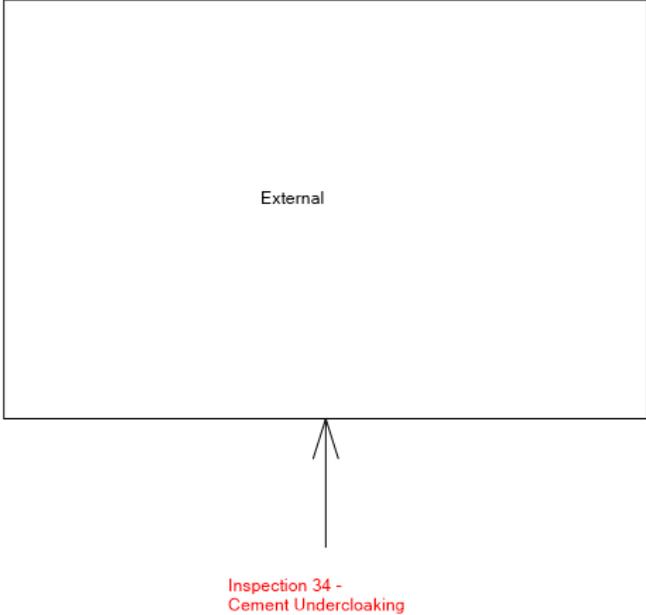
<p>External</p> <p>Inspection 34 - Cement Undercloaking</p>	<p><b>External</b></p> <p>Asbestos = Red</p> <p>No Access = Blue</p> <p>Non Asbestos = Green</p> <p>NOT TO SCALE</p>
