## **Refurbishment Survey (with MA only)**

**At  
55 Nursery Road  
Bournemouth  
Dorset,  
BH9 3AT**

**Sanctuary Group**

Job Number	J278572
------------	---------

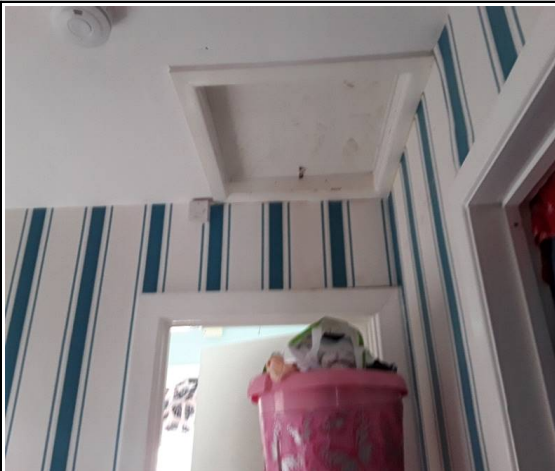
Inspection Number:	1	Intrusive Area – Yes or No:	Yes
<b>Material Assessment</b>			
Item:	Detail:		
Building:	1 / 3 Bedroom Mid terraced house		
Location:	Roof / Loft Space R01		
Sample Number:	Visual		
Description:	Inaccessible		
Position:			
Extent:			
Product Type:	N/A		
Damage & Deterioration:	N/A		
Surface Treatment:	N/A		
Asbestos Type:	N/A		
Material Score:	N/A

Room Comments:	Stored items below

Sample Comments:	N/A	
Total Assessment Score:	12	
Risk Assessment Category:		
Recommendation:	Inspect prior to disturbance

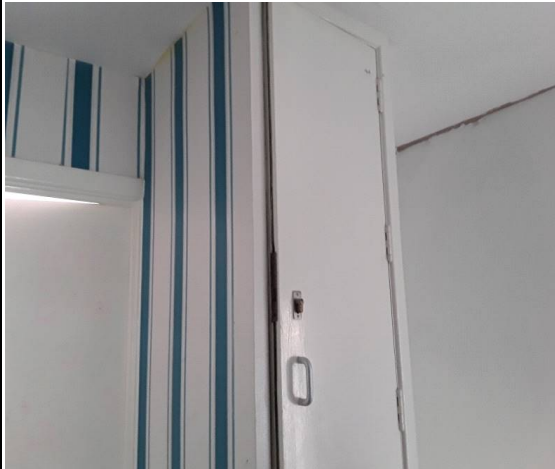
Inspection Number:	2	Intrusive Area – Yes or No:	Yes
<b>Material Assessment</b>			
Item:	Detail:		
Building:	1 / 3 Bedroom Mid terraced house		
Location:	First / Landing 101		
Sample Number:	Visual		
Description:	No suspect materials visually found		
Position:			
Extent:			
Product Type:	N/A		
Damage & Deterioration:	N/A		
Surface Treatment:	N/A		
Asbestos Type:	-		
Material Score:	0

Room Comments:	Plasterboard ceiling. Plaster skimmed solid walls. Carpet on timber floorboards. Upvc window and timber sill. Non suspect Cupboard.

Sample Comments:	N/A	
Total Assessment Score:	0	
Risk Assessment Category:	N/A	
Recommendation:	Not applicable

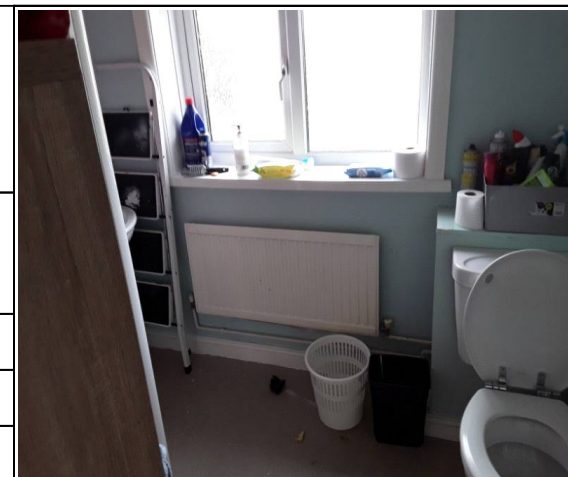
Inspection Number:	3	Intrusive Area – Yes or No:	Yes
<b>Material Assessment</b>			
Item:	Detail:		
Building:	1 / 3 Bedroom Mid terraced house		
Location:	First / Bathroom 102		
Sample Number:	Visual		
Description:	No suspect materials visually found		
Position:			
Extent:			
Product Type:	N/A		
Damage & Deterioration:	N/A		
Surface Treatment:	N/A		
Asbestos Type:	-		
Material Score:	0

Room Comments:	Plasterboard ceiling. Plaster skimmed solid walls partially ceramic tiled. Modern vinyl on timber floorboards. Upvc window and timber upvc/sill. Ceramic furniture. Plastic shower tray. Wall mounted radiator.
Sample Comments:	N/A
Total Assessment Score:	0
Risk Assessment Category:	N/A
Recommendation:	Not applicable

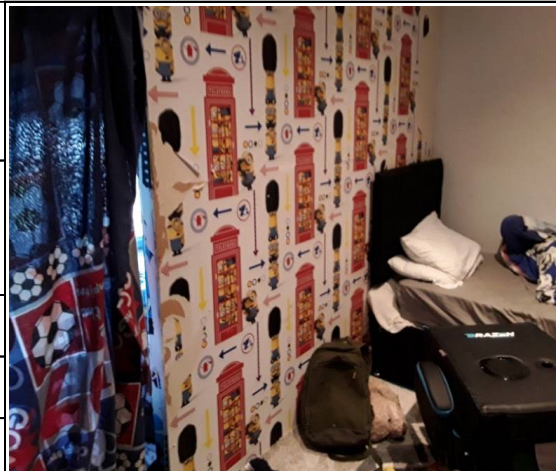
Inspection Number:	4	Intrusive Area – Yes or No:	Yes
<b>Material Assessment</b>			
Item:	Detail:		
Building:	1 / 3 Bedroom Mid terraced house		
Location:	First / Bedroom 103		
Sample Number:	Visual		
Description:	No suspect materials visually found		
Position:			
Extent:			
Product Type:	N/A		
Damage & Deterioration:	N/A		
Surface Treatment:	N/A		
Asbestos Type:	-		
Material Score:	0

Room Comments:	1 Plasterboard ceiling. Plaster skimmed solid walls. Carpet on timber floorboards. Upvc window and timber sill. Timber door and frame. Wall mounted radiator. Timber partition.

Sample Comments:	N/A	
Total Assessment Score:	0	
Risk Assessment Category:	N/A	
Recommendation:	Not applicable

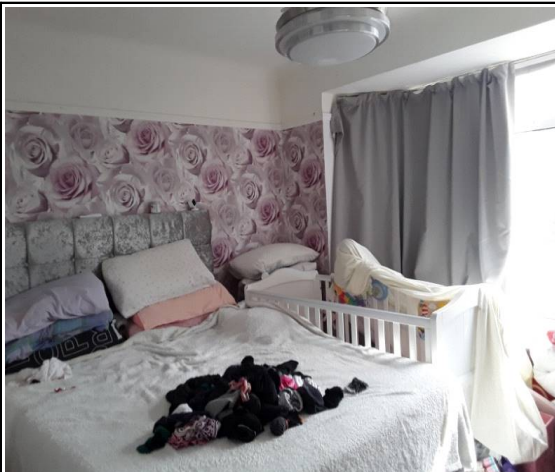
Inspection Number:	5	Intrusive Area – Yes or No:	Yes
<b>Material Assessment</b>			
Item:	Detail:		
Building:	1 / 3 Bedroom Mid terraced house		
Location:	First / Bedroom 104		
Sample Number:	Visual		
Description:	No suspect materials visually found		
Position:			
Extent:			
Product Type:	N/A		
Damage & Deterioration:	N/A		
Surface Treatment:	N/A		
Asbestos Type:	-		
Material Score:	0

Room Comments:	2 Plasterboard ceiling. Plaster skimmed solid walls. Carpet on timber floorboards. Upvc window and timber sill. Timber door and frame. Wall mounted radiator.

Sample Comments:	N/A	
Total Assessment Score:	0	
Risk Assessment Category:	N/A	
Recommendation:	Not applicable

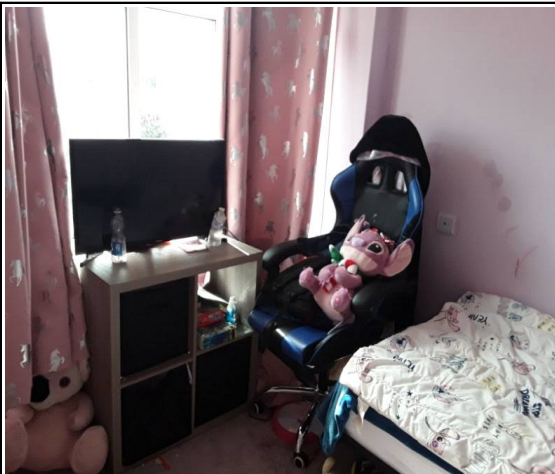
Inspection Number:	6	Intrusive Area – Yes or No:	Yes
<b>Material Assessment</b>			
Item:	Detail:		
Building:	1 / 3 Bedroom Mid terraced house		
Location:	First / Bedroom 105		
Sample Number:	Visual		
Description:	No suspect materials visually found		
Position:			
Extent:			
Product Type:	N/A		
Damage & Deterioration:	N/A		
Surface Treatment:	N/A		
Asbestos Type:	-		
Material Score:	0

Room Comments:	3 Plasterboard ceiling. Plaster skimmed solid walls. Carpet on timber floorboards. Upvc window and timber sill. Timber door and frame. Wall mounted radiator.

Sample Comments:	N/A	
Total Assessment Score:	0	
Risk Assessment Category:	N/A	
Recommendation:	Not applicable

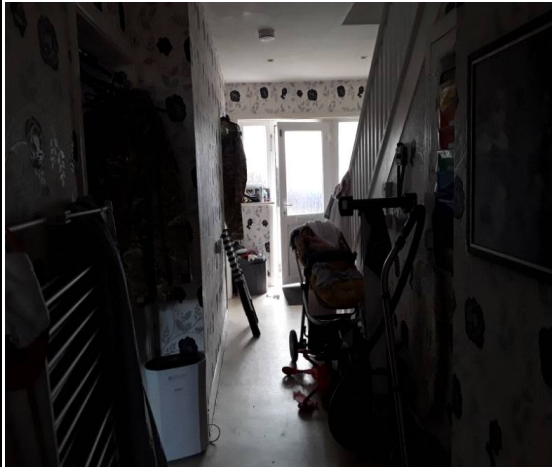
Inspection Number:	7	Intrusive Area – Yes or No:	Yes
<b>Material Assessment</b>			
Item:	Detail:		
Building:	1 / 3 Bedroom Mid terraced house		
Location:	Ground / Hall G01		
Sample Number:	Visual		
Description:	No suspect materials visually found		
Position:			
Extent:			
Product Type:	N/A		
Damage & Deterioration:	N/A		
Surface Treatment:	N/A		
Asbestos Type:	-		
Material Score:	0

Room Comments:	Plasterboard ceiling. Plaster skimmed solid walls. Modern flooring on timber floorboards. Upvc door and window with timber sills. Wall mounted radiator. Non suspect Cupboard below stairs.

Sample Comments:	N/A	
Total Assessment Score:	0	
Risk Assessment Category:	N/A	
Recommendation:	Not applicable

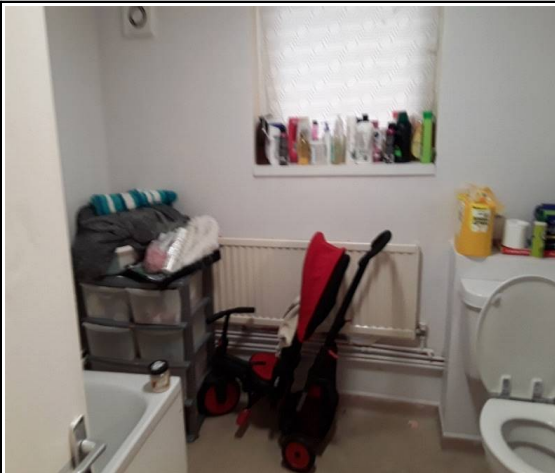
Inspection Number:	8	Intrusive Area – Yes or No:	Yes
<b>Material Assessment</b>			
Item:	Detail:		
Building:	1 / 3 Bedroom Mid terraced house		
Location:	Ground / Bathroom G02		
Sample Number:	Visual		
Description:	No suspect materials visually found		
Position:			
Extent:			
Product Type:	N/A		
Damage & Deterioration:	N/A		
Surface Treatment:	N/A		
Asbestos Type:	-		
Material Score:	0

Room Comments:	Plasterboard ceiling. Plaster skimmed solid walls partially ceramic tiled. Modern vinyl on concrete floor. Timber door and frame. Upvc window and sill. Wall mounted radiator. Timber bath panel reveals copper pipework. Timber boxing. Ceramic furniture.

Sample Comments:	N/A	
Total Assessment Score:	0	
Risk Assessment Category:	N/A	
Recommendation:	Not applicable

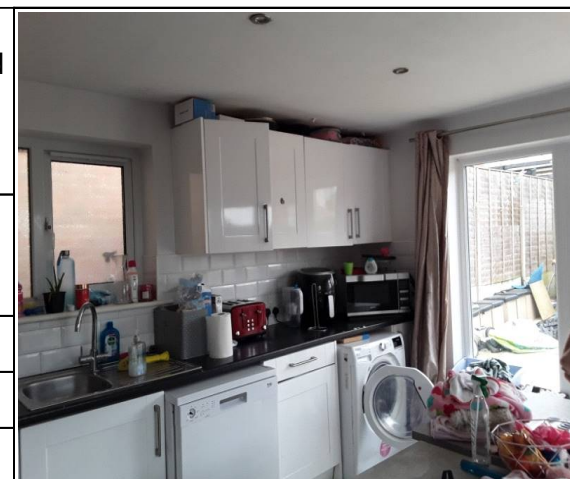
Inspection Number:	9	Intrusive Area – Yes or No:	Yes
<b>Material Assessment</b>			
Item:	Detail:		
Building:	1 / 3 Bedroom Mid terraced house		
Location:	Ground / Kitchen G03		
Sample Number:	Visual		
Description:	No suspect materials visually found		
Position:			
Extent:			
Product Type:	N/A		
Damage & Deterioration:	N/A		
Surface Treatment:	N/A		
Asbestos Type:	-		
Material Score:	0

Room Comments:	Plasterboard ceiling. Plaster skimmed solid walls partially ceramic tiled. Ceramic tiles to concrete floor. Timber door and frame. Upvc rear door. Upvc window and timber sill. Timber door and frame. Wall mounted radiator. Modern furniture.
Sample Comments:	N/A
Total Assessment Score:	0
Risk Assessment Category:	N/A
Recommendation:	Not applicable

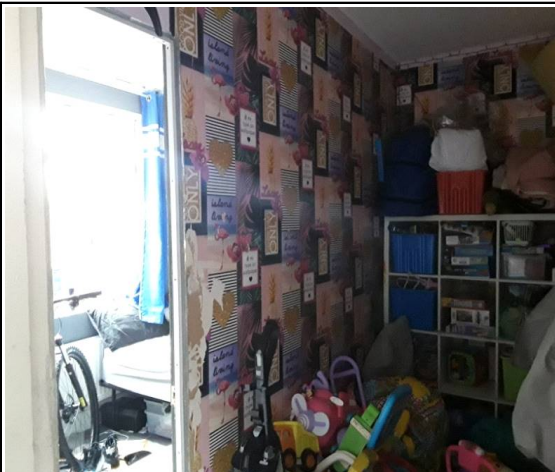
Inspection Number:	10	Intrusive Area – Yes or No:	Yes
<b>Material Assessment</b>			
Item:	Detail:		
Building:	1 / 3 Bedroom Mid terraced house		
Location:	Ground / Dining Room G04		
Sample Number:	Visual		
Description:	No suspect materials visually found		
Position:			
Extent:			
Product Type:	N/A		
Damage & Deterioration:	N/A		
Surface Treatment:	N/A		
Asbestos Type:	-		
Material Score:	0

Room Comments:	Plasterboard ceiling. Plaster skimmed solid walls. Carpet on timber floorboards. Timber door and frame. Upvc window and timber sill. Wall mounted radiator.

Sample Comments:	N/A	
Total Assessment Score:	0	
Risk Assessment Category:	N/A	
Recommendation:	Not applicable

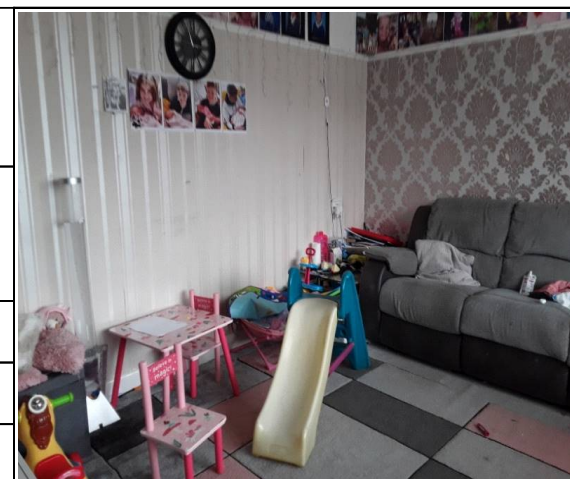
Inspection Number:	11	Intrusive Area – Yes or No:	Yes
<b>Material Assessment</b>			
Item:	Detail:		
Building:	1 / 3 Bedroom Mid terraced house		
Location:	Ground / Living Room G05		
Sample Number:	Visual		
Description:	No suspect materials visually found		
Position:			
Extent:			
Product Type:	N/A		
Damage & Deterioration:	N/A		
Surface Treatment:	N/A		
Asbestos Type:	-		
Material Score:	0

Room Comments:	Plasterboard ceiling. Plaster skimmed solid walls. Carpet on timber floorboards. Timber door and frame. Upvc window and timber sill. Wall mounted radiator.
Sample Comments:	N/A
Total Assessment Score:	0
Risk Assessment Category:	N/A
Recommendation:	Not applicable

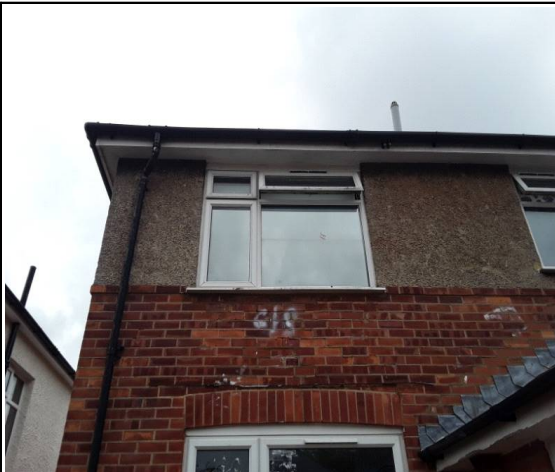
INSPECTION NO	BUILDING	LOCATION	SAMPLE NO	DESCRIPTION	EXTENT	PRODUCT TYPE (MA)	DAMAGE (MA)	SURFACE TREATMENT (MA)	ASBESTOS TYPE (MA)	TOTAL MA SCORE (MA)	ACTION
12	1 / 3 Bedroom Mid terraced house	External / External E01 / to underside of	Visual	Asbestos Insulating Board	40lm	Asbestos Insulating Board (2)	Low Damage (1)	Surface Sealed (1)	Amosite (2)	Low (6)	Manage and Monitor

Inspection Number / Location:	Asbestos Type / Product:	Extent:	Recommendation:
Visual - 12 / External / External E01	Amosite Asbestos Insulating Board to underside of	40 lm	Manage and Monitor

Inspection Number:	12	Intrusive Area – Yes or No:	Yes
<b>Material Assessment</b>			
Item:	Detail:		
Building:	1 / 3 Bedroom Mid terraced house		
Location:	External / External E01		
Sample Number:	Visual		
Description:	Asbestos Insulating Board		
Position:	to underside of		
Extent:	40lm		
Product Type:	Asbestos Insulating Board		
Damage & Deterioration:	Low Damage		
Surface Treatment:	Enclosed sprays and lagging, Sealed AIB		
Asbestos Type:	Amosite		
Material Score:	6

Room Comments:	Clay tiled roof. Board soffits. Plastic rainwater goods. Brick walls. Boards soffits at low level. Cement Undercloaking to front canopy.

Sample Comments:	Soffits	
Total Assessment Score:	6	
Risk Assessment Category:	Low	
Recommendation:	Manage and Monitor

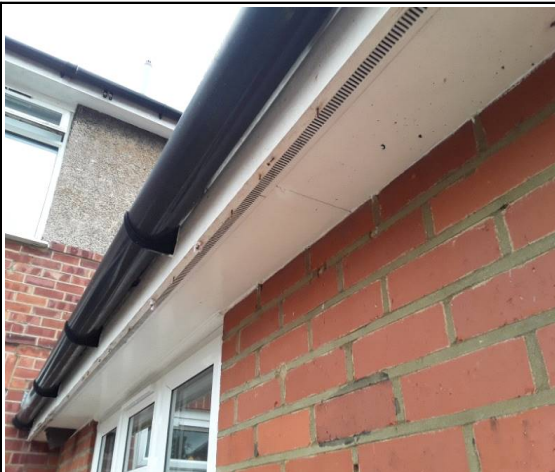
Inspection Number:	13	Intrusive Area – Yes or No:	Yes
<b>Material Assessment</b>			
Item:	Detail:		
Building:	1 / 3 Bedroom Mid terraced house		
Location:	External / External E01		
Sample Number:	GO000253		
Description:	Asbestos Insulating Board		
Position:	to roof		
Extent:	16lm		
Product Type:	Insulating Board		
Damage & Deterioration:	Low Damage		
Surface Treatment:	Enclosed sprays and lagging, Sealed AIB		
Asbestos Type:	No Asbestos Detected		
Material Score:	0

Room Comments:	Clay tiled roof. Board soffits. Plastic rainwater goods. Brick walls. Boards soffits at low level. Cement Undercloaking to front canopy.

Sample Comments:	Low level only	
Total Assessment Score:	0	
Risk Assessment Category:	N/A	
Recommendation:	Not applicable

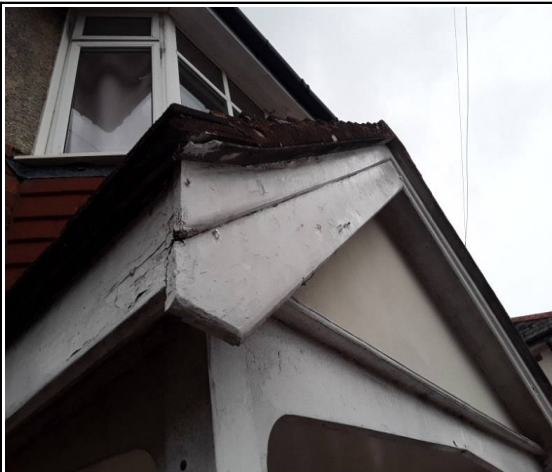
Inspection Number:	14	Intrusive Area – Yes or No:	Yes
<b>Material Assessment</b>			
Item:	Detail:		
Building:	1 / 3 Bedroom Mid terraced house		
Location:	External / External E01		
Sample Number:	GO000254		
Description:	Asbestos Cement		
Position:	to underside of		
Extent:	8lm		
Product Type:	Cement		
Damage & Deterioration:	Low Damage		
Surface Treatment:	Enclosed sprays and lagging, Sealed AIB		
Asbestos Type:	No Asbestos Detected		
Material Score:	0

Room Comments:	Clay tiled roof. Board soffits. Plastic rainwater goods. Brick walls. Boards soffits at low level. Cement Undercloaking to front canopy.

Sample Comments:	Front canopy	
Total Assessment Score:	0	
Risk Assessment Category:	N/A	
Recommendation:	Not applicable
