Site ID: **r1-229518** Re-Inspection of Surveys

1-36, Blackman Gardens
Swindon
Wiltshire
SN3 1RN
United Kingdom

2nd October 2019

The original survey was conducted by DMW Environmental Safety Ltd. Report reference **A-55491**.

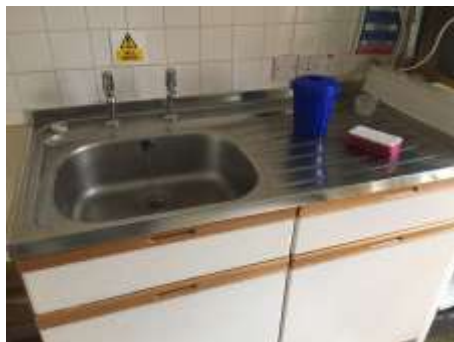
Chrysotile (white)

Sample taken? **Yes**Product Type **Bitumen Sink Pad**Surface Treatment. **Sealed Composite Material**Condition **Low Damage**Surface **Sink**Material Risk Assessment **3**Quantity: **1 SQ M**Next Inspection Date: **As per client policy/plan.**

Sink and drainer pad Original sample reference a-55491-i39-52

The material was seen to be in fair condition at the time of the initial inspection.

The condition of the material should be managed by a competent person/company and its presence made aware to those at risk, as part of a Control of Asbestos Regulations (CAR) 2012 compliant management strategy.
