## RBS Inspection

Work Order  
Number 00000762

Reason for  
Inspection Inspection following a small fire to the lounge.

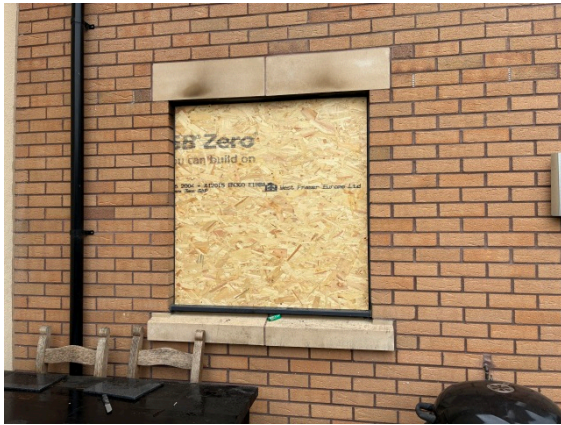
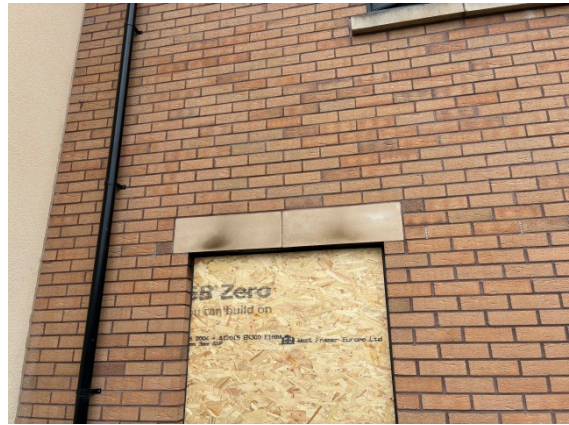
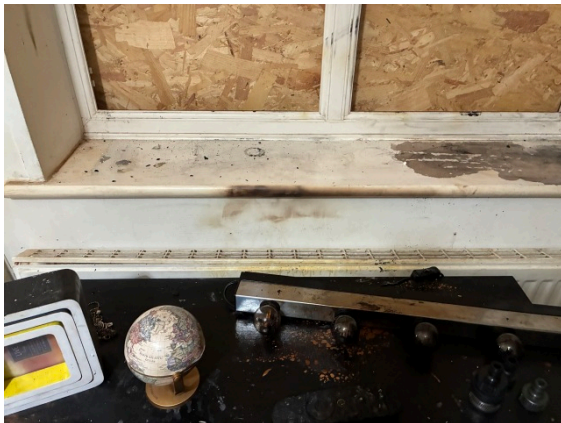
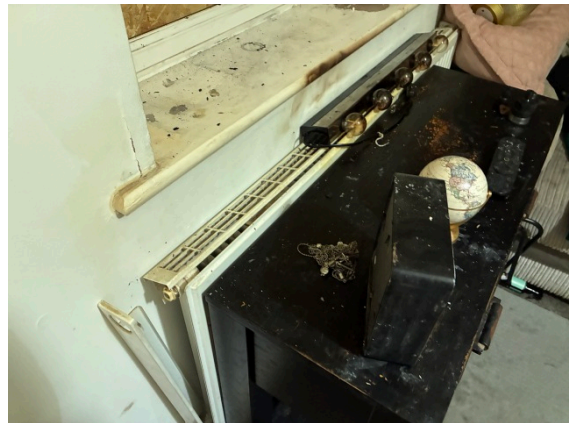
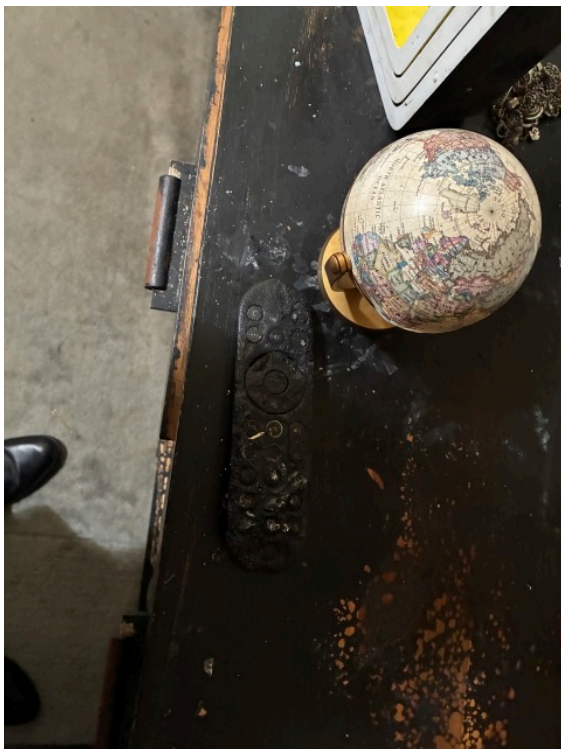
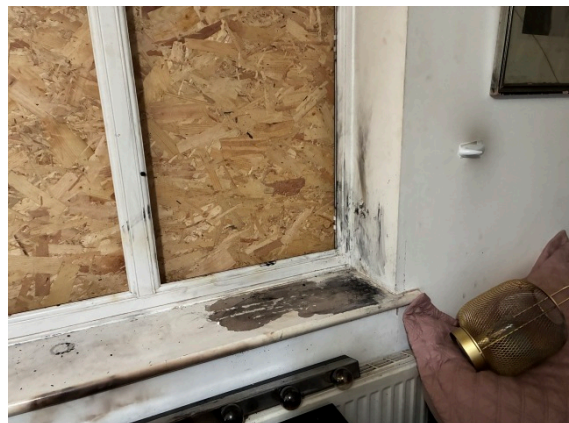
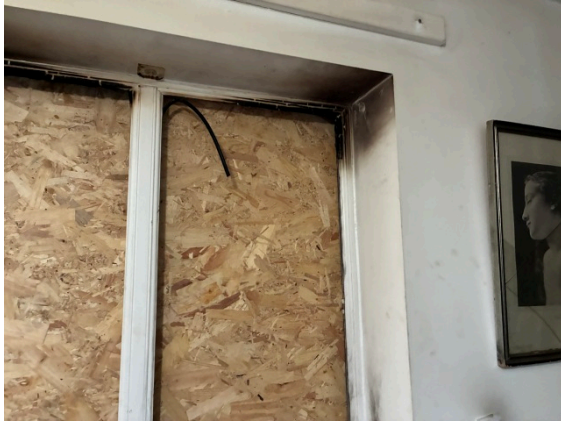
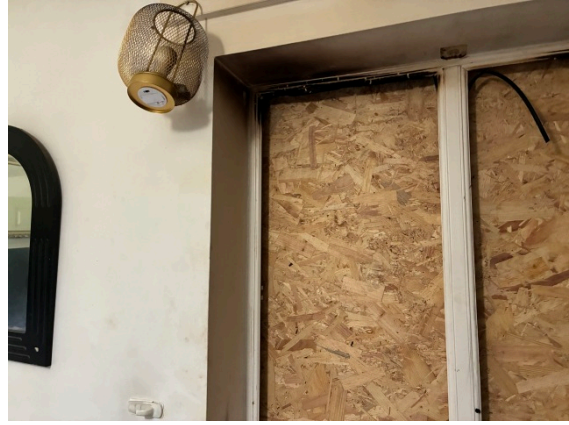
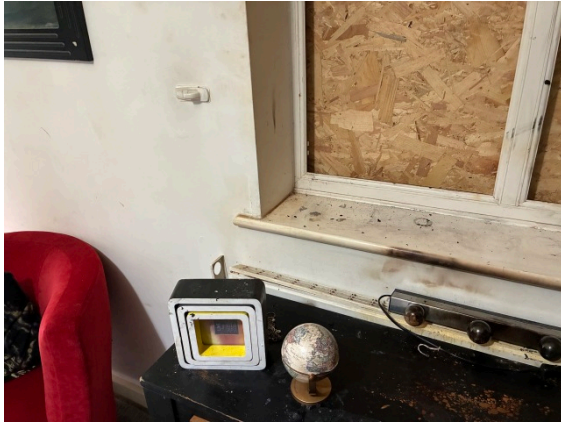
Issue(s) or Defect(s) Identified .There has been a small fire in the lounge that has resulted in damage to the UPVC window, timber window board and sooting to the window reveals and walls. The window is approximately 1.2m x 1.4m with two opening lights. Both lights have been damaged as has the frame and it will require a new window to be installed. There is smoke damage to the timber window board and to the reveals and walls. Although not obvious, the walls and ceilings are likely to be lightly smoke damaged and the ceiling and walls will all need to be repainted. The affected areas will need to be treated with smoke stain block and the walls and ceiling re-painted. There was seen to be a remote controller that was damaged by heat but the resident's son was unable to confirm the cause or source of the fire. There was also seen to be some slight smoke damage externally but this would not need to be treated or cleaned.

Works to be raised Renew window to lounge. Apply suitable stain block to walls (approx 2 sqm) Re-paint walls and ceiling to room ne 20 sqm in floor area. Apply undercoat and top coat to timber window board n.e 300mm girth. 2m run
