RBS Inspection

Work Order Number 00000770

Case Number	00017997	CX Repair Request Id	1209324
Work Order Number	00000770	CX Work Order Reference	LW848410
Property Address	17 Knightstone Heights, Locks Hill, Frome, Somerset, BA11 1NR	Last Modified By	Julian Mallia, 21/07/2025, 13:42

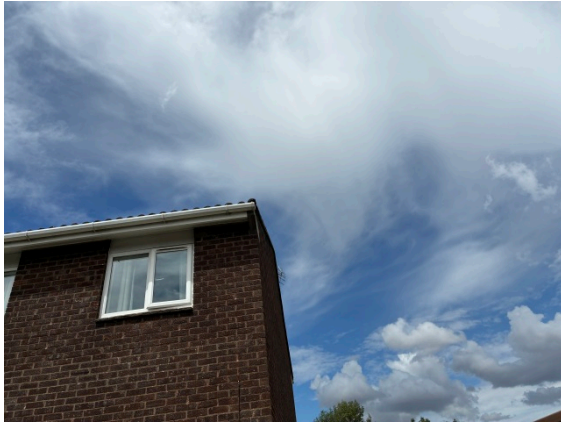
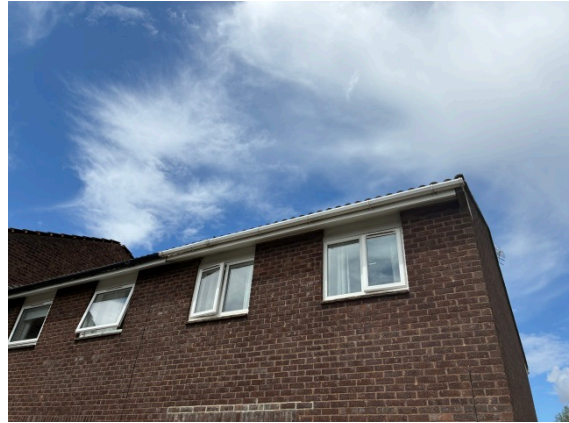
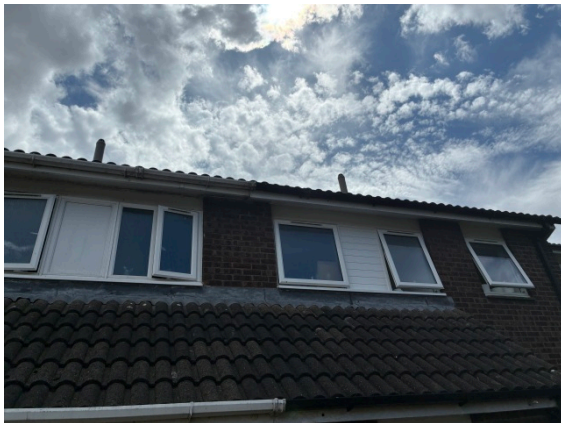
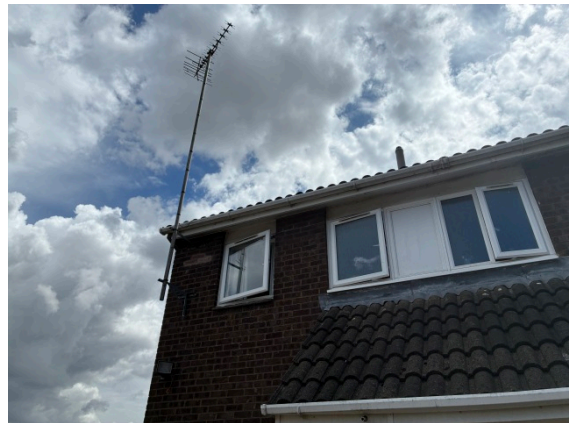
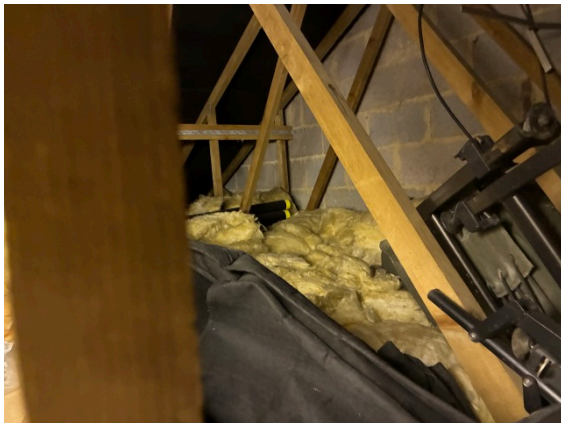
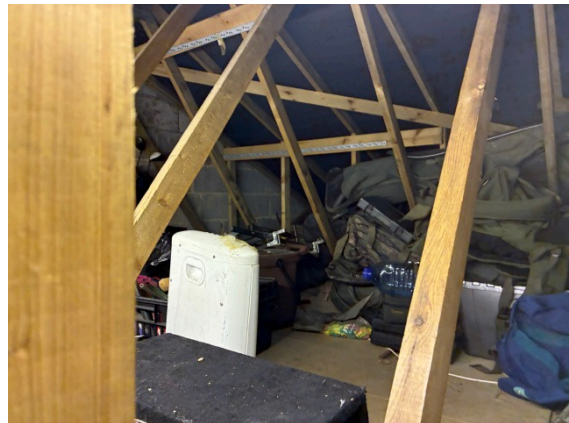
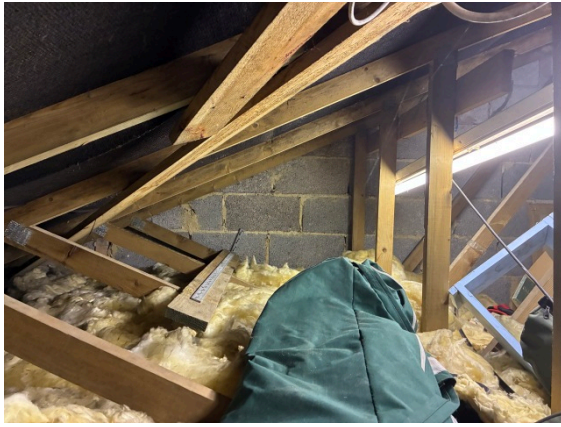
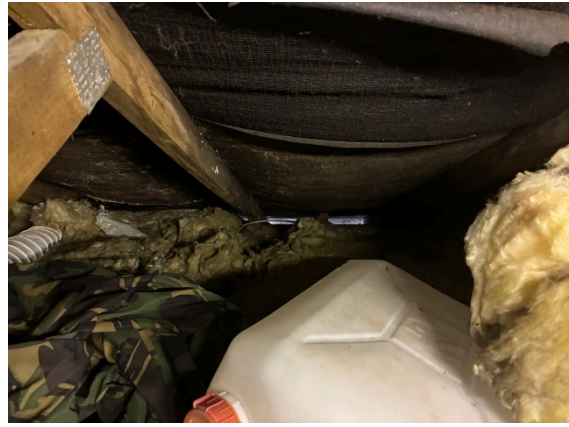
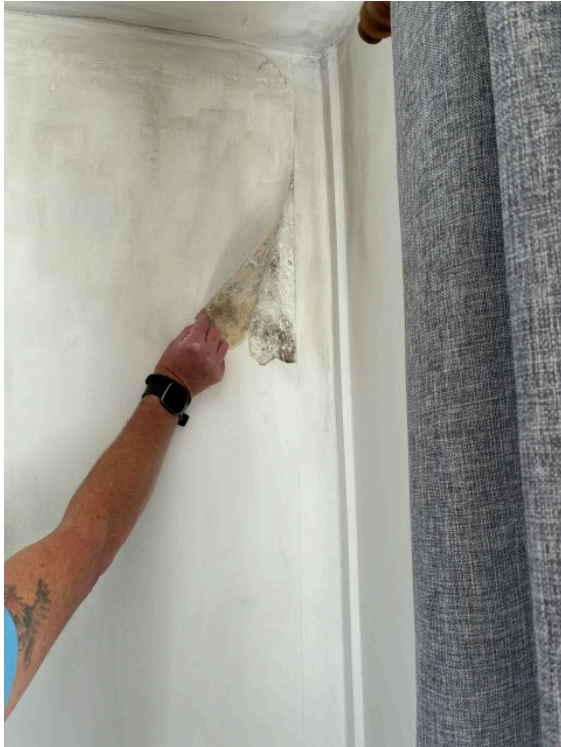
Issue(s) or Defect(s) Identified	<p>There is evidence of water damage around the eaves and along the gable wall. There was seen to be a lifted tile on the rear corner of the back bedroom. This was in line with an area of water damage and mould behind the painted wall paper in that room. There was also evidence of mould staining along the ceiling by the eaves and gable wall in the back bedrooms and front bedroom. Inspection of the loft showed that there was a certain amount of belongings being stored. We have advised the tenant that this should be removed in accordance with the terms of the tenancy which states that lofts should not be used for storage. It was also noted that additional insulation had been installed but that this was done in such a manner as to restrict loft ventilation. We will raise a job to treat the areas of mould in the bedrooms and the tenant will remove the damaged wall paper to allow this to be done. We will also raise a job to fit lap vents in the loft and the tenant will need to clear the loft to allow this to be done. A job will also need to be raised to repair and re-site lifted tiles on the rear corner to ensure there is no water penetration at that point.</p>

Works to be raised	<p>Mould clean to 3 bedrooms Lift and re-lay up to 5 tiles at verge including repairing any verge mortar. Supply and fit lap vents to roof.</p>
RBS Inspection General Notes
