SCHEME RISK ASSESSMENT

8 Jul 2025 / Lianne Short / SCHEME COLLETT ROAD NORTON  
FITZWARREN TAUNTON SOMERSET TA2 6DD

SRA-001188

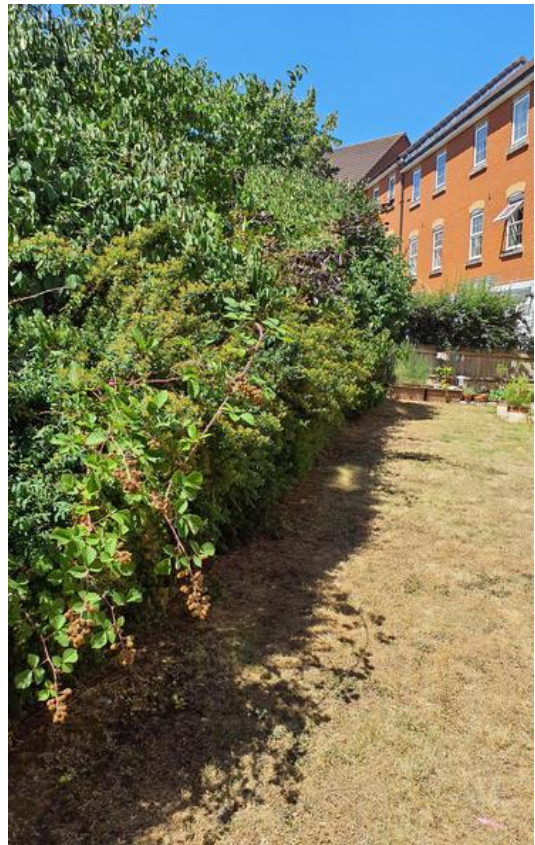
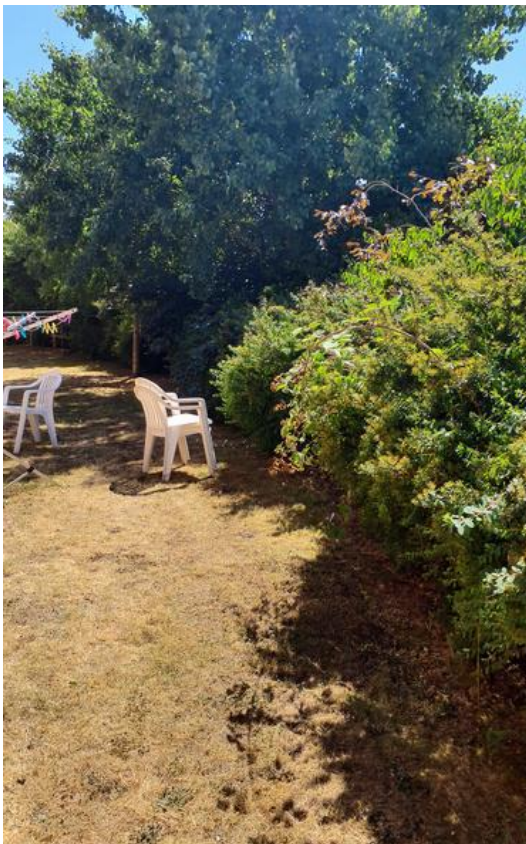
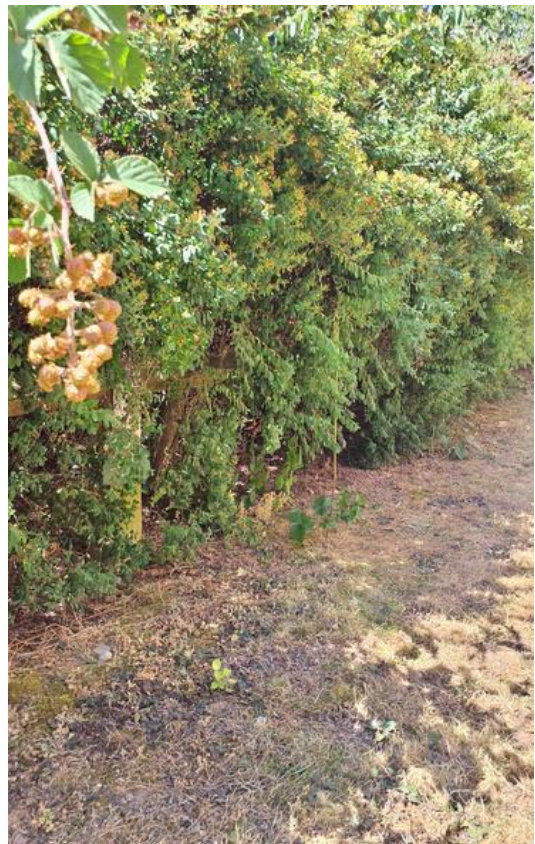
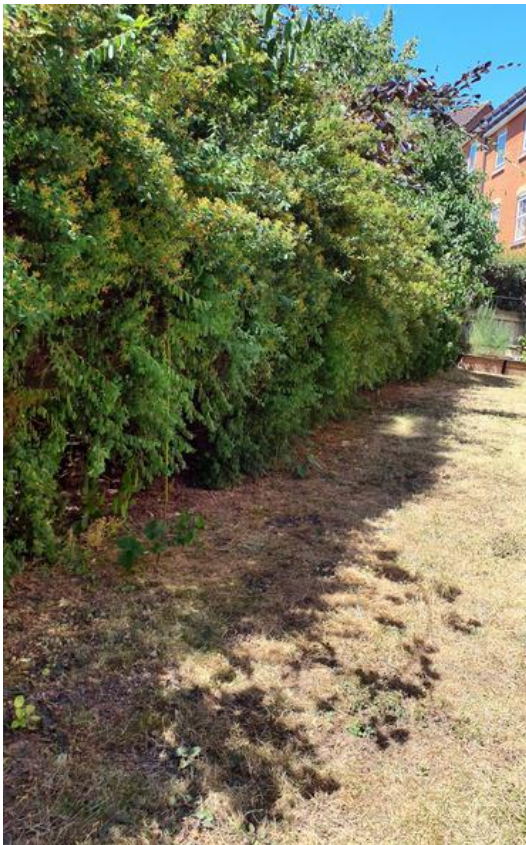
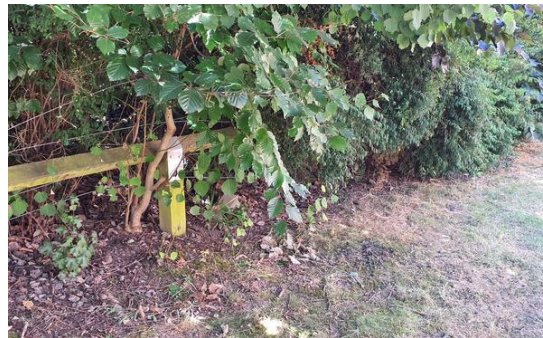
Bushes to rear need cutting back to fence.

Collett Road - planting to rear of scheme overgrown

Planting to the rear of the scheme needs cutting back as bushes and trees are encroaching into the shared garden area and well over the low fence. DS raised on CX 09/07/2025 CRM193953

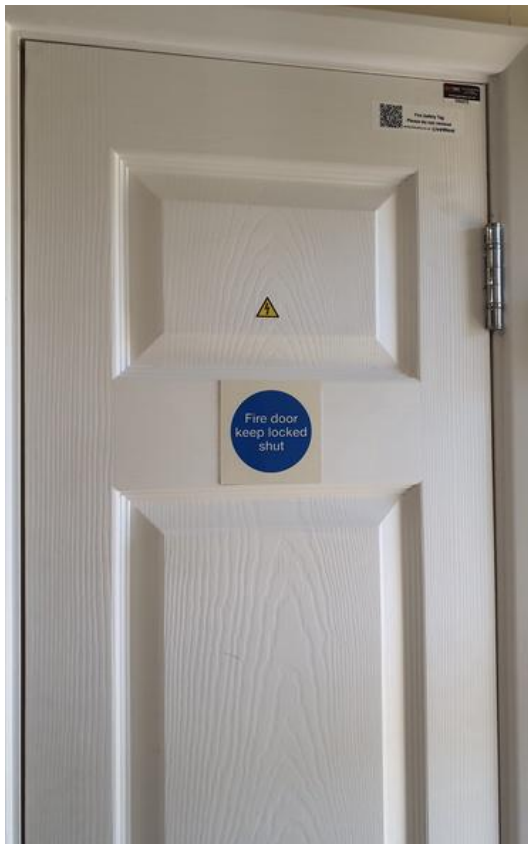
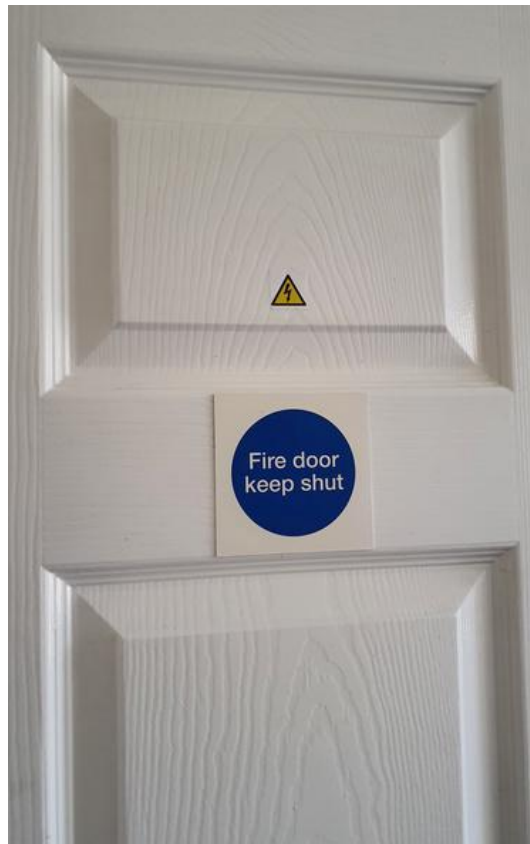
The main consumer unit cupboard has an electrical sticker, but more stickers are needed - requested from team leader.

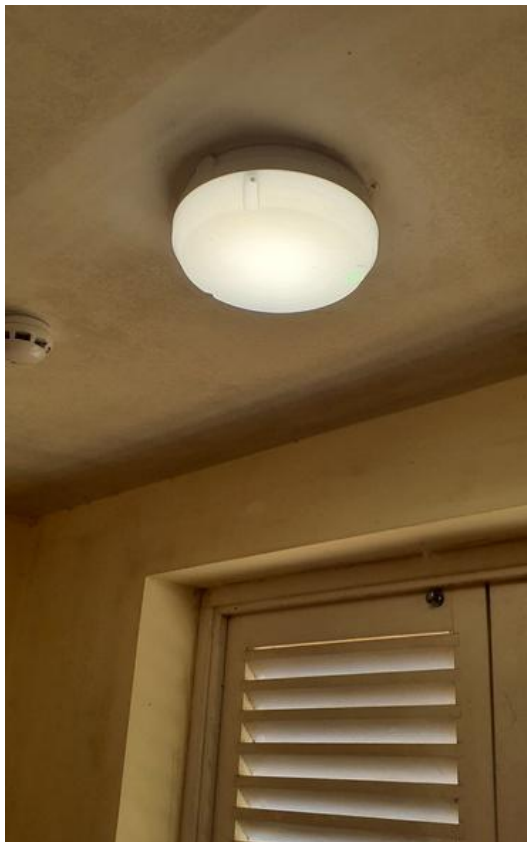
Photo 43

Faulty light in bike store in block 56-66

56-66 Collett Road - Bike store light faulty

The light in the bike store is reportedly flashing on and off constantly. Could be due to a faulty or dirty sensor? Please raise job for this to be looked at. DS raised on CX 09/07/2025 UR0827773

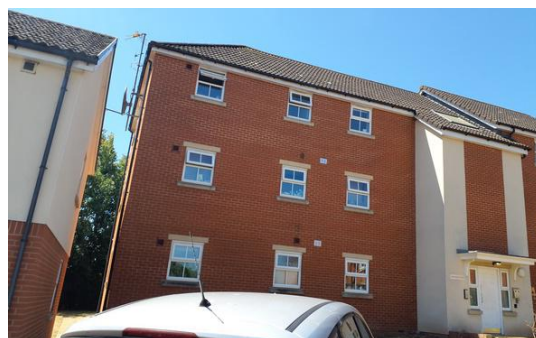
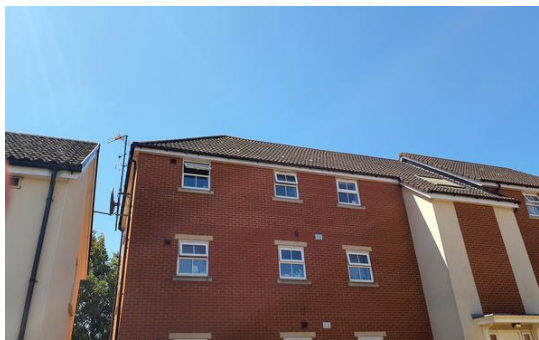
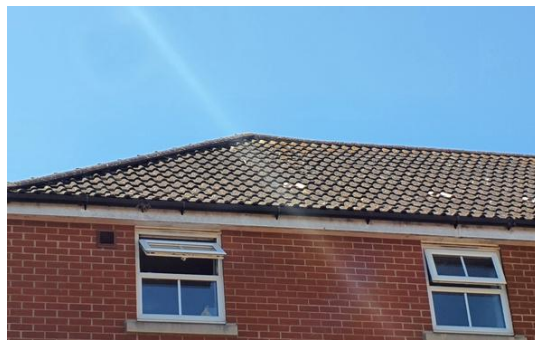
Resident reported small roof tile falling onto the grass which needs to be investigated.

Small roof tile along edge has slipped off

#### 56-65 Collett Road - Small roof tile slipped off

Resident reported that a small roof tile has previously fallen from the roof onto the grass. it is a small piece of tile along the edge of the roof now missing. This is a 3 storey building but this will need to be investigated.
