## **CCTV Inspection Report**

The Dell Royal Victoria Park Bath.

10/07/2025

Job Number: 1406159

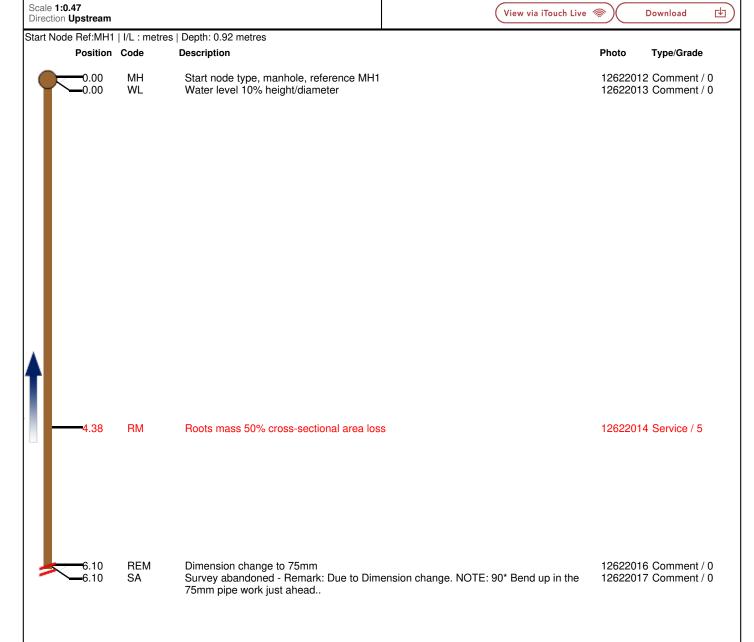
Pipe Size: 100mm Use: Watercourse In this section the survey identified Mass-roots at 4.38mtrs + Survey abandoned at 6.10mtrs due to a Dimension change to 75mm pipe work. NOTE: The 75mm pipe work has a 90\* Bend up at the point of survey abandoned & Looks to be high levels of Scale build-up in the 75mm pipe.

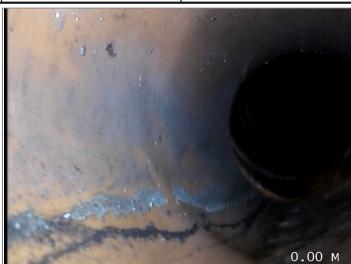
Water level 10% height/diameter

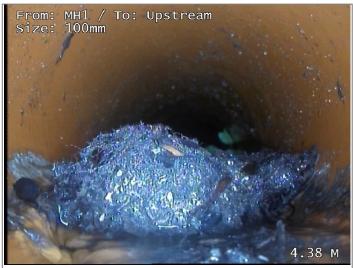
Roots mass 50% cross-sectional area loss

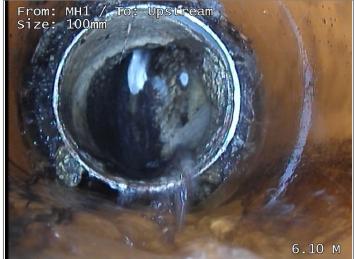
Dimension change to 75mm

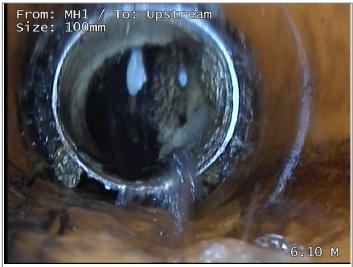
Survey abandoned - Remark: Due to Dimension change. NOTE: 90\* Bend up in the 75mm pipe work just ahead..
