Asbestos Management Survey with
refurbishment element to specified
area(s) only

N/A 26 Barnard's Hill Drive, Salisbury, Wiltshire
SP2 9RA

REPORT DATE – 7 Jul 2025

BATCH REF – J037763

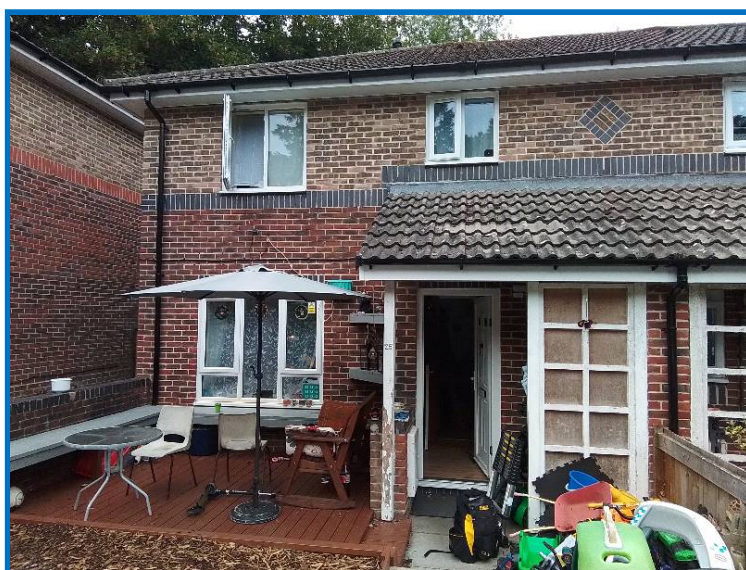
Floor Level	Location	Item, Position & Description	Materials/ Comments	Risk Level Assessment	Sample No	Photo
External	External	No suspect materials found	No Asbestos Detected		16
