Asbestos Management Survey with
refurbishment element to specified
area(s) only
4 Beatty Drive, Reading, Berkshire RG30 6NE

REPORT DATE – 18 Apr 2025
BATCH REF – J037448
PROJECT NUMBER – 803161

Asbestos Summary Report

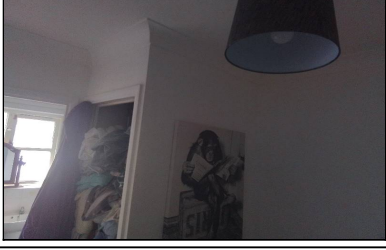
First Floor	First Floor - Landing & cupboard 1 (4) - No suspect materials found	08/04/2025	5	0	0	0	0	0		No Asbestos Detected		Plasterboard panels to ceiling, solid & plasterboard walls, carpet to wood flooring.	No Action Required	N/A

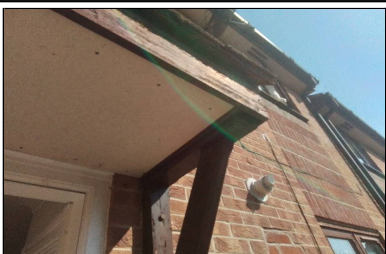
External	External - Externals (1) - Front porch ceiling - Insulating board	08/04/2025	BC001213_10	0	0	0	0	0	Sampled	No Asbestos Detected	1m²	Solid brick walls, concrete slabs, clay roof tiling, plastic guttering and soffits.	No Action Required	N/A

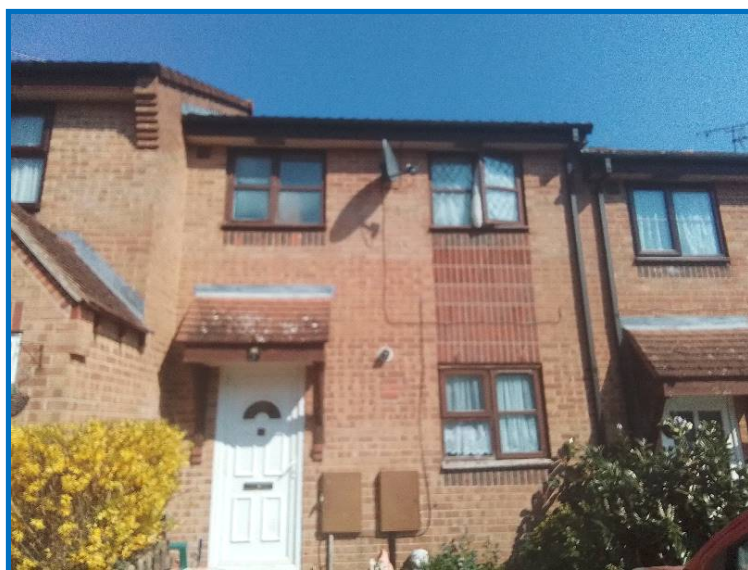
Floor Level	Location	Item, Position & Description	Materials/ Comments	Risk Level Assessment	Sample No	Photo
External	Externals	Front porch ceiling - Insulating board	No Asbestos Detected		BC001213_10
