**An Asbestos Management Survey with part Refurbishment/Demolition (MA and PA) to
the refurbishment survey to areas affected by kitchen replacement**

**at
2 Wellsway Park
Bath
BA2 2DD**

Survey Carried Out On:	20 August 2018	 
Commissioned By:	Daniel Edwards Guinness Partnership The Guinness Partnership 30 Brock Street Regents Place London NW1 3FG	
Date:	24 August 2018	
Our Reference:	J117228	
Surveyed By:	Fiona Williamson

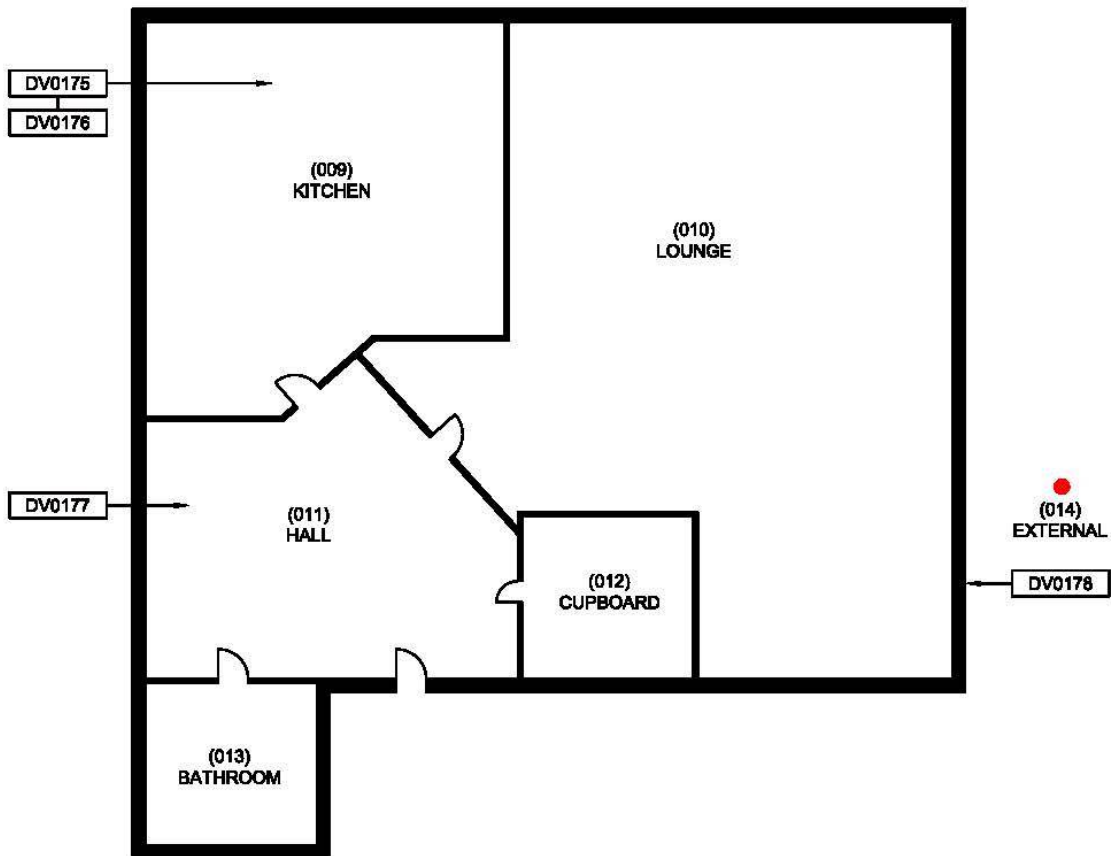
GROUND FLOOR

Please Note: Sketch Plans may only illustrate main asbestos components or specific areas of no access (general areas of no access stipulated not shown)
