**An Asbestos Management Survey (MA & PA) at
11 CHELSCOMBE, BATH, SOMERSET
BA1 4DA**

Survey Conducted:	21 October 2022	
Date of approval:	25 Oct 2022	
Our Reference:	J295772	
Surveyed By:	Fiona Williamson	
UPRN:	13199	
Scope of Works:	Management survey to all accessible areas of the property.	
Requested By:

Pennington Choices Ltd carried out an Asbestos Management Survey (MA & PA) at VOID 11 Chelscombe. The survey and this report are in accordance with HSG264 – Asbestos: The Survey Guide.

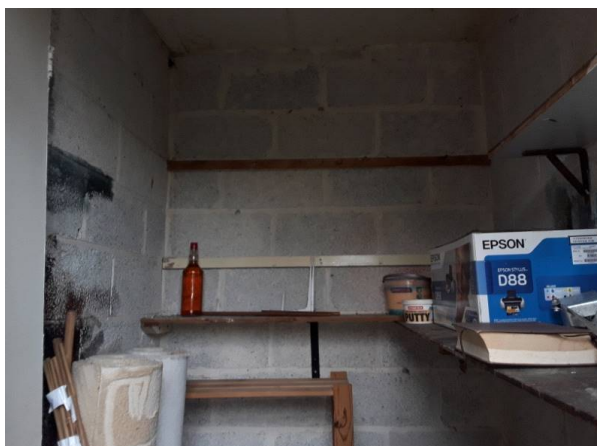
Building:	11 Chelscombe	Floor Level:	Ground	Item Ref:	J295772-13
Room Name:	(007) Cupboard				
Sample Ref:					
Component:	No asbestos containing materials found				
Extent:

Material Assessment		
Product Type	Extent of damage	Surface Treatment Score
Asbestos Type	Material Assessment Score (MA)	
No suspect materials

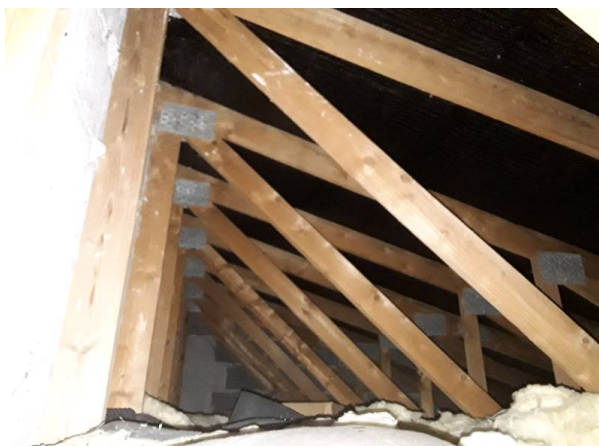
Building:	11 Chelscombe	Floor Level:	Roof Void	Item Ref:	J295772-14
Room Name:	(008) Loft				
Sample Ref:					
Component:	No asbestos containing materials found				
Extent:

Material Assessment		
Product Type	Extent of damage	Surface Treatment Score
Asbestos Type	Material Assessment Score (MA)	
No suspect materials
