# **RBS - Short Inspection Form V1**

22 Apr 2025 / Flat 15 Blackhorse Court Blackhorse Road, Kingswood, Bristol, BS15 8EA / Julian Mallia - RBS North

RBS Inspection requested by d2d to check condition of windows, according to suppliers they are unable to source replacement mechanisms in UK

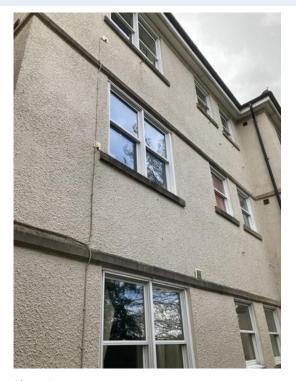
Photo 3

There are five pairs of sliding sash windows in flat 15 and the cords are broken on 3 of the 5 windows. Our in house team have researched these windows to try to source the correct parts to allow the windows to be repaired and it appears that they would need to be sourced from the USA and approximate costs for obtaining the correct parts for the 3 windows would be around £700 plus any fitting costs etc. The design means that springs could not be used instead and the diameter and make up of the cord is critical to be able to pass through openings and pullies that form the mechanism.

Consideration needs to be given to bringing the block forward in the programme. If this is not feasible then it will be necessary to replace a minimum of 3 windows as an ACR.
