## Asbestos Refurbishment Survey

**0408002700**  
**27 BUCKLAND CLOSE**  
**PARK NORTH**  
**SWINDON**  
**WILTS**  
**SN3 2RP**

**Swindon Borough Council**

Project Number:	Survey Date:	Issue Date:
N-58424	10 September 2024	15 September 2024

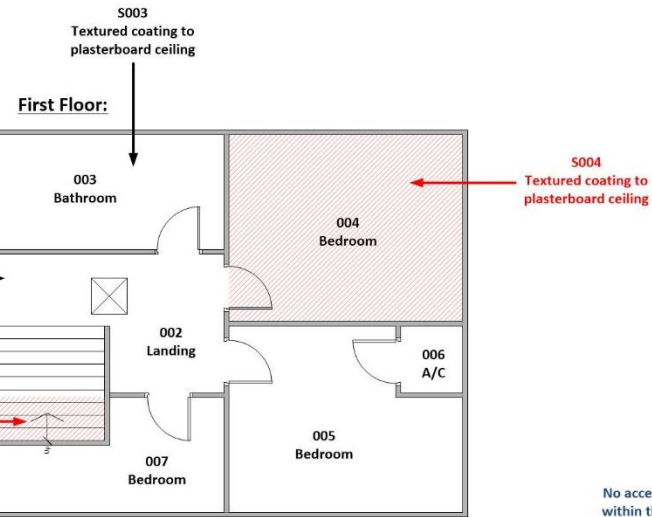
No access was gained below the floor covering throughout, due to decorative damage that would be caused.
