## Management Survey (with MA only)

**9-49 Various  
Haydon Court  
Swindon**

**,  
SN25 1QN**

**Sanctuary Group**

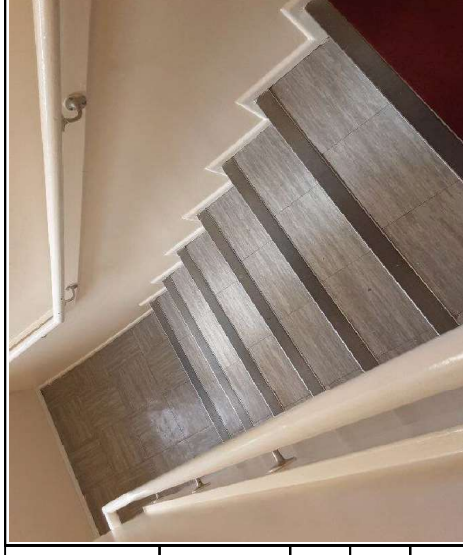
| Inspection Number: | 5 | Intrusive Area – Yes or No: | No |

| Damage & Deterioration: | Good Condition | | |

| Recommendation: | Not applicable |

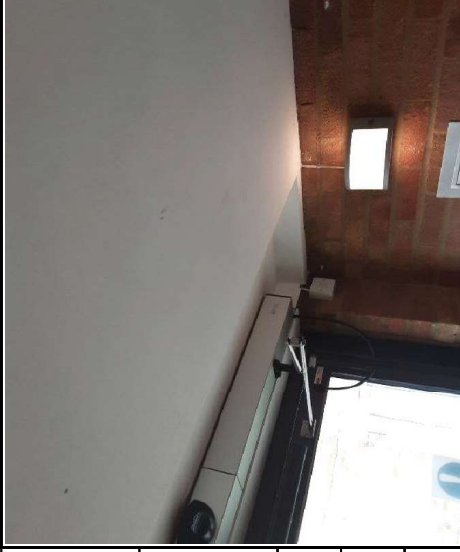
| Room Comments: | Plasterboard ceiling solid walls .concrete floor with carpet covering. | |
