Site ID: **a-104807** Management Survey

Sanctuary Housing Group
Client ID: **S130**

The Hermitage
1 Bremilham Road
Malmesbury
Swindon
SN16 0PQ
United Kingdom

23rd February 2017

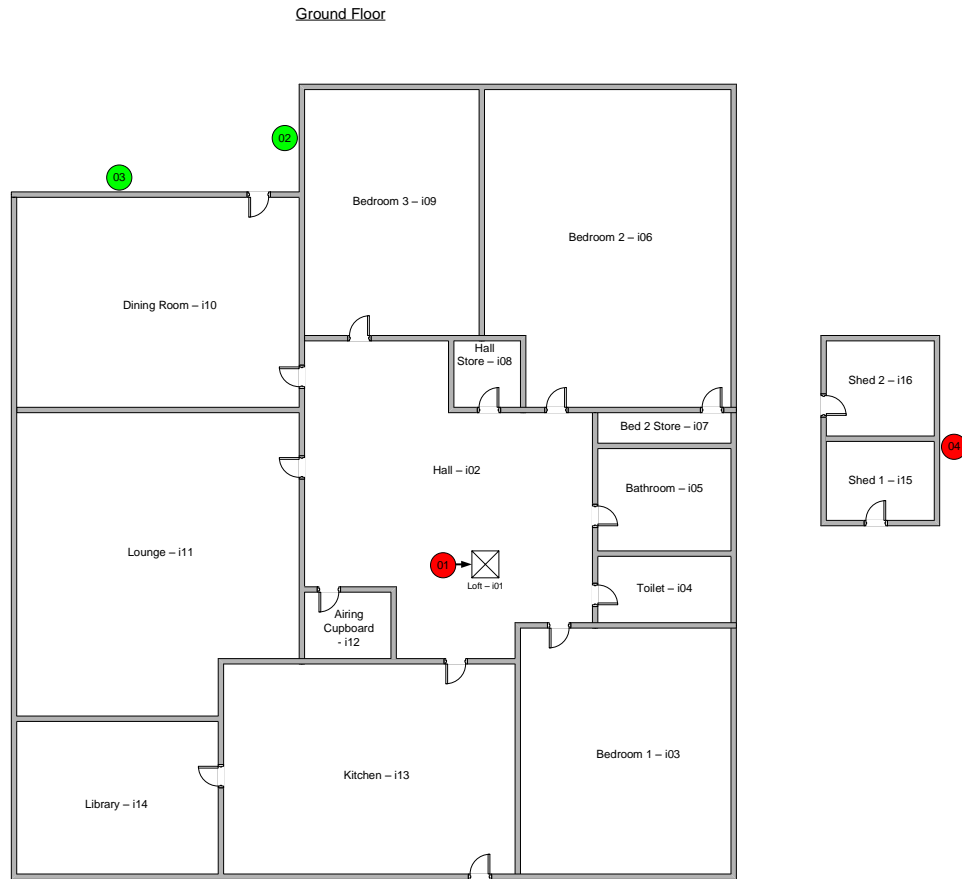
Sanctuary Group – The Hermitage, 1 Bremilham Road, Malmesbury, Swindon, SN16 0PQ

- Key
- Asbestos
 - Non Asbestos
 - Loft Access
