Our Ref: 12018
Date: 29th January 2025

Fire Damage at 13 Hyde Close, Sway.

Thank you for appointing R Elliott Associates Ltd to inspect the roof timbers at 13 Hyde Close, Sway, following a fire in August 2024. A site visit was carried out on Wednesday 22nd January 2025, during which part of the house was inspected internally.

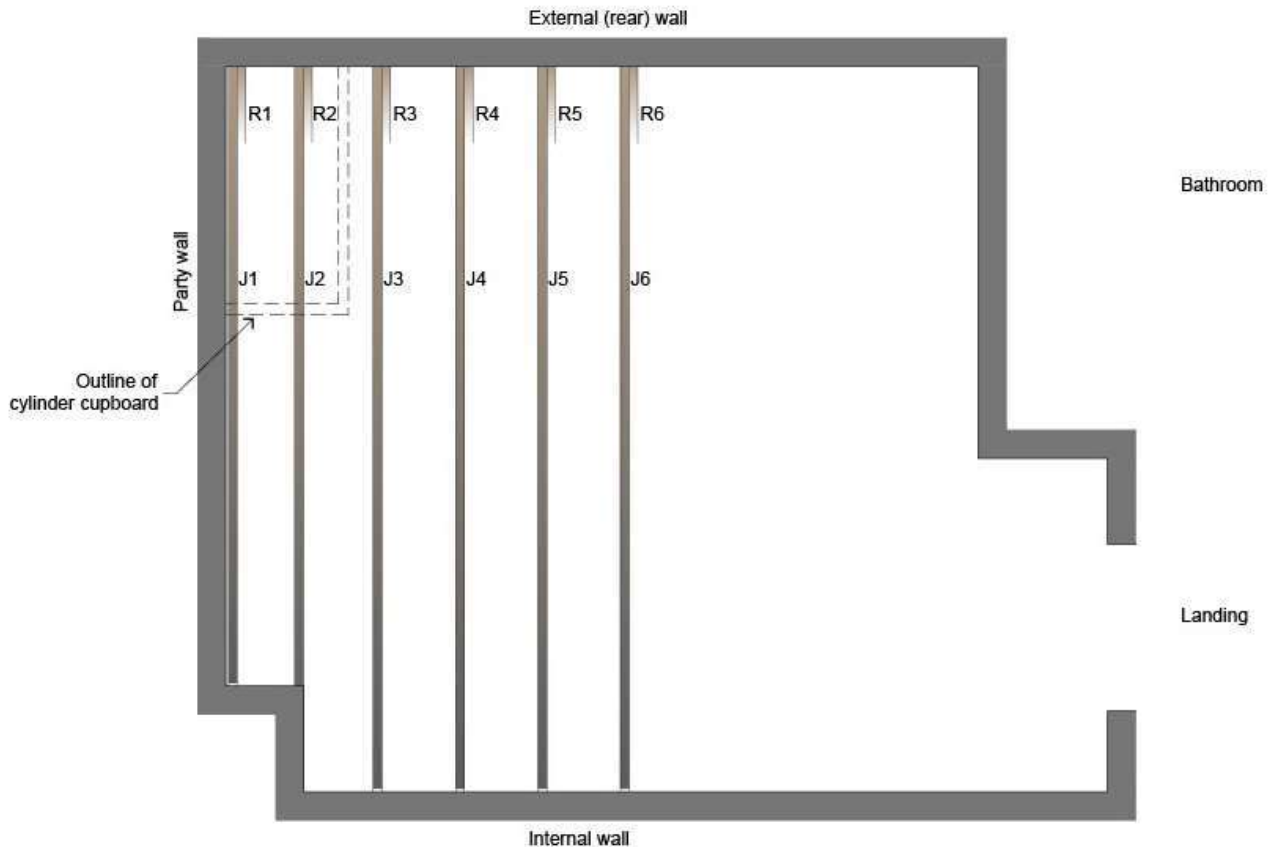
Much of the ceiling still has a plasterboard finish but there were six ceiling joists that were exposed, to varying degrees, that could be assessed for damage, along with the rafters above that were accessible for inspection. The plasterboarded areas were not included in this assessment.

The methodology for this survey was to determine the remaining section of the timber sections by removing the charred timber from the external face of the timbers in a small area in what appeared to be the worst affected areas. The remaining section was measured and the section size subsequently analysed to confirm whether the timber would be suitable for re-use or require replacement.

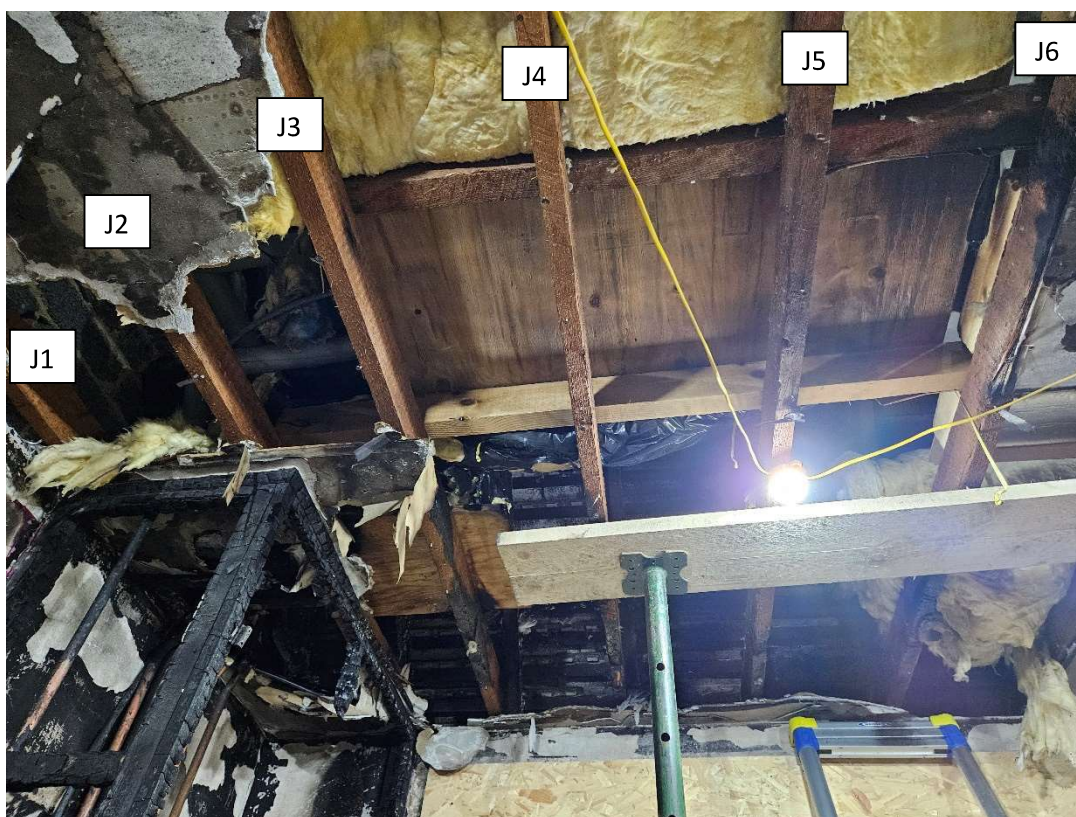
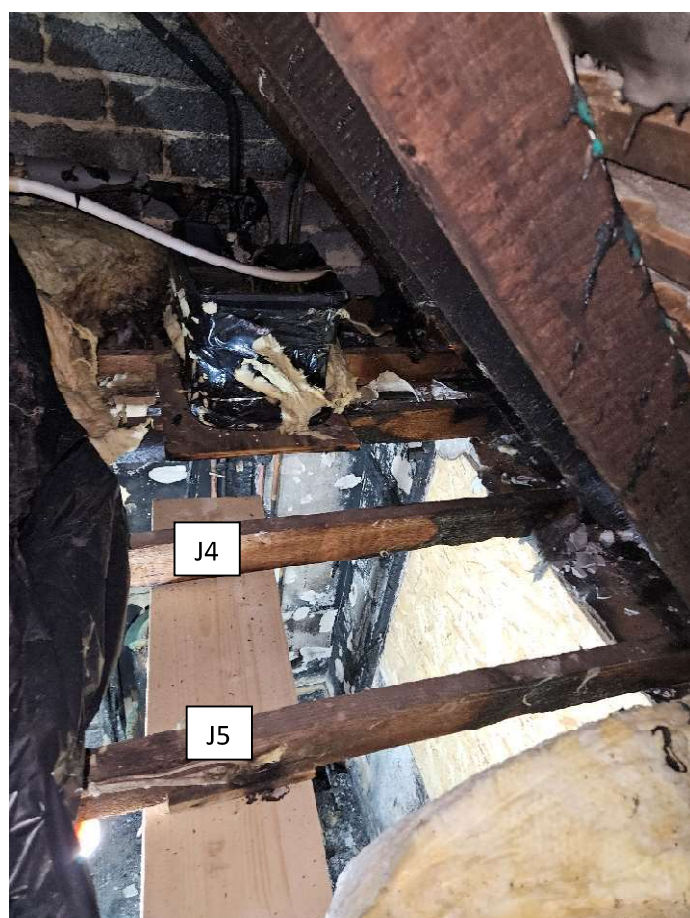
Joist 1 / Rafter 1

Rafter	R1 38x100	R2 38x100	R3 34x99	R4 37x99	R5 38x100	R6 38x100
Joist	J1 35x98	J2 34x99	J3 33x100	J4 34x94	J5 33x100	J6 38x100
