RBS - Short Inspection Form V1

11 Feb 2025 / 43 York Road, Montpelier,
Bristol, BS6 5QB / Richard Phillips - RBS
North

An RBS inspection was requested to inspect the side elevation porch which is used as the main entrance as the customer is concerned that the porch is unstable and in need of repairs

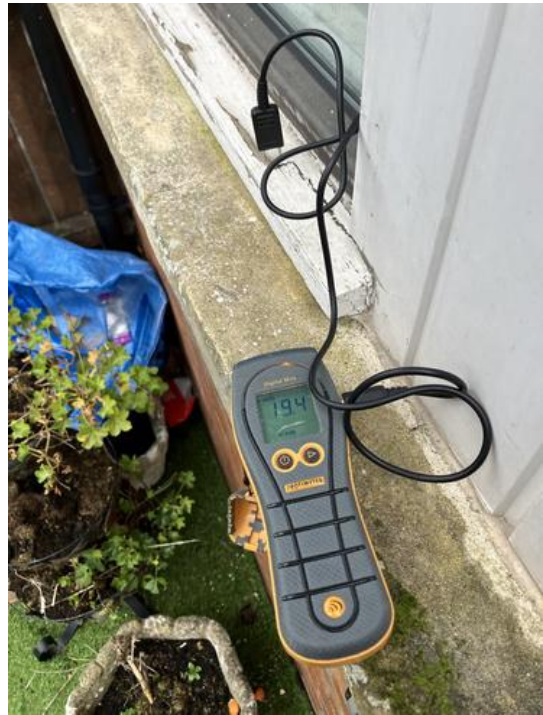
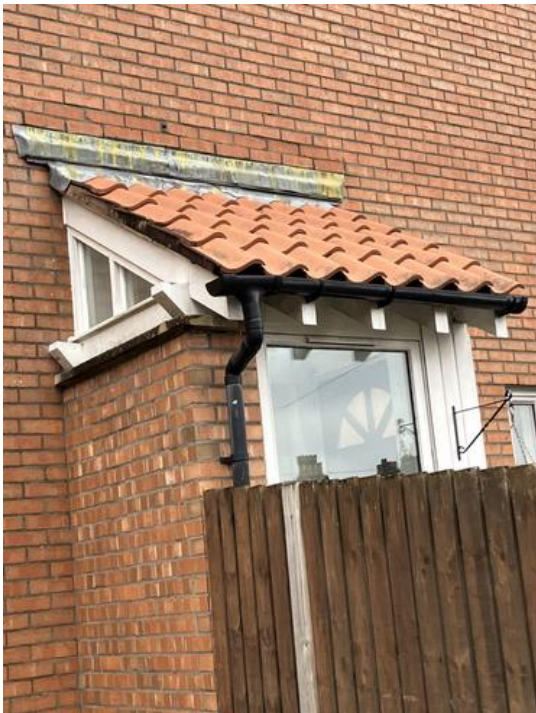
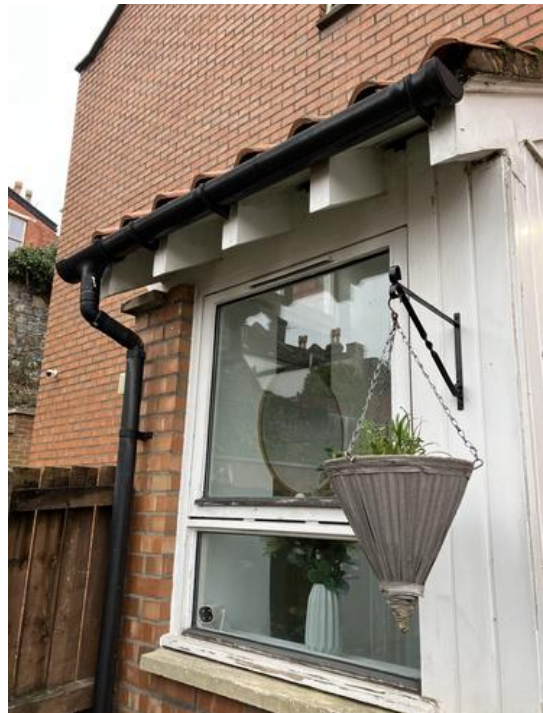
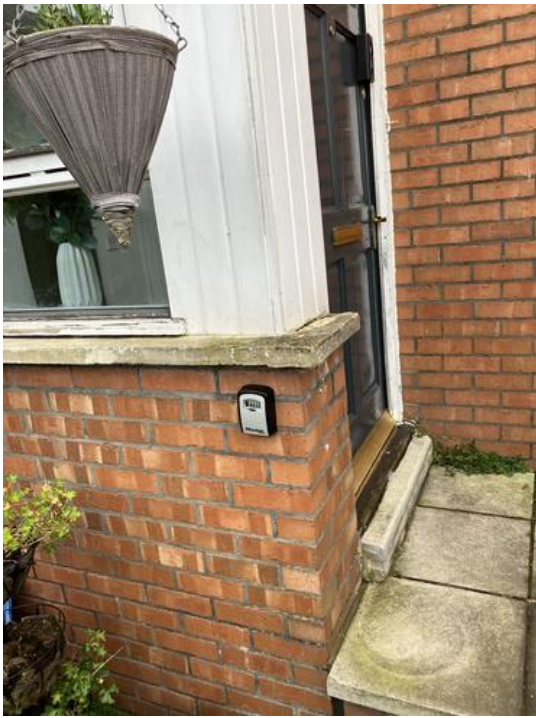
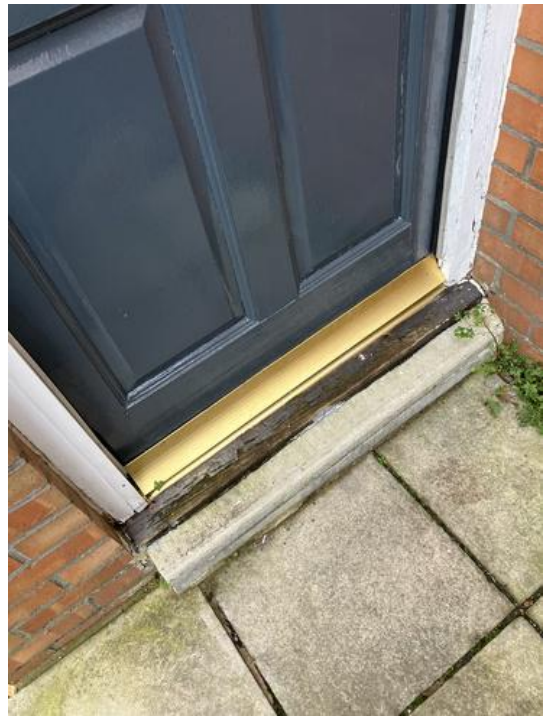
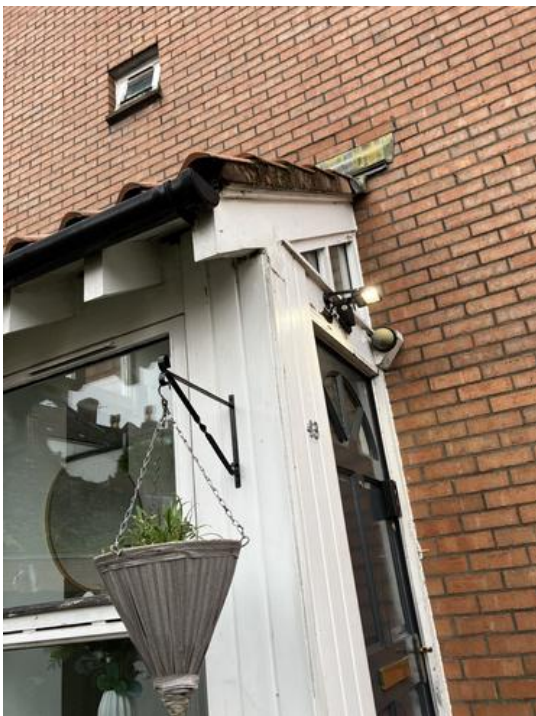
Visually the timberwork on the porch had delaminated paintwork and further moisture level readings were taken of various timbers which were in the at risk category and absorbing moisture.

Brick work - Initial inspection of the brickwork found that it is probably structurally strong enough to cope with a new UPVC porch and a new porch design will generally be lighter and weather proof.

The customer was concerned over some defective minor sections of cement/concrete which has come away.

Repairs including a new door and frame and any other repairs required once the timbers are exposed would be a considerable cost and a new component replacement which will last 15 years may be cheaper and a better investment.
