EXPERT WITNESS REPORT HOUSING DISREPAIR

At 58 Mill Road, Purbrook, PO7 7BZ

Prepared by:		Damien George
Inspection date:		Saturday 10 th July 2021
Report Dated:		Friday 30 th July 2021

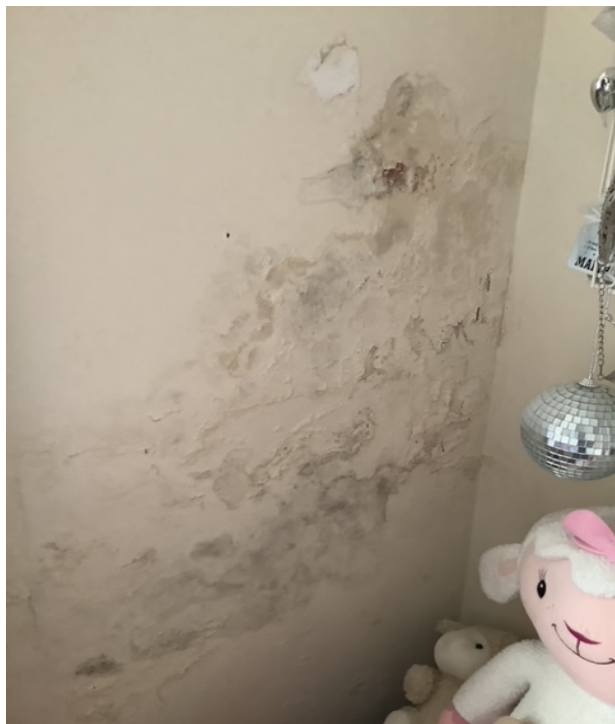
2.2 Upon inspection of the rear upstairs bedroom, damp penetration was observed on the rear wall and requires hacking off.

2.3 Saturated and high Wet readings were recorded, using a Protimeter MMS, in search modes on the rear wall which was recorded at 1000% MC.

Image of damp penetration to rear wall of bedroom

2.6 Rear upstairs bedroom wall will need to be hacked off and allowed to dry with an industrial dehumidifier before re-plastering with waterproof render and then apply skim coat to make good. Once completed, apply two coats of white emulsion paint to wall.

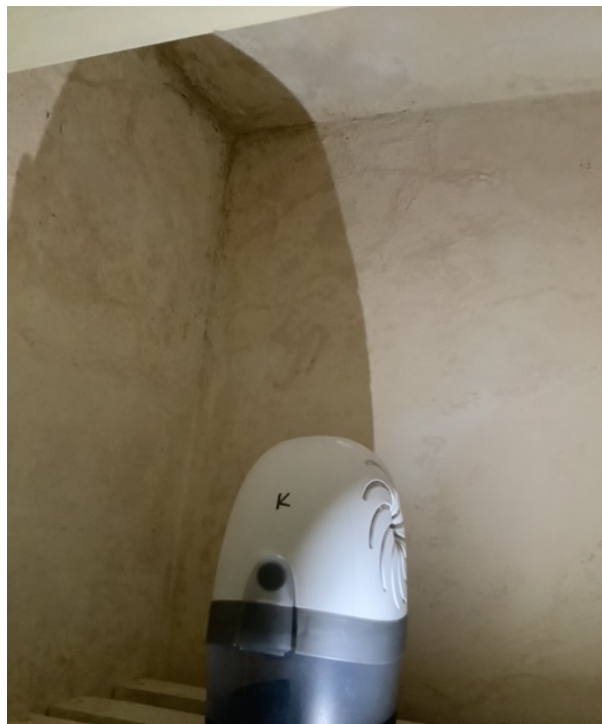
2.2.1 When inspecting the storage cupboards in the rear middle bedroom, damp and mould growth was observed on the walls and ceiling.

2.2.2 Saturated and high Wet readings were recorded, using a protimeter MMS, in search modes on the rear wall which was recorded at 1000% MC.

2.2.3 Brown water staining was observed on the ceiling of the storage cupboard.

- 2.2.5** The cause of damage to the storage cupboards is due to an ongoing roof leak which requires an investigation.

Image of mould growth and damp penetration to storage cupboard

- 2.2.7** An investigation is required to check full integrity of the roof and a report should be provided.
- 2.2.8** Entire storage cupboard will need to be hacked off and allowed to dry with an industrial dehumidifier before re-plastering with waterproof render and then apply skim coat to make good. Once completed, apply two coats of white emulsion paint to wall.

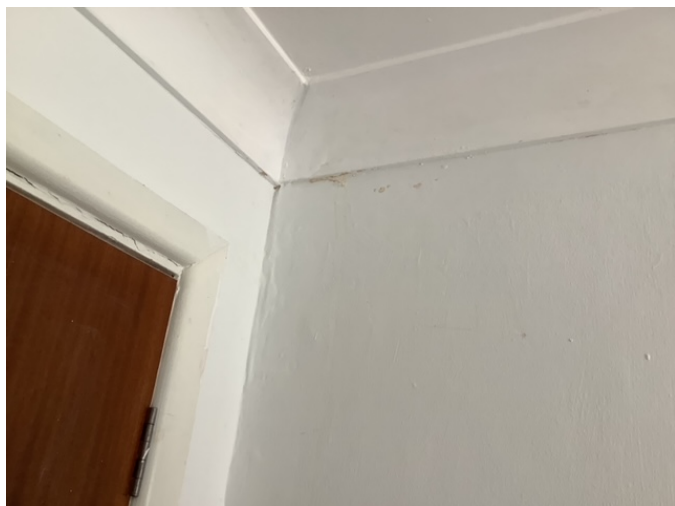
Image of mould growth brown water staining on left hand side wall to bedroom

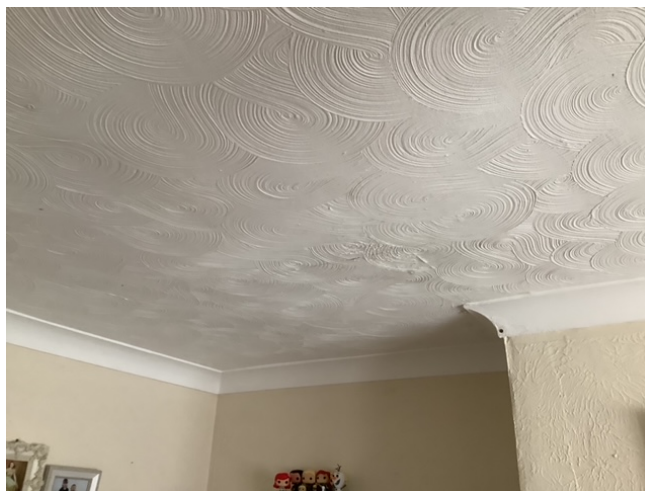
- 2.3.1** Upon inspection of the living room, brown water staining was observed on the plasterboard ceiling.
- 2.3.2** Upon inspection of the upstairs front right bedroom, brown water was observed on the plasterboard ceiling.

- 2.3.3** Similar to point 2.2.5 an ongoing roof leak has led to damage to plasterboard ceilings.

Image of damage section of plasterboard ceiling

- 2.3.4** New section of plasterboard ceiling required to bedroom and living room with decorative works to match existing ceiling.

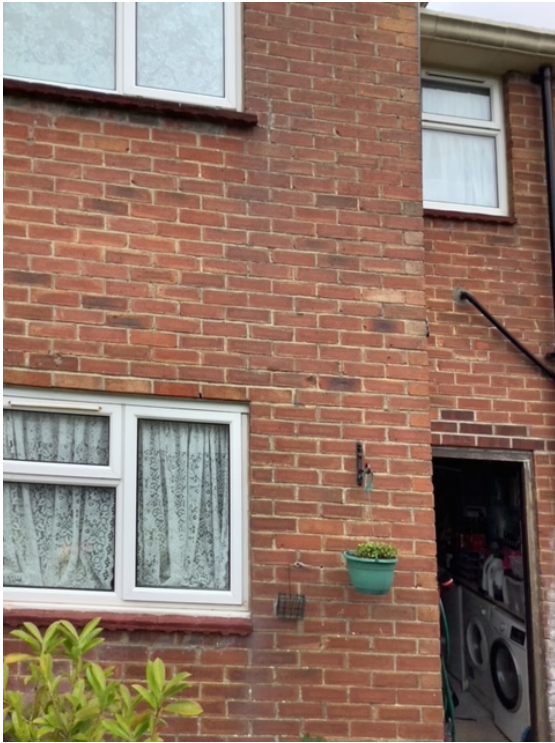
2.4 As per point 2.1.1, defective brickwork to the rear elevation has led to water ingress causing plaster damage onto wall.

Image of defective brickwork to rear elevation

2.5 Re-pointing works required to rear elevation as there are a few spalled bricks.
