Refurbishment Survey (with MA only)
At
**29 Whittox Lane,
BA11 3BY**

Sanctuary Group

Scope of Survey Works

Detailed Scope of Works:
Sample to bathroom ceiling

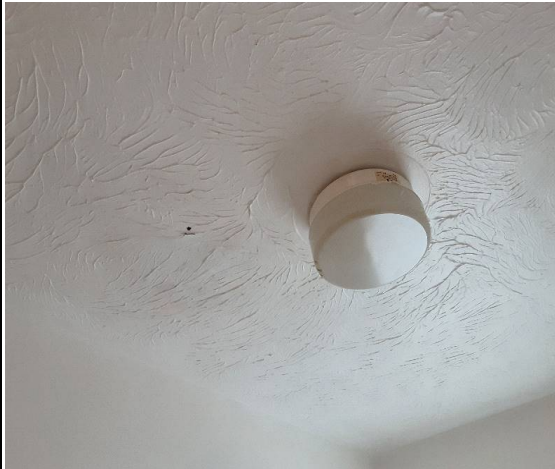
| Inspection Number: | 1 | Intrusive Area – Yes or No: | Yes |

| Description: | Decorative Finishes | | |
| Product Type: | Textured Coating | | |
| Damage & Deterioration: | Low Damage | | |
| Asbestos Type: | No Asbestos Detected | | |
| Material Score: | 0 | | |

| Room Comments: | Ceiling sampled | |

| Recommendation: | Not applicable | |
