RBS Inspection

Property Address 116 Freeview Road, Bath, BA2 1DZ

Reason for Inspection The tenant is concerned about the safety of the timber decking and steep back garden.

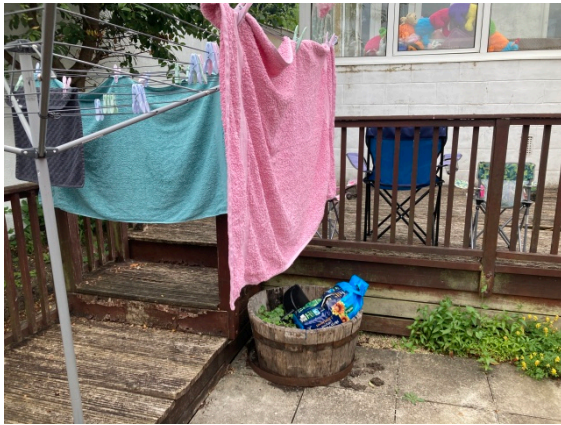
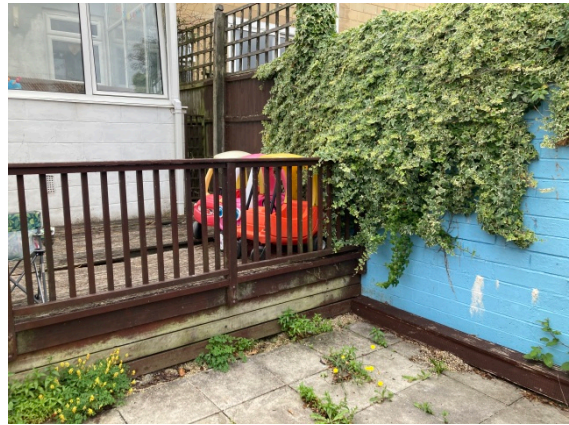
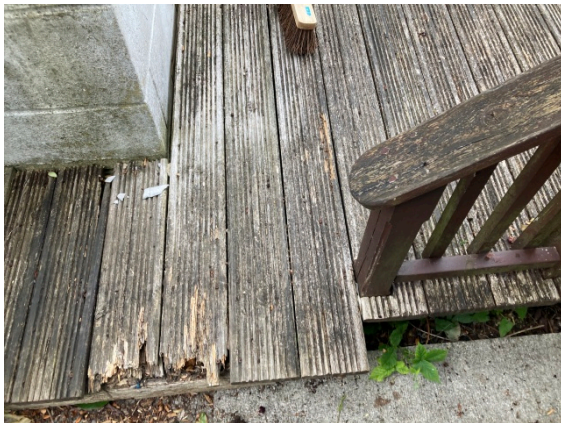
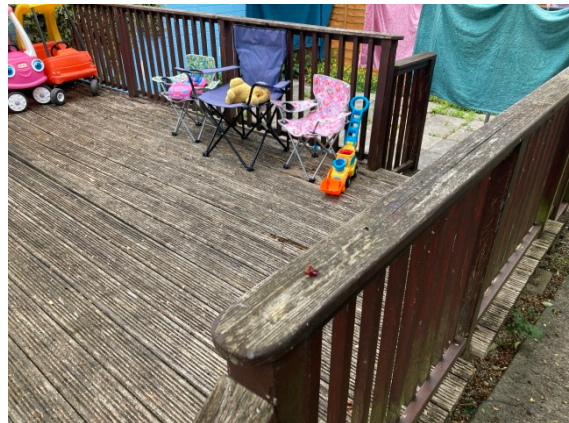
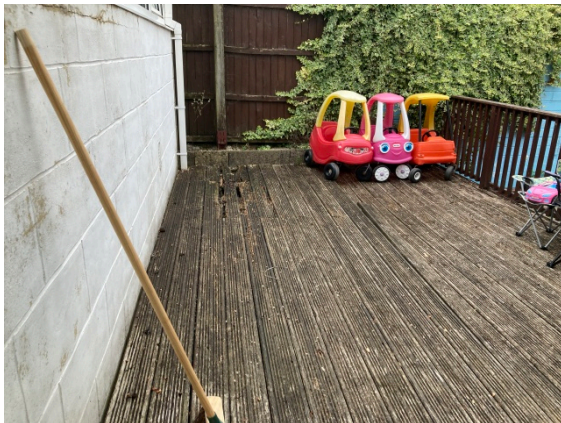
Photographs

Issue(s) or Defect(s) Identified	There is a large area of timber decking at the rear of the property which was already in place when they took the tenancy. The decking is in very poor condition and constitutes a hazard. It will need to be completely removed and the ground beneath left in a safe condition. The tenant understands that the decking will not be replaced and only minimal work will be done to the ground beneath to make sure there are no hazards present. It will then be their responsibility to maintain this area of the garden. The decking is 5m x 4m with a stair 1m x 1.5m. It is about 500mm above ground level at the highest point.
Works to be raised	Take down timber decking together with the stairs and handrailing. Remove from site and make sure ground beneath is left free of any hazard ready for the tenant to improve as garden that will be their responsibility.
RBS Inspection General Notes
